Technical Service Information

THM 325

NO SHIFTS AFTER KICK DOWN

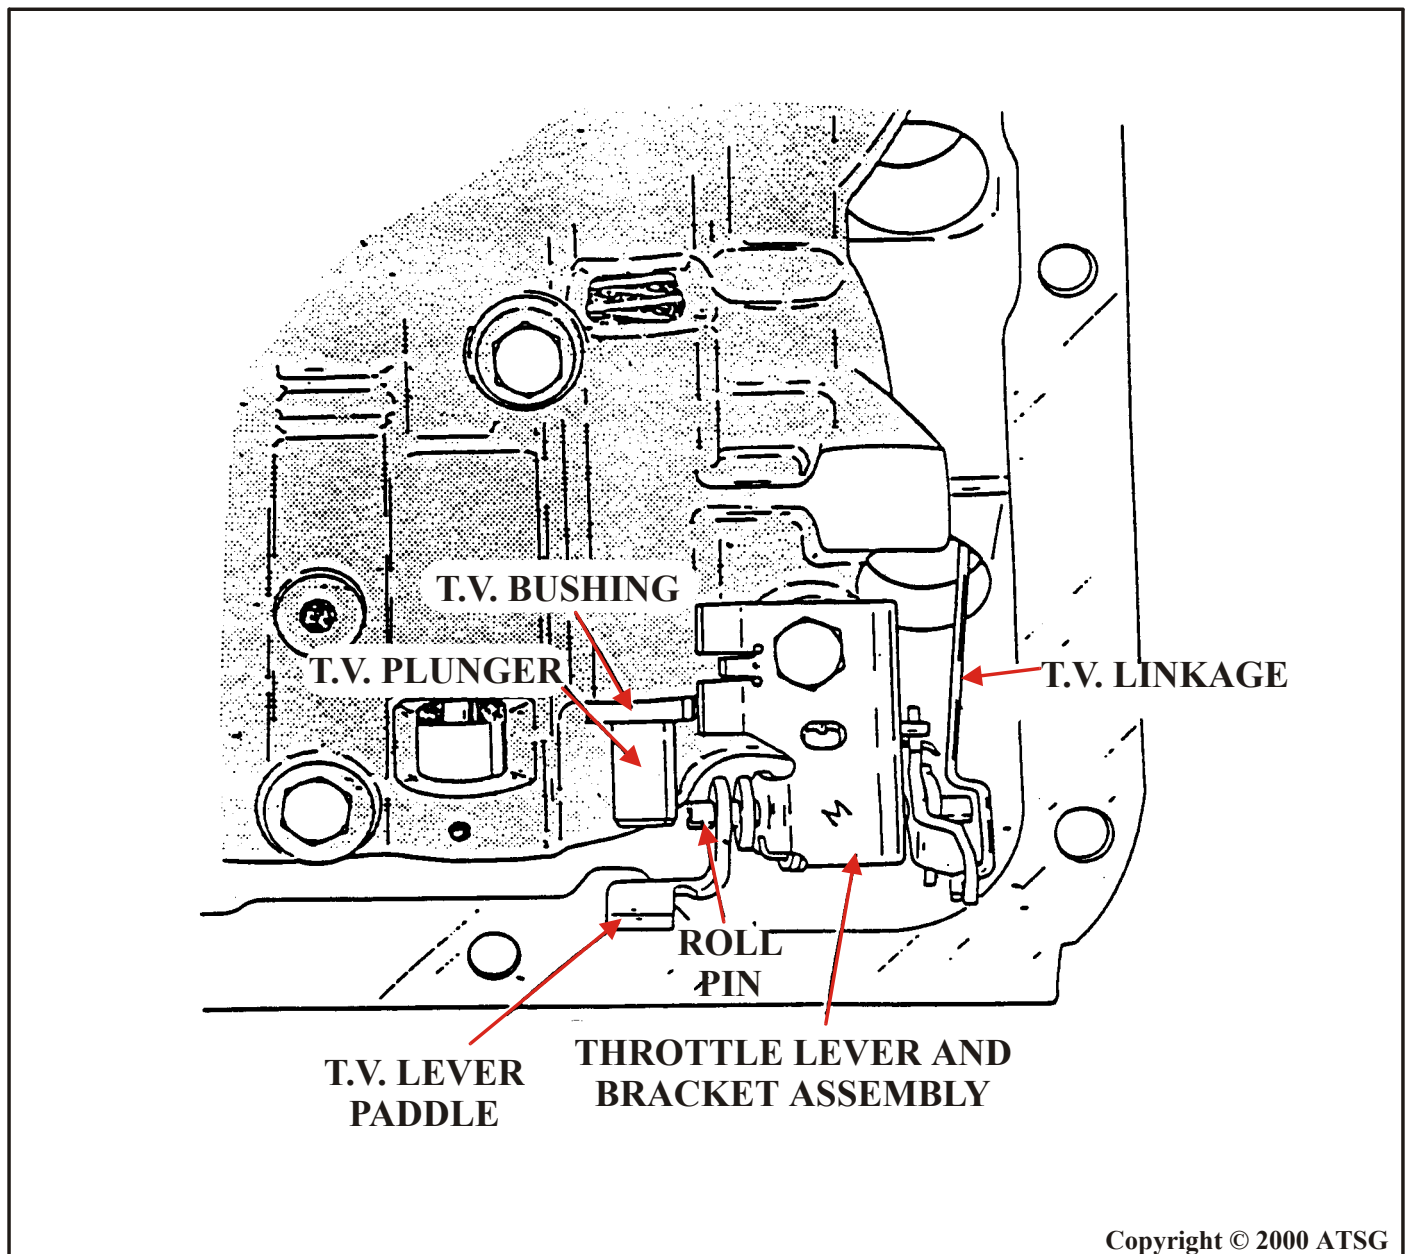
Figure1

COMPLAINT: Late upshifts or erratic shifting after using kick down.

CAUSE: The T.V. Valve may be binding due to the roll pin in the throttle lever and bracket assembly, which is extending beyond the T.V. Lever paddle See Figure 1.

CORRECTION: Drive the roll pin towards the bracket to have clearance between the valve and the roll pin.
