# Technical Service Information

## FORD AXOD/AXOD-E ERRATIC UPSHIFTS AND DOWNSHIFTS ERRATIC LINE PRESSURES PREMATURE CLUTCH/BAND FAILURE

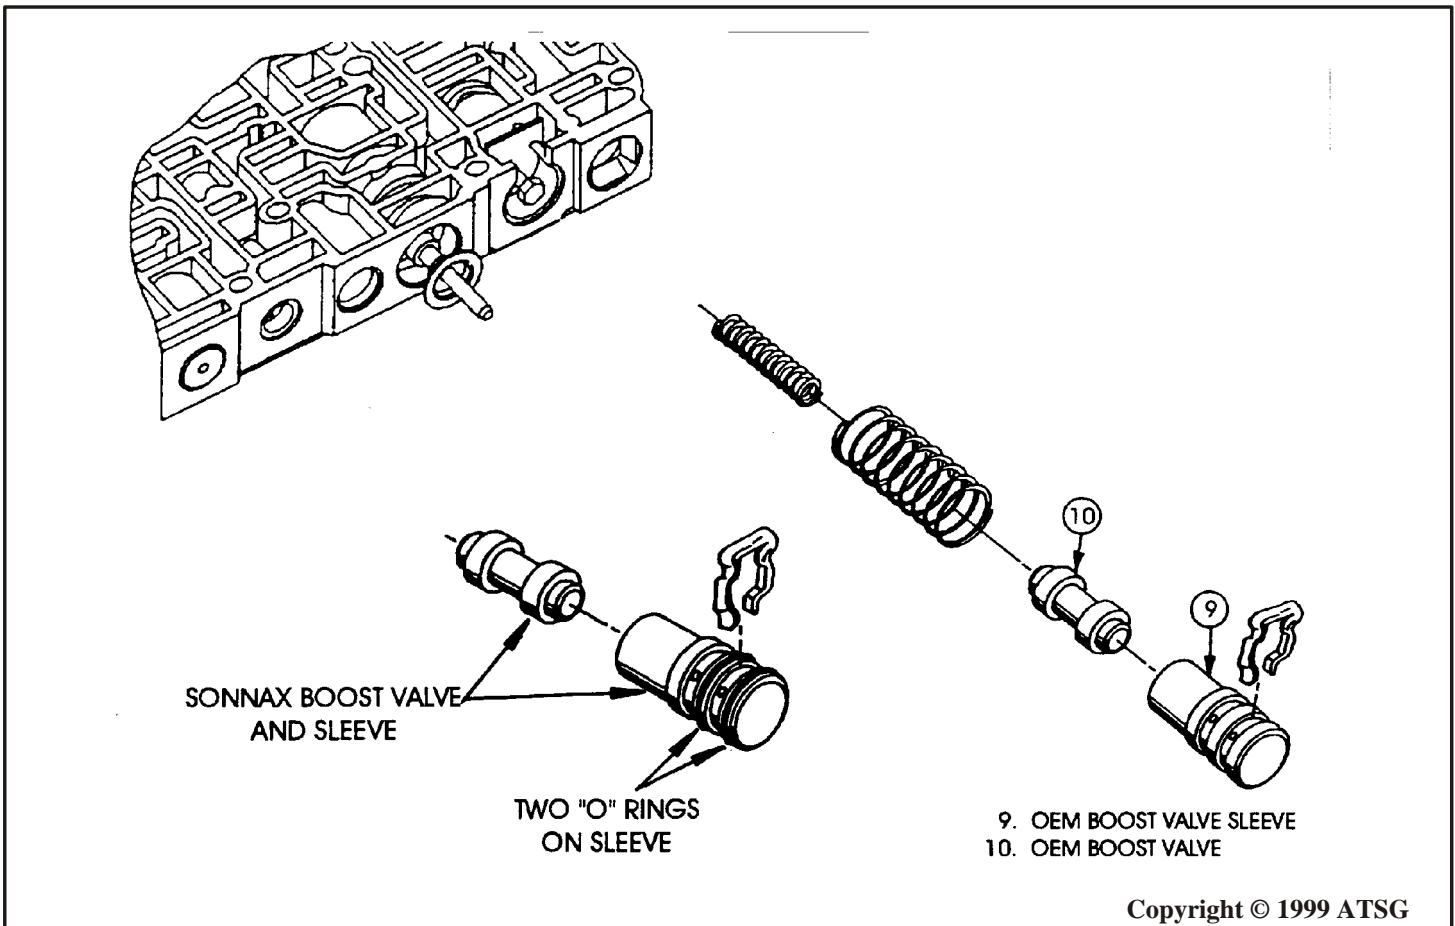
Figure 1

**COMPLAINT:** Some vehicles equipped with the AXOD or the AXODE transmission may exhibit a flair 1-2 or 2-3 upshift, 2-1 downshift clunk, non-adjustable throttle pressure, high line pressure, harsh reverse (300 PSI) and clutch and/or band failure from poor line rise.

**CAUSE:** The cause may be, the boost valve wearing the inside diameter of the boost sleeve. When this occurs, oil that enters the T.V. orifice leaks past the boost valve and exhausts through the reverse orifice. The outside diameter of the boost sleeve also allows some leakage through the valve body (See Figure 1).

**CORRECTION:** The Sonnax replacement assembly is designed to help eliminate the problems listed above, and is available under Sonnax part number 96201-01 K from your transmission parts supplier. The new parts are specially coated to eliminate excessive wear and the two "O" rings provide additional protection against leakage through the valve body, as shown in Figure 1.
