MAZDA/FORD GF4A-EL/GF4EAT HARSH UPSHIFTS

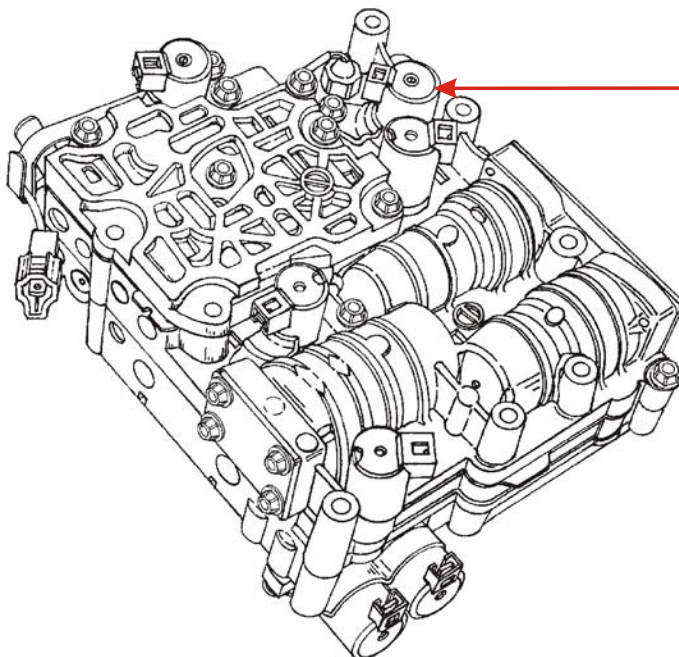
PRESSURE CONTROL SOLENOID

CAUSE: The cause may be, a faulty Pressure Control Solenoid, a worn Boost Valve and Sleeve and/or a worn Pressure Regulator Valve bore which is part of the Rear Control Valve Body.

CORRECTION: Replace the Pressure Control Solenoid as shown in Figure 1, with Ford part number F32Z-7G136-AA or Mazda part number FU9A-21-1G1A. Inspect the Pressure Regulator Valve and the Pressure Regulator Valve bore for wear or scoring as shown in Figure 2. If the bore has "shiny" spots where the Valve rides a "New" Rear Control Valve Body can be purchased from Mazda. Inspect the Boost Valve and Boost Valve Sleeve for wear or scoring, and replace as needed with Sonnax boost valve and sleeve as shown in Figure 2.

**FORD PART NO.
F32Z-7G136-AA**

**MAZDA PART NO.
FU9A-21-1G1A**

**NOTE: These Part Numbers
Are For The Same Solenoid.**
