CHRYSLER RWD TRANSMISSIONS IMPROVED LINE RISE & THROTTLE RESPONSE

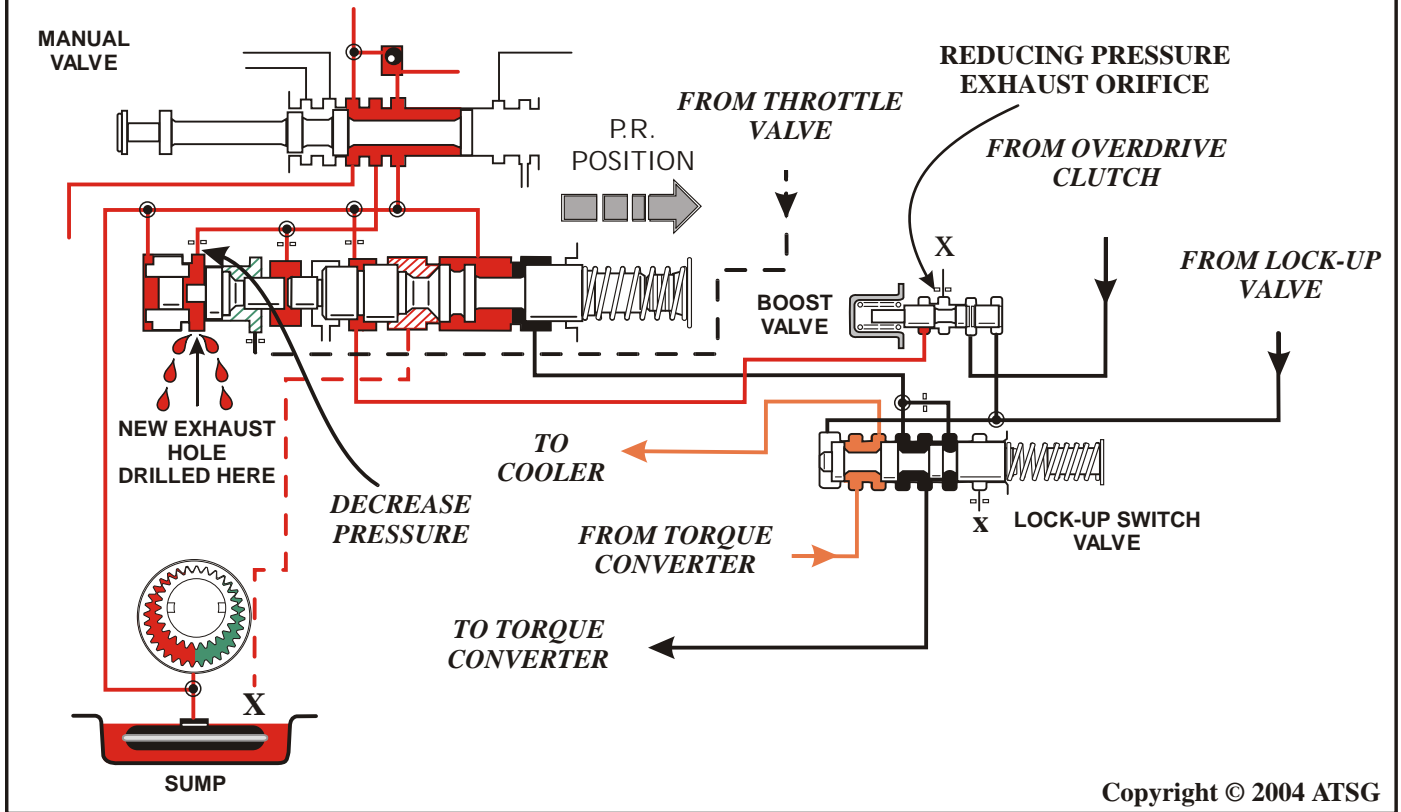
Figure 1

CAUSE: Decrease pressure supplied to the pressure regulator valve throttle plug, which is used to prevent line pressure from exceeding approximately 100 to 120 psi at wide open throttle (See Figure 1).

PARTIAL HYDRAULIC SCHEMATIC OF PRESSURE REGULATOR VALVE "DRIVE" POSITION 1st thru 3rd GEAR

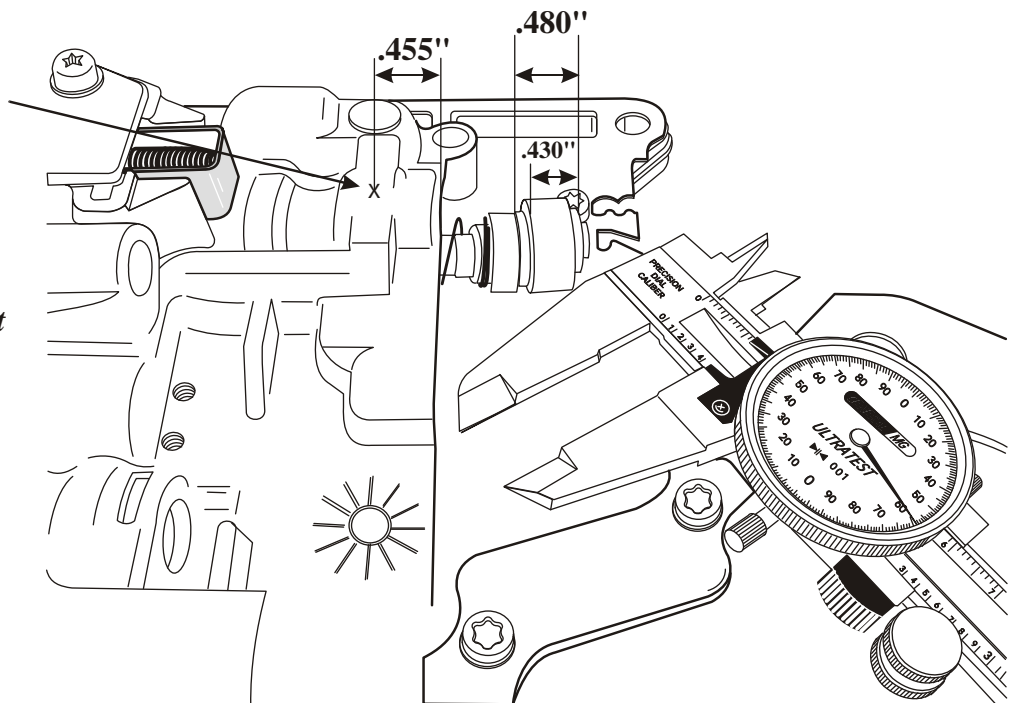
Figure 2

COMPLAINT: It is commonly known that line rise of RWD Chrysler transmissions, i.e. 904, 727, 500/618, all **“PRE”** 1996 RE units is sluggish and in many cases insufficient. This causes technicians to find themselves having to adjust the throttle rod/cable in an attempt to located a happy medium of shift feel and shift timing. Many times the vehicle is delivered with out really achieving the desired shift characteristics.

CORRECTION: Drill a .040" exhaust hole through the exterior casting into the decrease pressure circuit by following the “example” steps below and illustrated in Figure 2. A controlled venting of this oil will allow a more rapid line rise response to throttle opening, improving the shift characteristics of the transmission. It also will allow a more desirable top end line pressure reading as well as a slight increase in the converter clutch apply pressure.

Step 1. Measure the overall length of the plug (.480") as seen with the example in Figure 2.

Step 2. Measure the length of the plug minus one shoulder (.430") as seen with the example in Figure 2.

Step 3. The difference between the two readings is .050". By dividing that number in half (.025") and adding it to the figure acquired in step 2 (.430"), the depth from the edge of the bore to the decrease circuit can be marked for drilling on the top side of casting, approximately .455", also shown in Figure 2.

Measure approximately .455" in from the edge of the valve body over the pressure regulator valve throttle plug bore and drill a .040" exhaust hole through the valve body casting.
