# Technical Service Information

## FORD E4OD NO 2-3 UP SHIFT

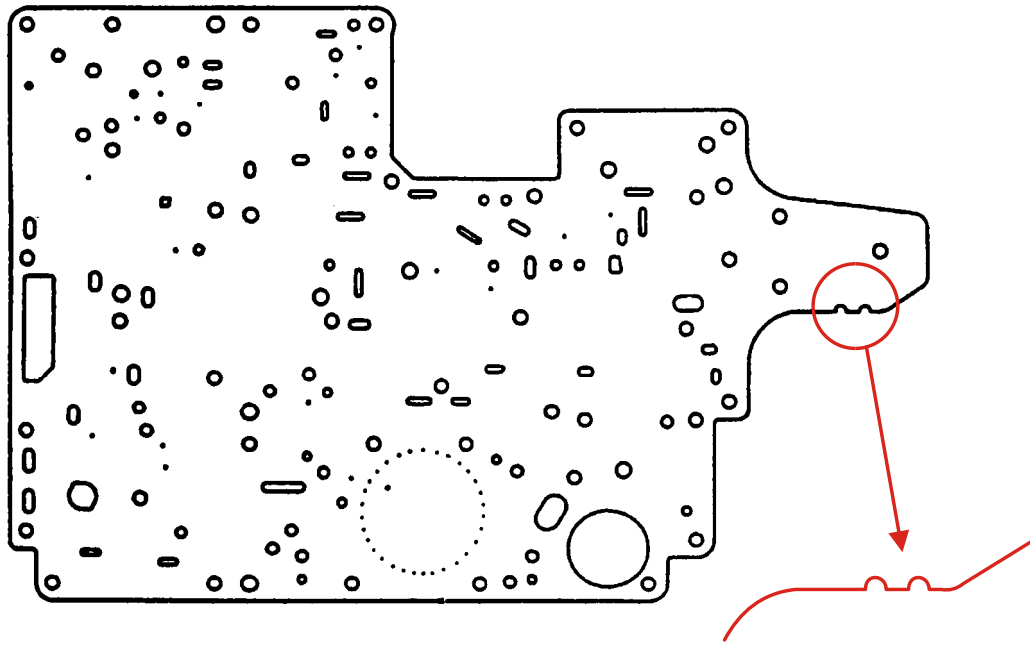
Figure 2

**CAUSE:** The cause may be, cross leakage between the spacer plate and valve body and/or transmission case, created by distortion of the spacer plate.

## SEPARATOR PLATE 1990 - UP

**CORRECTION:** Remove the valve body spacer plate, and inspect for spacer plate distortion in the area shown in Figure 2. Both valve body gaskets must be removed to see the distortion. If the spacer plate is distorted, replace it with OEM part number F4TZ-7A008-A, and re-install using new valve body gaskets. Refer to Figure 3 for the new spacer plate I.D.

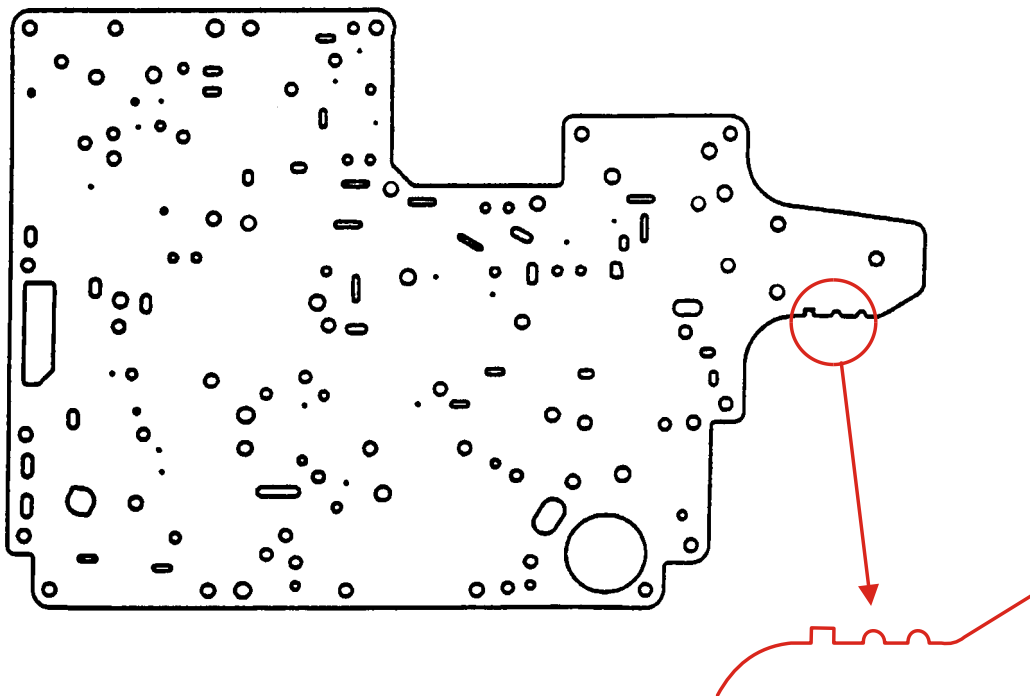
Figure 3

## NEW DESIGN SEPARATOR PLATE
