## KM 175 HARSH SHIFTS (SERVO SEAL)

### PURPOSE

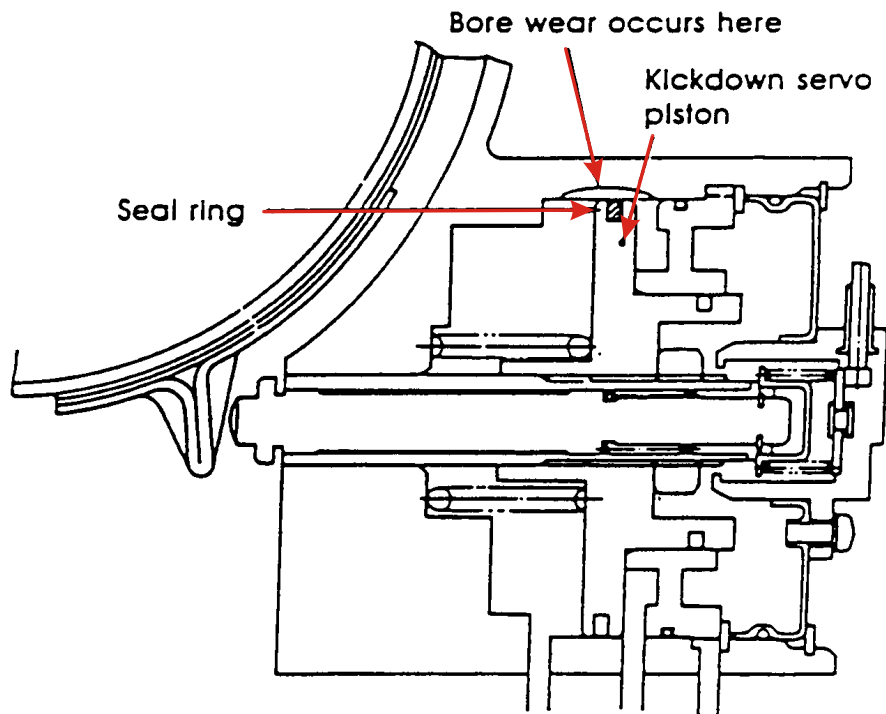
These symptoms may be due to the kickdown servo piston not releasing properly. This Is caused by hydraulic fluid leaking past the seal ring of the servo piston as a result of wear In the piston bore (Figure 1). Because wear of the piston bore varies between vehicles, the severity of the symptoms will also vary.
