Technical Service Information

THM 4L60-E SOFT 1-2 UPSHIFT

96-16
Page 1 of 1

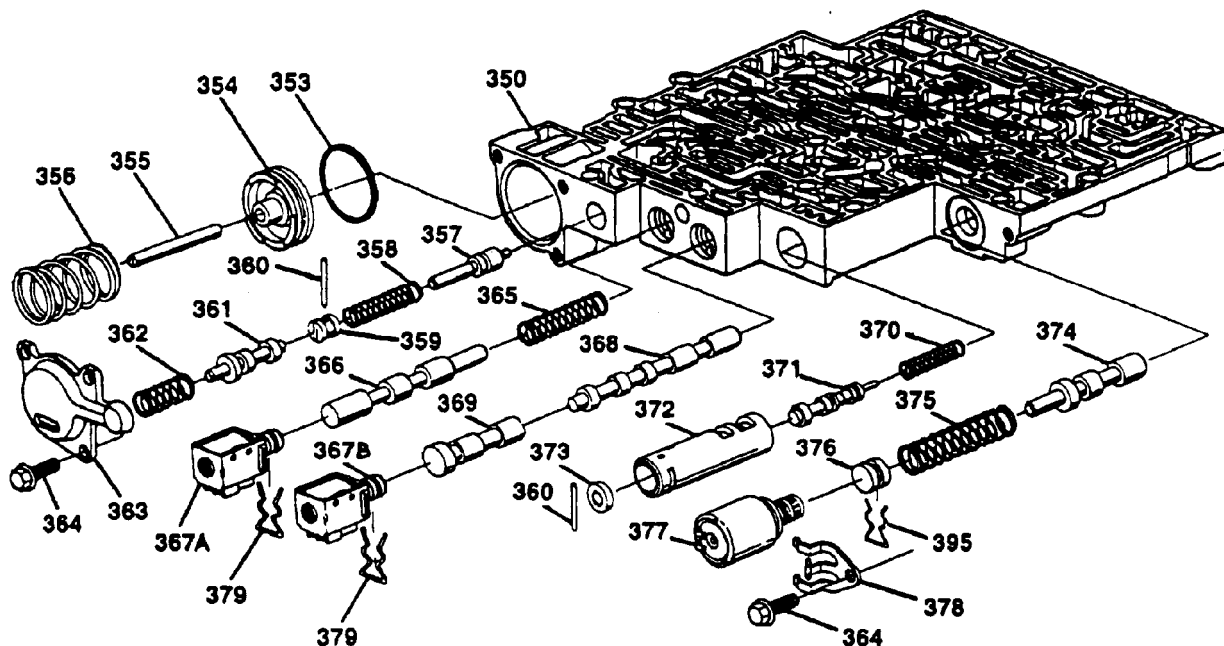
COMPLAINT: Some 1994 model vehicles, equipped with the THM 4L60-E transmission may exhibit a soft 1-2 upshift condition.

CAUSE: The cause may be, calibration of the 1-2 accumulator valve in the valve body.

CORRECTION: There is now available a new calibration service package consisting of a 1-2 accumulator valve, valve spring, and 1-2 accumulator valve bushing for the valve body. These are items 370, 371, and 372, as shown in Figure 1 below. This new service package is available under OEM part number 24202698.

1-2 Accumulator Valve Service Package 24202698
