# Technical Service Information

## CHRYSLER 45RFE/55RFE BIND ON 3-4 OR 4-5 UPSHIFT

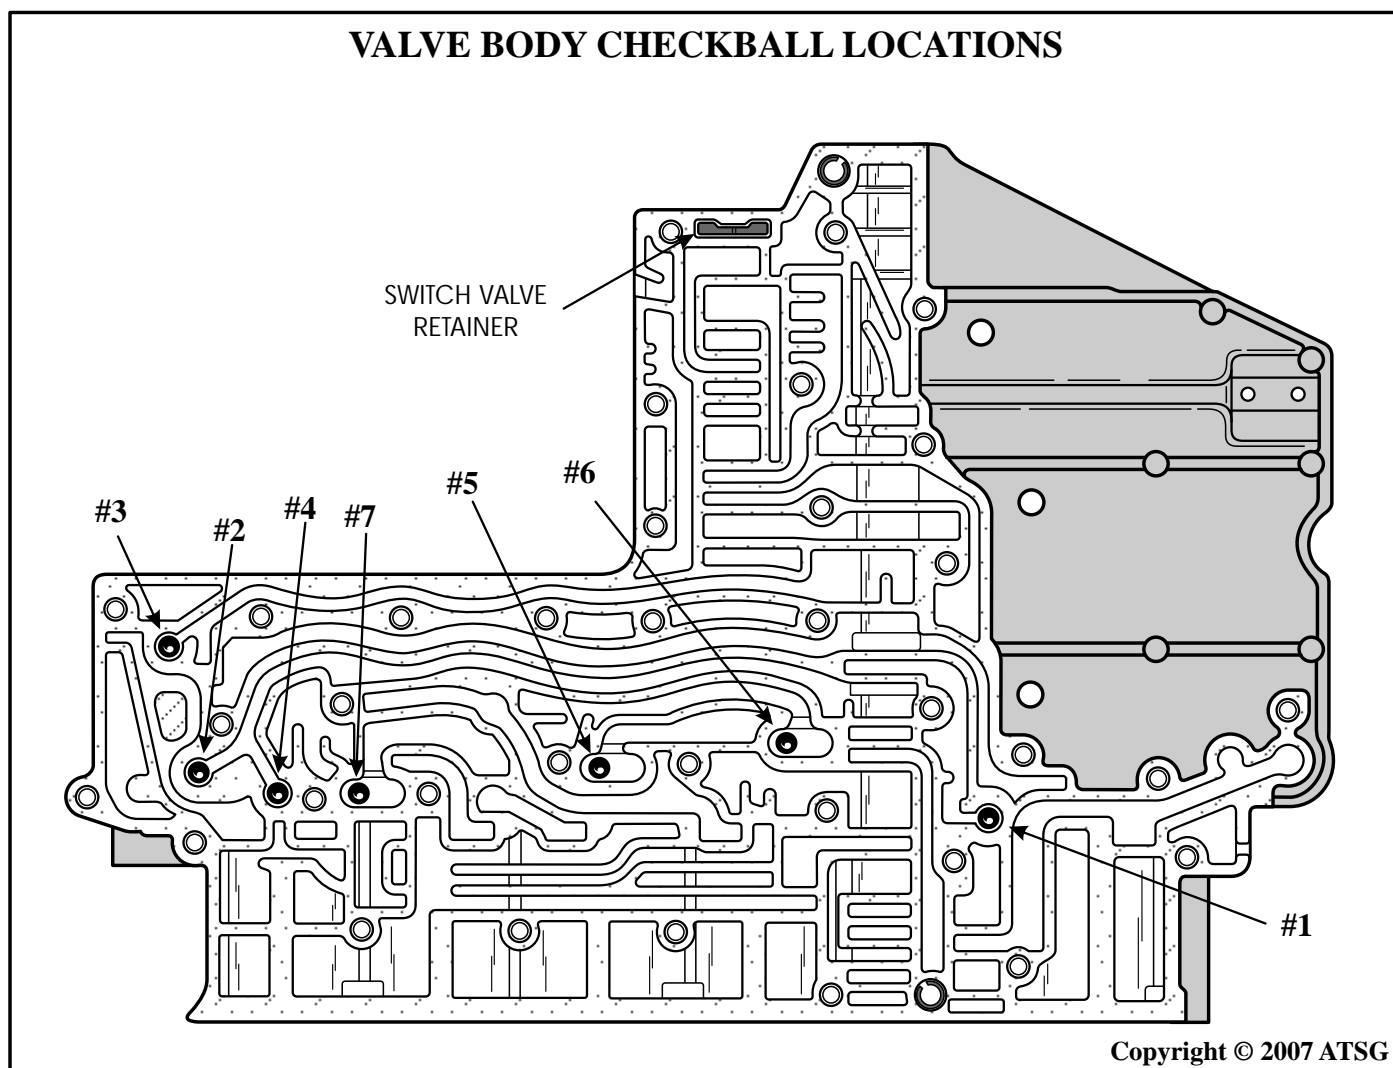
**COMPLAINT:** Chrysler vehicles equipped with the 45RFE or 545RFE may exhibit a binding condition on the 3-4 or 4-5 upshift.

**CAUSE:** The cause may be that the #2 checkball, as shown in Figure 1 has partially disintegrated, allowing the underdrive clutch to be partially or fully applied when the 3-4 or 4-5 upshift occurs causing a bind-up.

**CORRECTION:** Replace the checkballs with new plastic checkballs available in aftermarket rebuild kits or from an O.E. supplier. For Valvebody Exploded views refer to Figures 2 and 3.
