Technical Service Information

SATURN

DELAYED OR HARSH REVERSE ENGAGEMENT

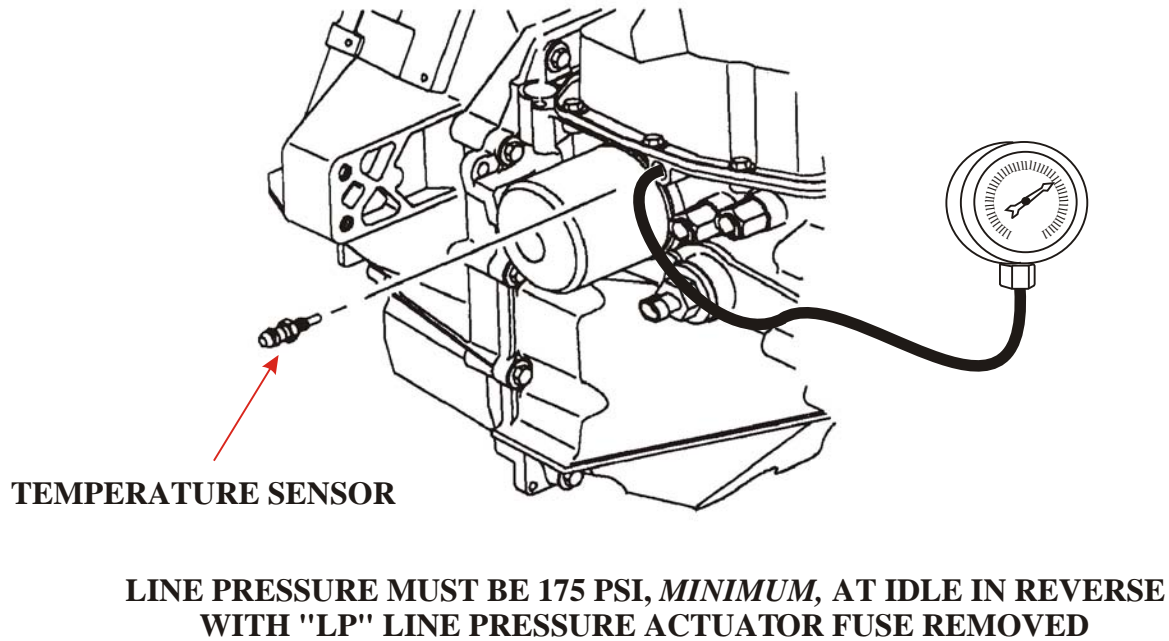
Figure 1

LINE PRESSURE CHECK

CORRECTION: Warm vehicle up to operating temperature. Remove temperature sensor and install a 0-300 psi. pressure gage, as shown in Figure 1. Remove 7.5 amp. Line Pressure Actuator fuse shown in Figure 2. Place selector in Reverse at an **Idle** and ensure that line pressure is not less than 175 psi. If the pressure gage indicates low pressure, remove the valve body and dis-assemble the Pressure regulator valve line up as shown in Figure 3. Locate the Line Pressure Regulator Valve Cushion Spring and inspect it for breakage. If the spring is not broken, reinstall the pressure regulator valve and place a flashlight over the valve body, shown in Figure 3, and look for light peering out between the valve and its bore. If light is seen or the Line Pressure Regulator Valve Cushion Spring is broken, replace the upper valve body with Saturn upper valve body kit, part no. 21005813.

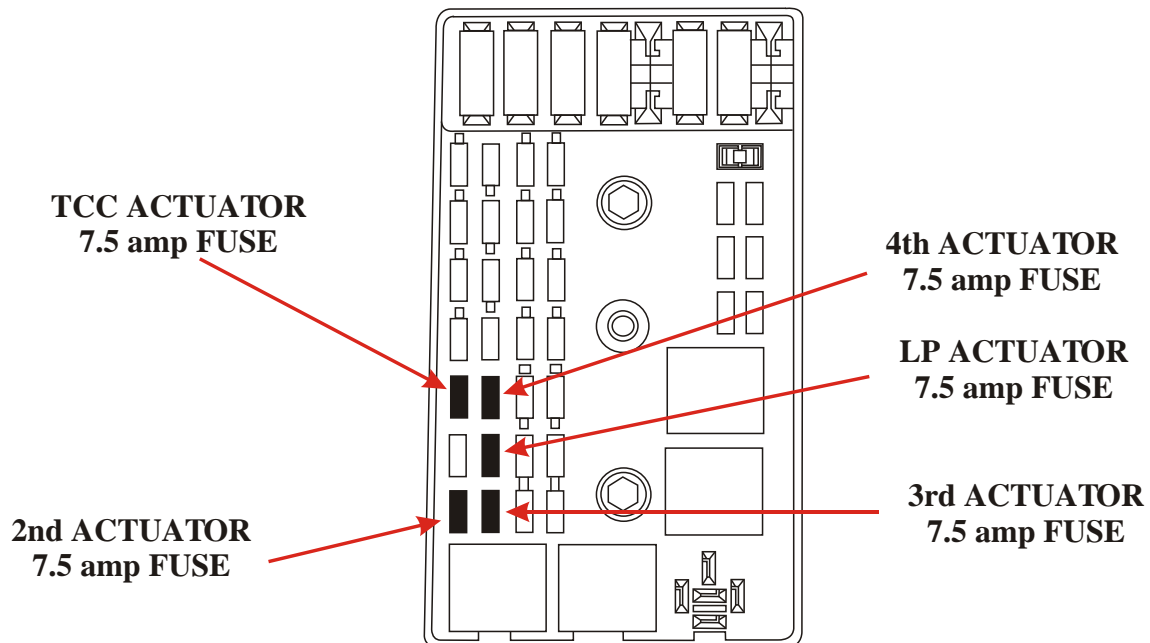
Figure 2

UNDER HOOD JUNCTION BOX

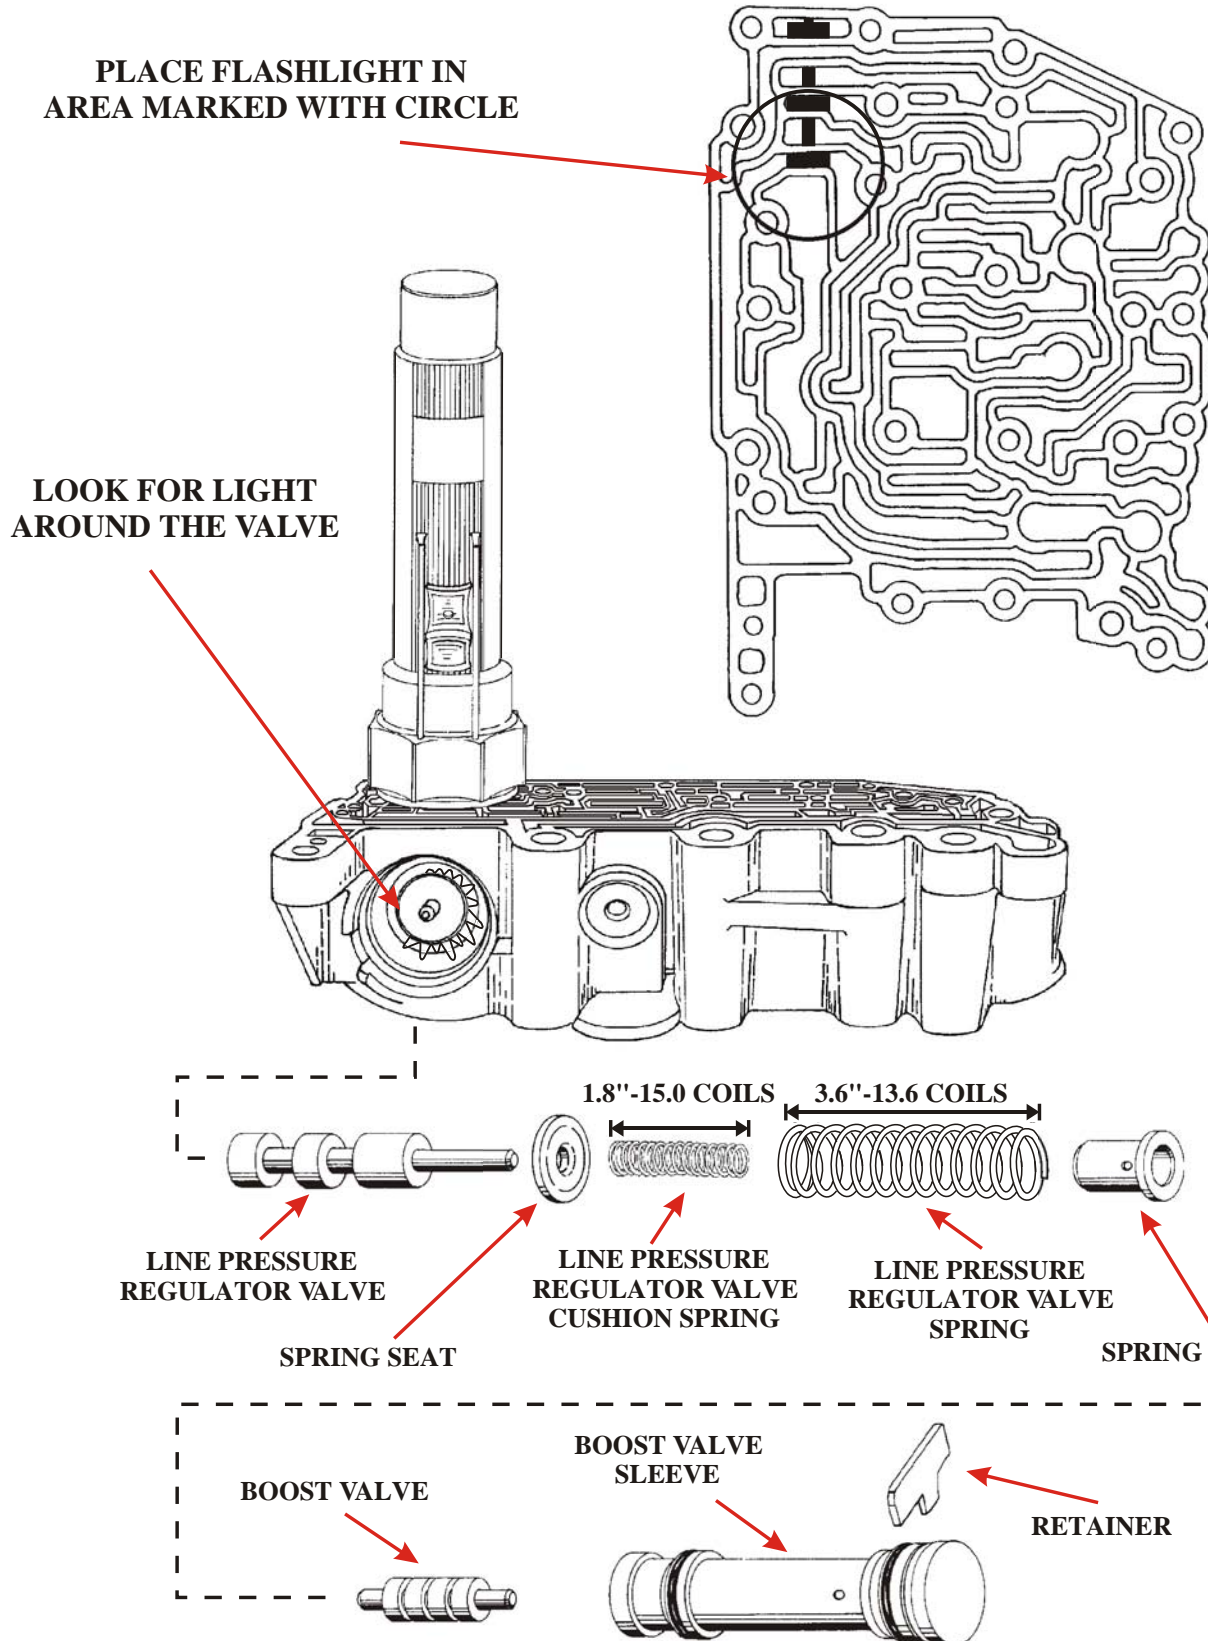
Figure 3

- A broken "Line Pressure Regulator Valve Cushion Spring."
- "Side to Side" Pressure Regulator Valve bore wear.

UPPER CONTROL VALVE BODY

SATURN UPPER VALVE BODY KIT.....21005813
Includes, upper control valve body, both spacer plate gaskets, valve body cover gasket, spacer plate, and actuator retainer exhaust diverter.
