Technical Service Information

FORD C-6

LACK OF LUBE TO REAR

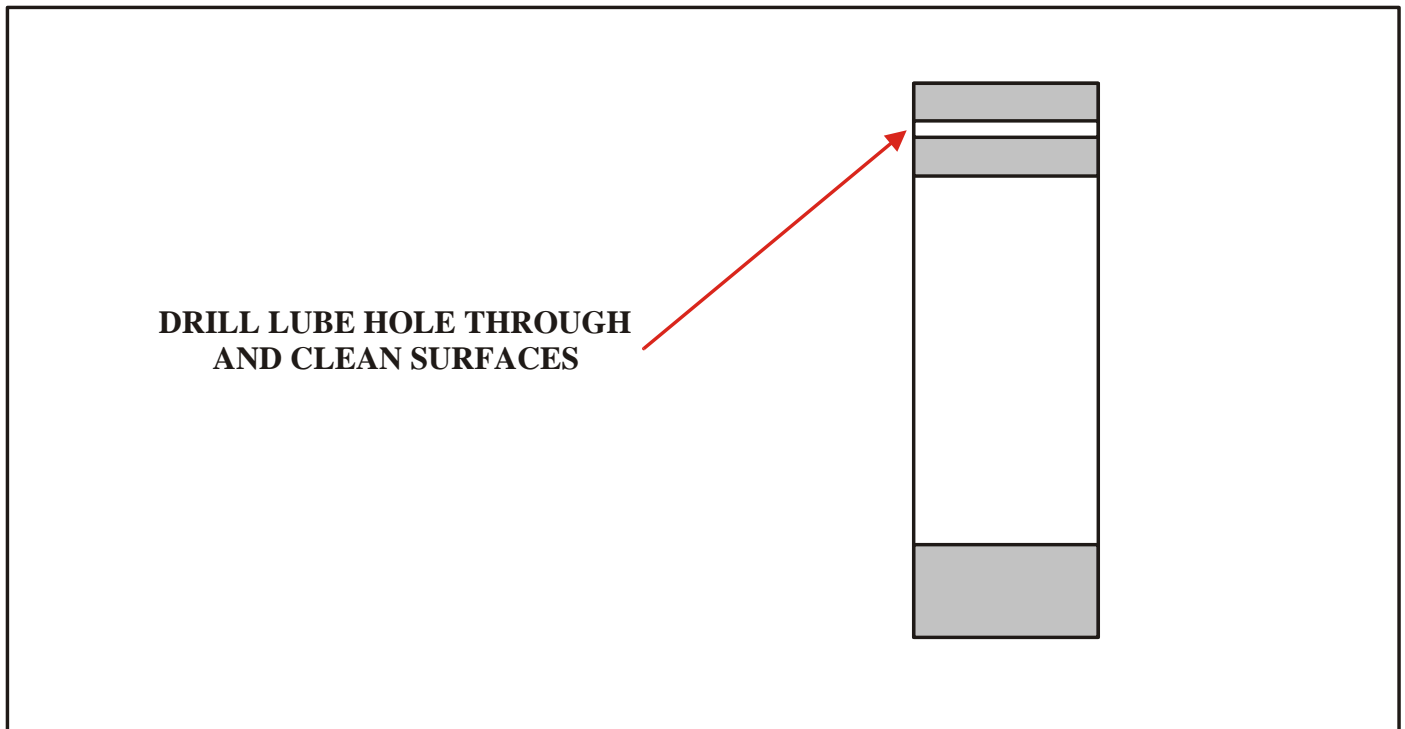
Figure1

COMPLAINT: Failure of number nine thrust washer on the C-6 transmission, in heavy duty applications such as tow trucks or modified ambulances.

CAUSE: Lack of lube to thrust washer

CORRECTION: On the back side of the overrun roller clutch inner race there is a lube hole that goes half way through the race. To get more lube to the number 9 thrust washer, drill the lube hole all the way through the race so it breaks out on the other side. The drilling will probably blue the drill, since the race is a hardened part.
