Technical Service Information

THM 4L80-E

2ND GEAR STARTS AND NO LINE RISE

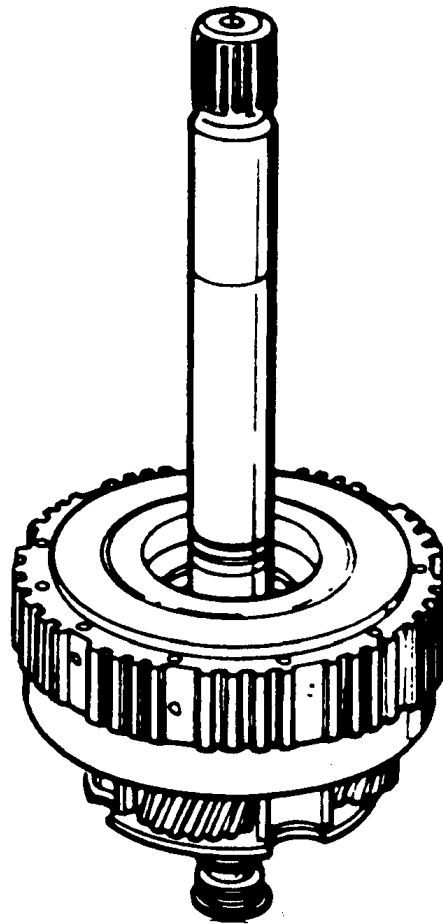
**HEAVY DUTY TURBINE SHAFT
AND O.D. CARRIER**

**OEM PART NUMBER
24200130**

- CAUSE:** The cause may be more torque load than the parts are capable of carrying, usually vehicle weight in heavy throttle conditions.
- CORRECTION:** There is now available from OEM a new service package that includes a heavy duty turbine shaft and overdrive carrier assembly. Refer to Figure 1. This service package, OEM part number 24200130, should be installed in "P" series cube vans, or any vehicle carrying a lot of extra weight.
