Technical Service Information

FORD 4R44E/4R55E/5R55E DELAYED REVERSE ENGAGEMENT

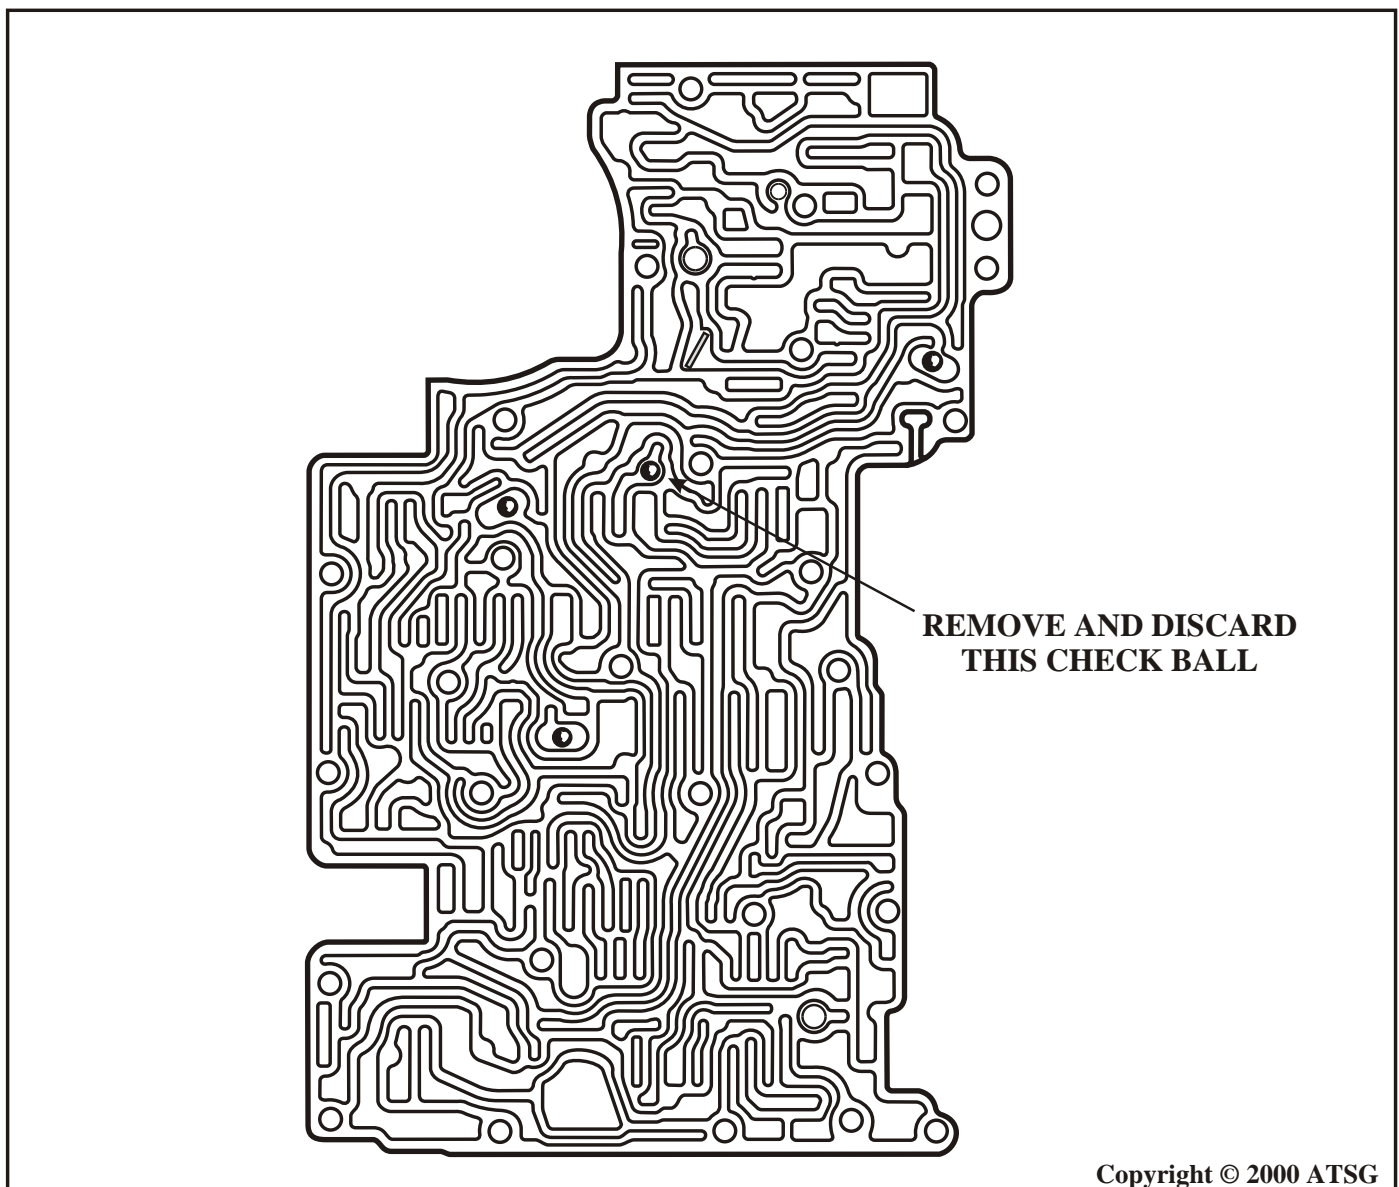
Figure 1

COMPLAINT: Some vehicles equipped with the 4R44E/4R55E may exhibit a delayed engagement in reverse .

CAUSE: One cause may be, insufficient feed to the direct clutch in reverse.

CORRECTION: Remove and discard the check ball as shown in Figure 1.
