Technical Service Information

FORD E4OD NO FORWARD ENGAGEMENT

SERVICE INFORMATION: 94-8-20

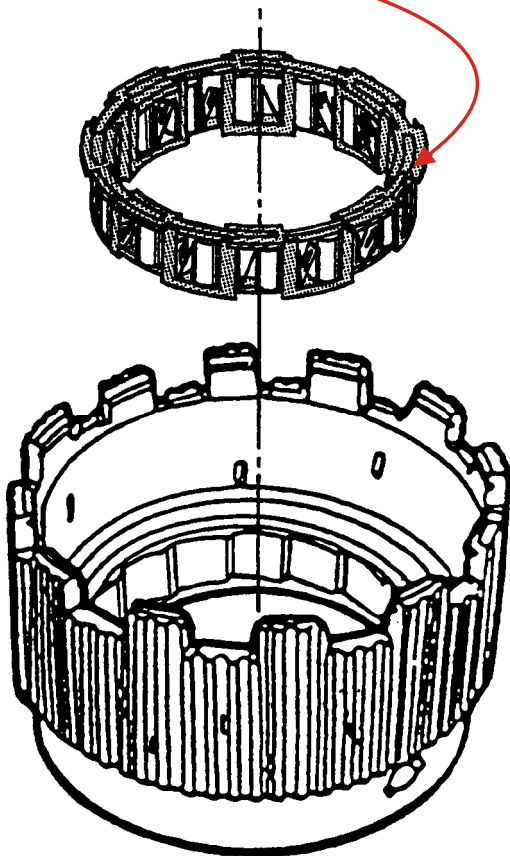
INCORRECT INSTALLATION

**NOTE TABS
ON OUTER EDGE**

**IF ROLLER CLUTCH IS INSTALLED
IN THIS DIRECTION THE CLUTCH
WILL FREEWHEEL BOTH
DIRECTIONS**

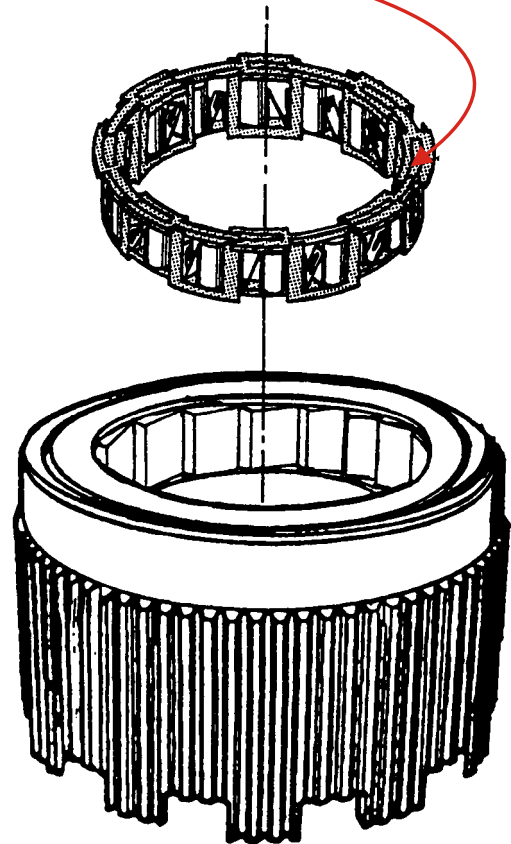
CORRECT INSTALLATION

**NOTE TABS
ON OUTER EDGE**

(2) Install the New Plastic Cage Roller Clutch Assembly through the REAR side of the Reverse Clutch Hub, with the tabs on the rear edge. Seat the Low Roller Clutch into the Reverse Clutch Hub, and rotate clock-wise to seat rollers and lock tabs in place. Refer to Figure 2 for proper installation.

**DISCARD BOTH SNAP RING
THEY ARE NOT USED WITH THE
PLASTIC ROLLER CLUTCH**
