Technical Service Information

ZF4HP22

PREMATURE FORWARD CLUTCH FAILURE

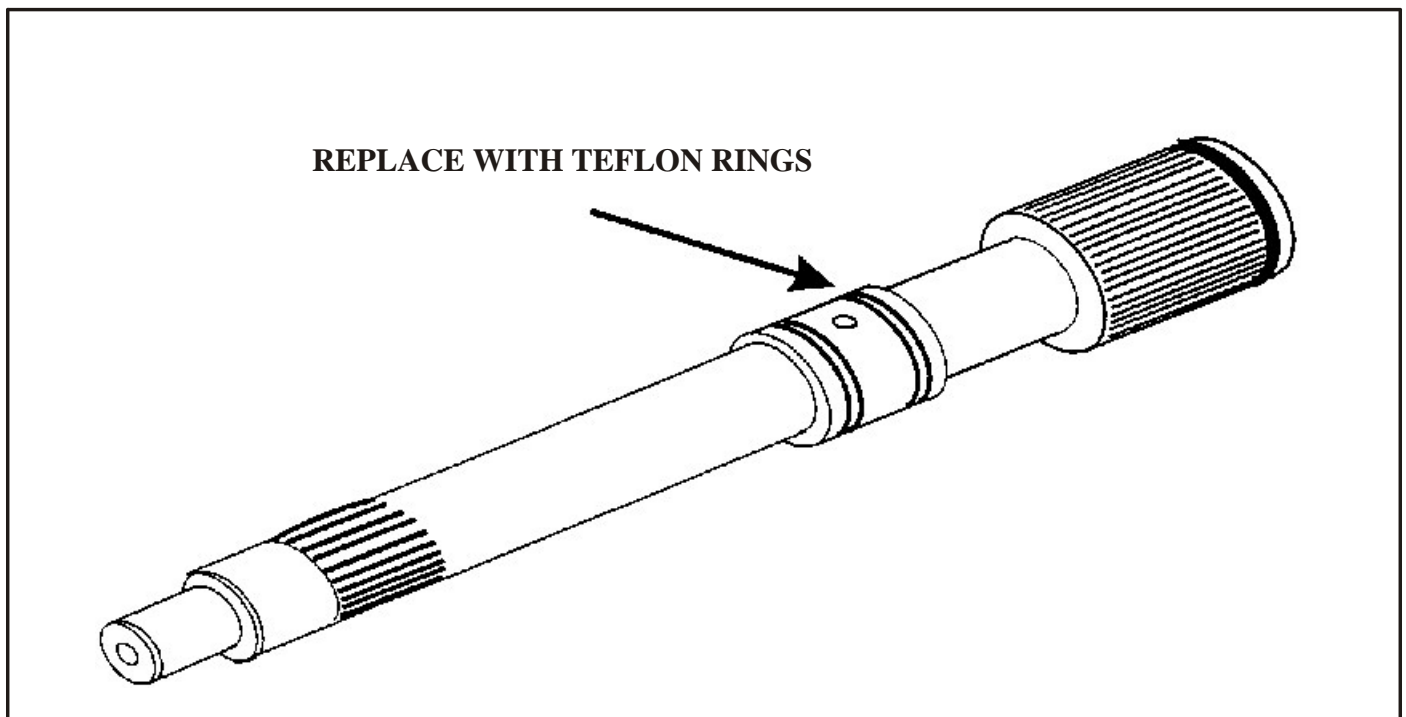
Figure 1

- CAUSE:** The turbine shaft has two sealing rings that direct oil to the converter. A worn stator support bore can cause a cross leak of converter oil into the forward clutch. Also the rear metal sealing ring on the turbine shaft can leak causing partial forward clutch apply.

STEP #2. Remove the rear metal turbine shaft ring and *discard it*. Replace the ring with one made of Teflon. Make your own if necessary.(See Figure 1.)
