Technical Service Information

MAZDA 929 R4A-EL PCM FAILURE

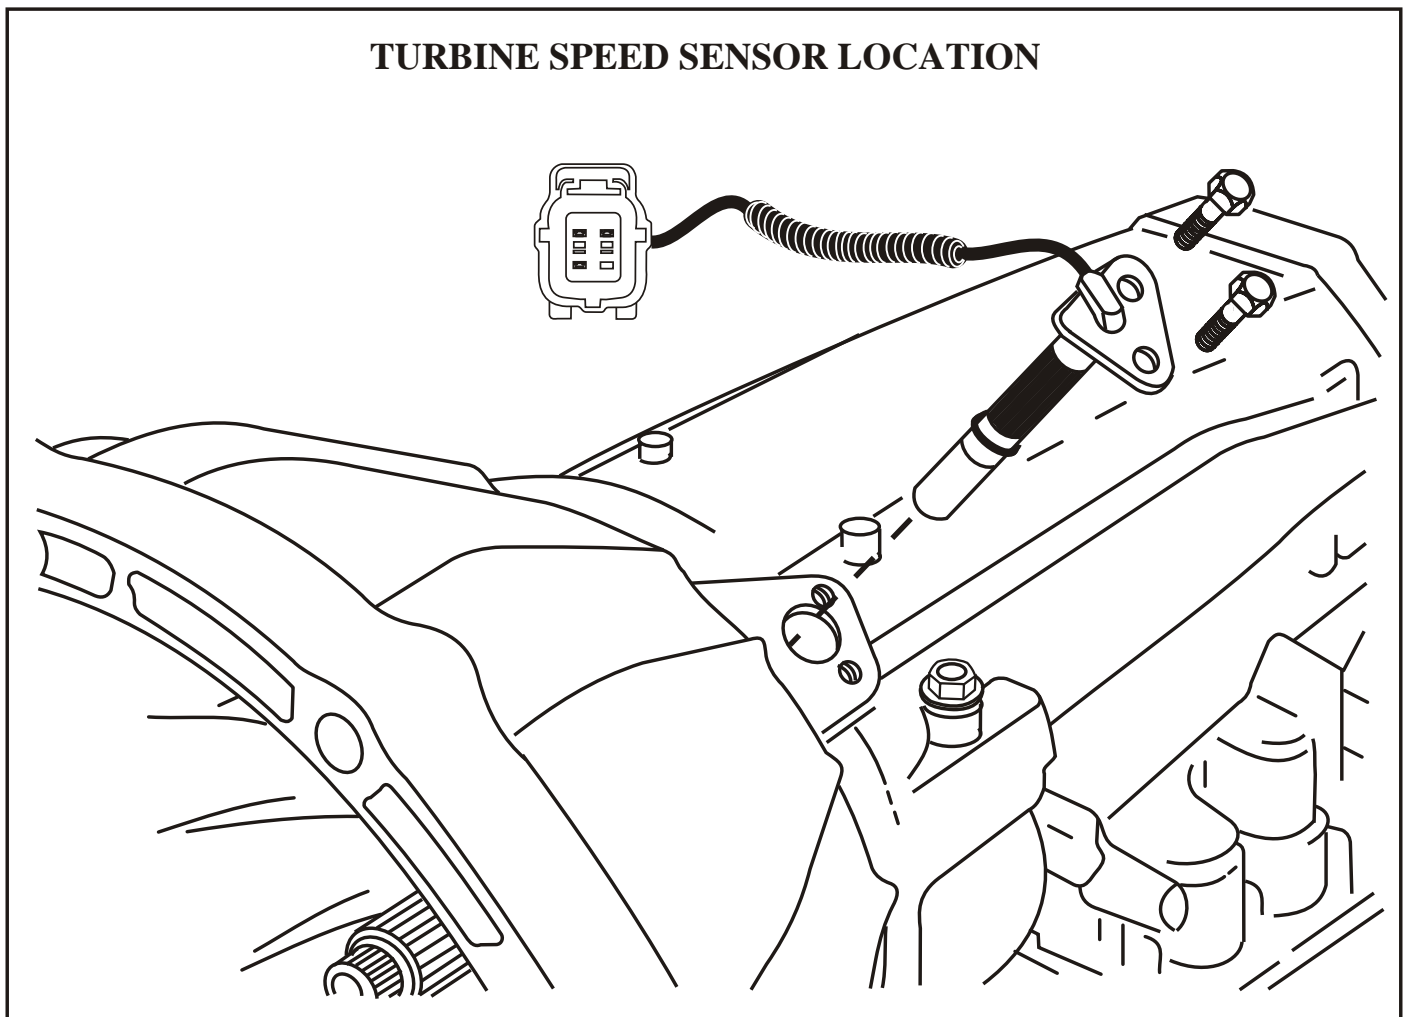
CAUSE: The cause may be, the female Turbine Speed Sensor connector was connected to the male Heated Oxygen Sensor connector upon re-installation of the transmission into the vehicle.

TURBINE SPEED SENSOR CONNECTOR

CORRECTION: This problem can be avoided by ensuring that both female and male harness connectors have the same amount of wires. Refer to Figure 1 for Turbine Speed Sensor location. Refer to Figure 2 for 3 pin Turbine Speed Sensor and 4 pin Heated Oxygen Sensor connector identification.

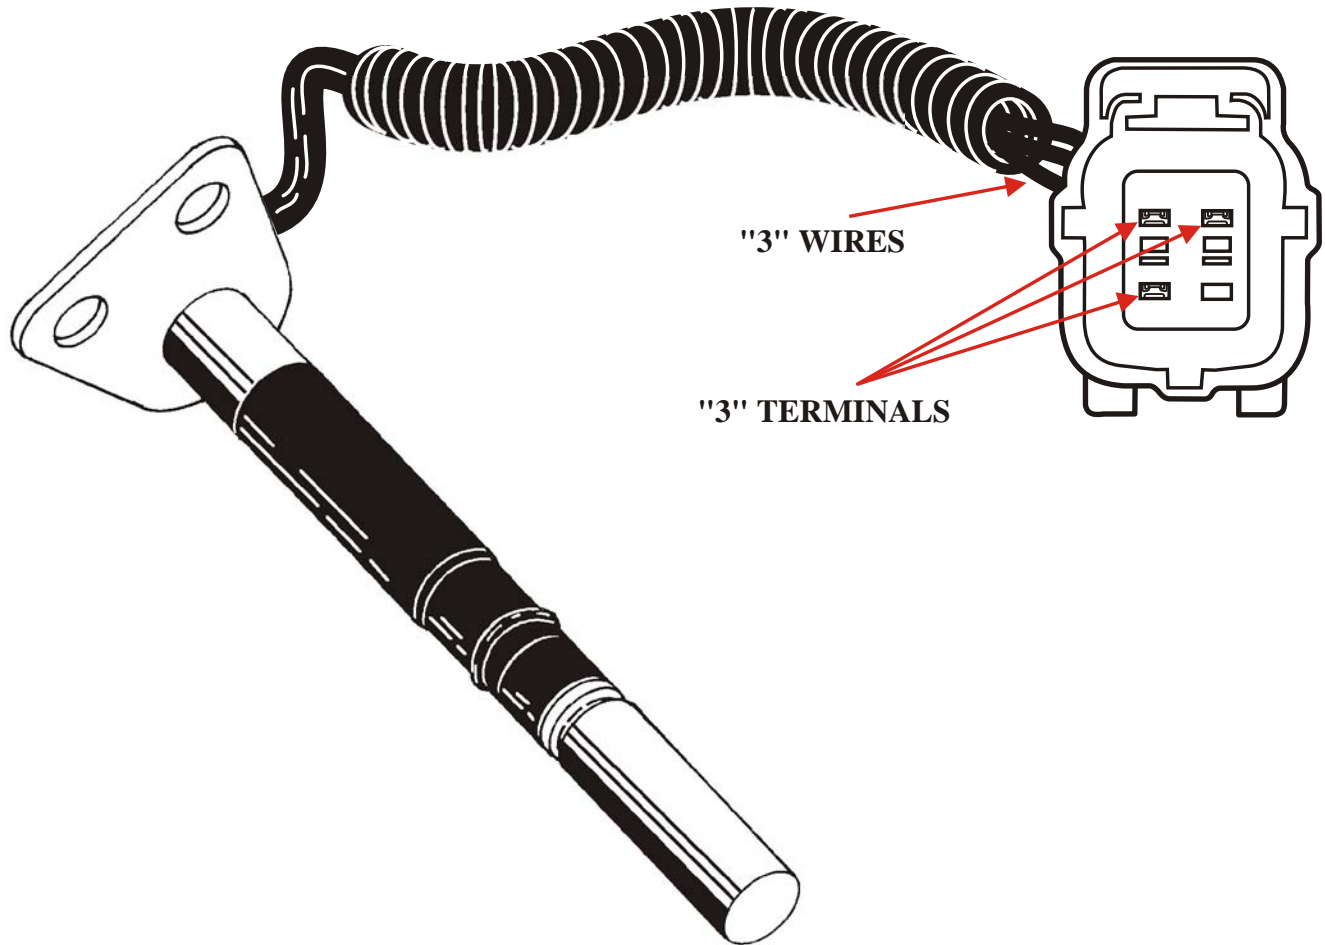
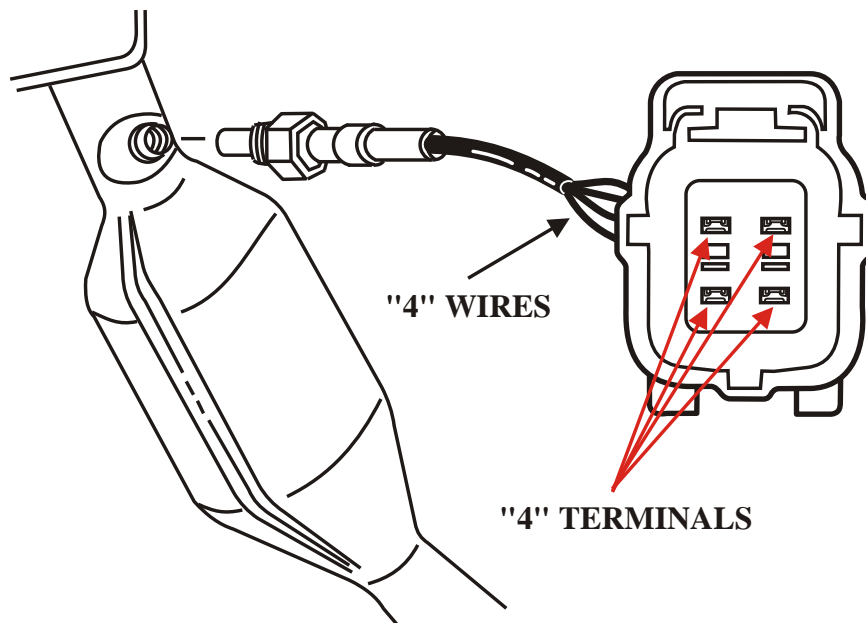
Figure 2

HEATED OXYGEN SENSOR AND CONNECTOR
