Technical Service Information

4T80-E SLIPPING OR NO REVERSE

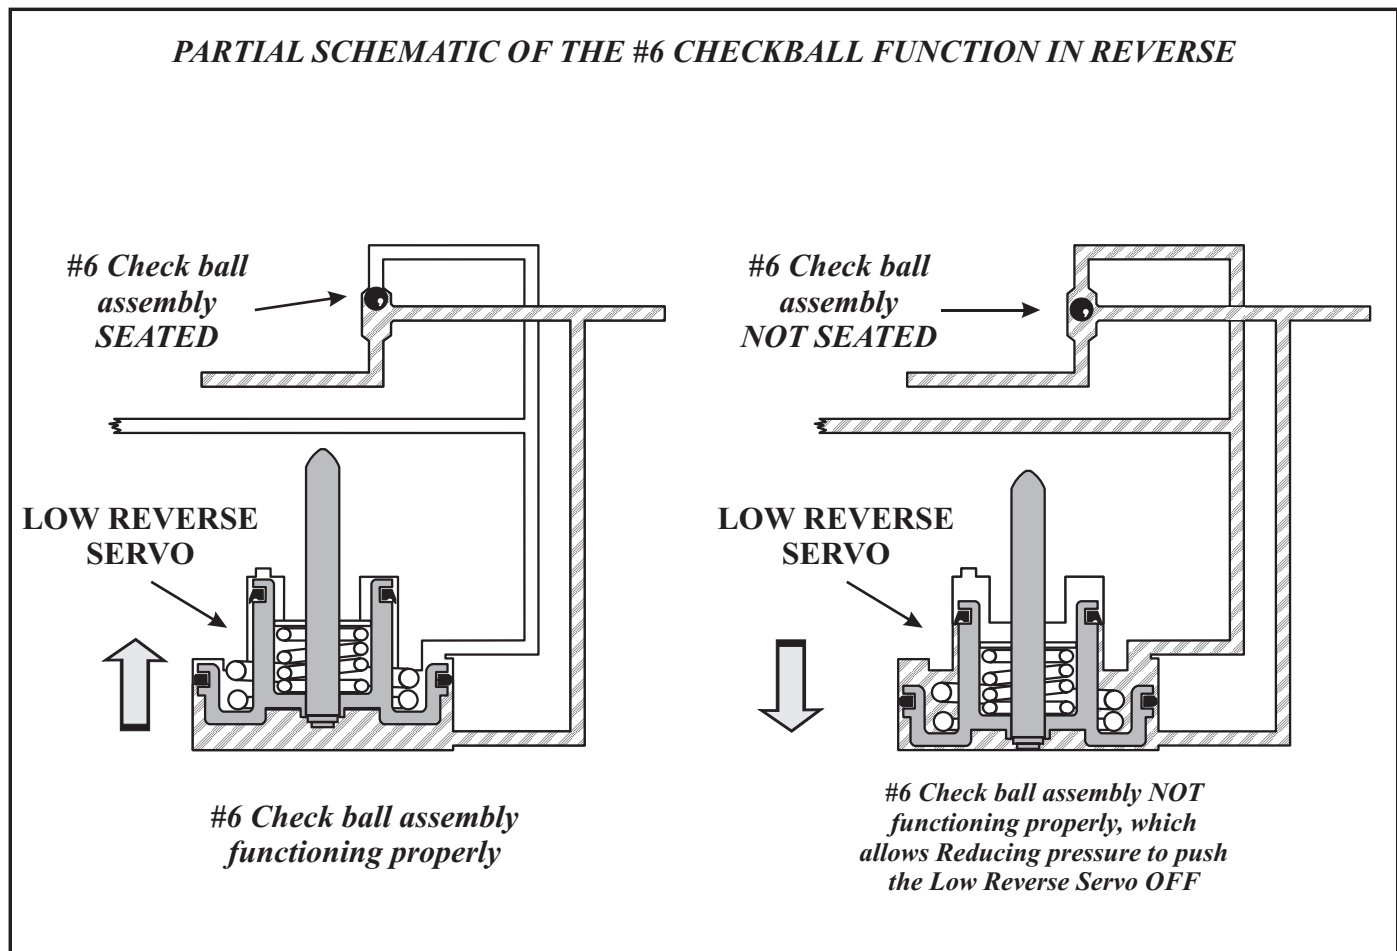
CAUSE: One cause may be the number six check ball in the lower valve body not seating in the valve body. There have been occasions where material would get in between the checkball and the valve body casting, keeping the ball from seating. If the number six check ball does not seal, oil pressure passes by the ball into the low/reverse band reducing chamber, this oil pressure will assist spring tension to keep the low/reverse servo from fully applying. See Figure 1 below for a brief circuit description.

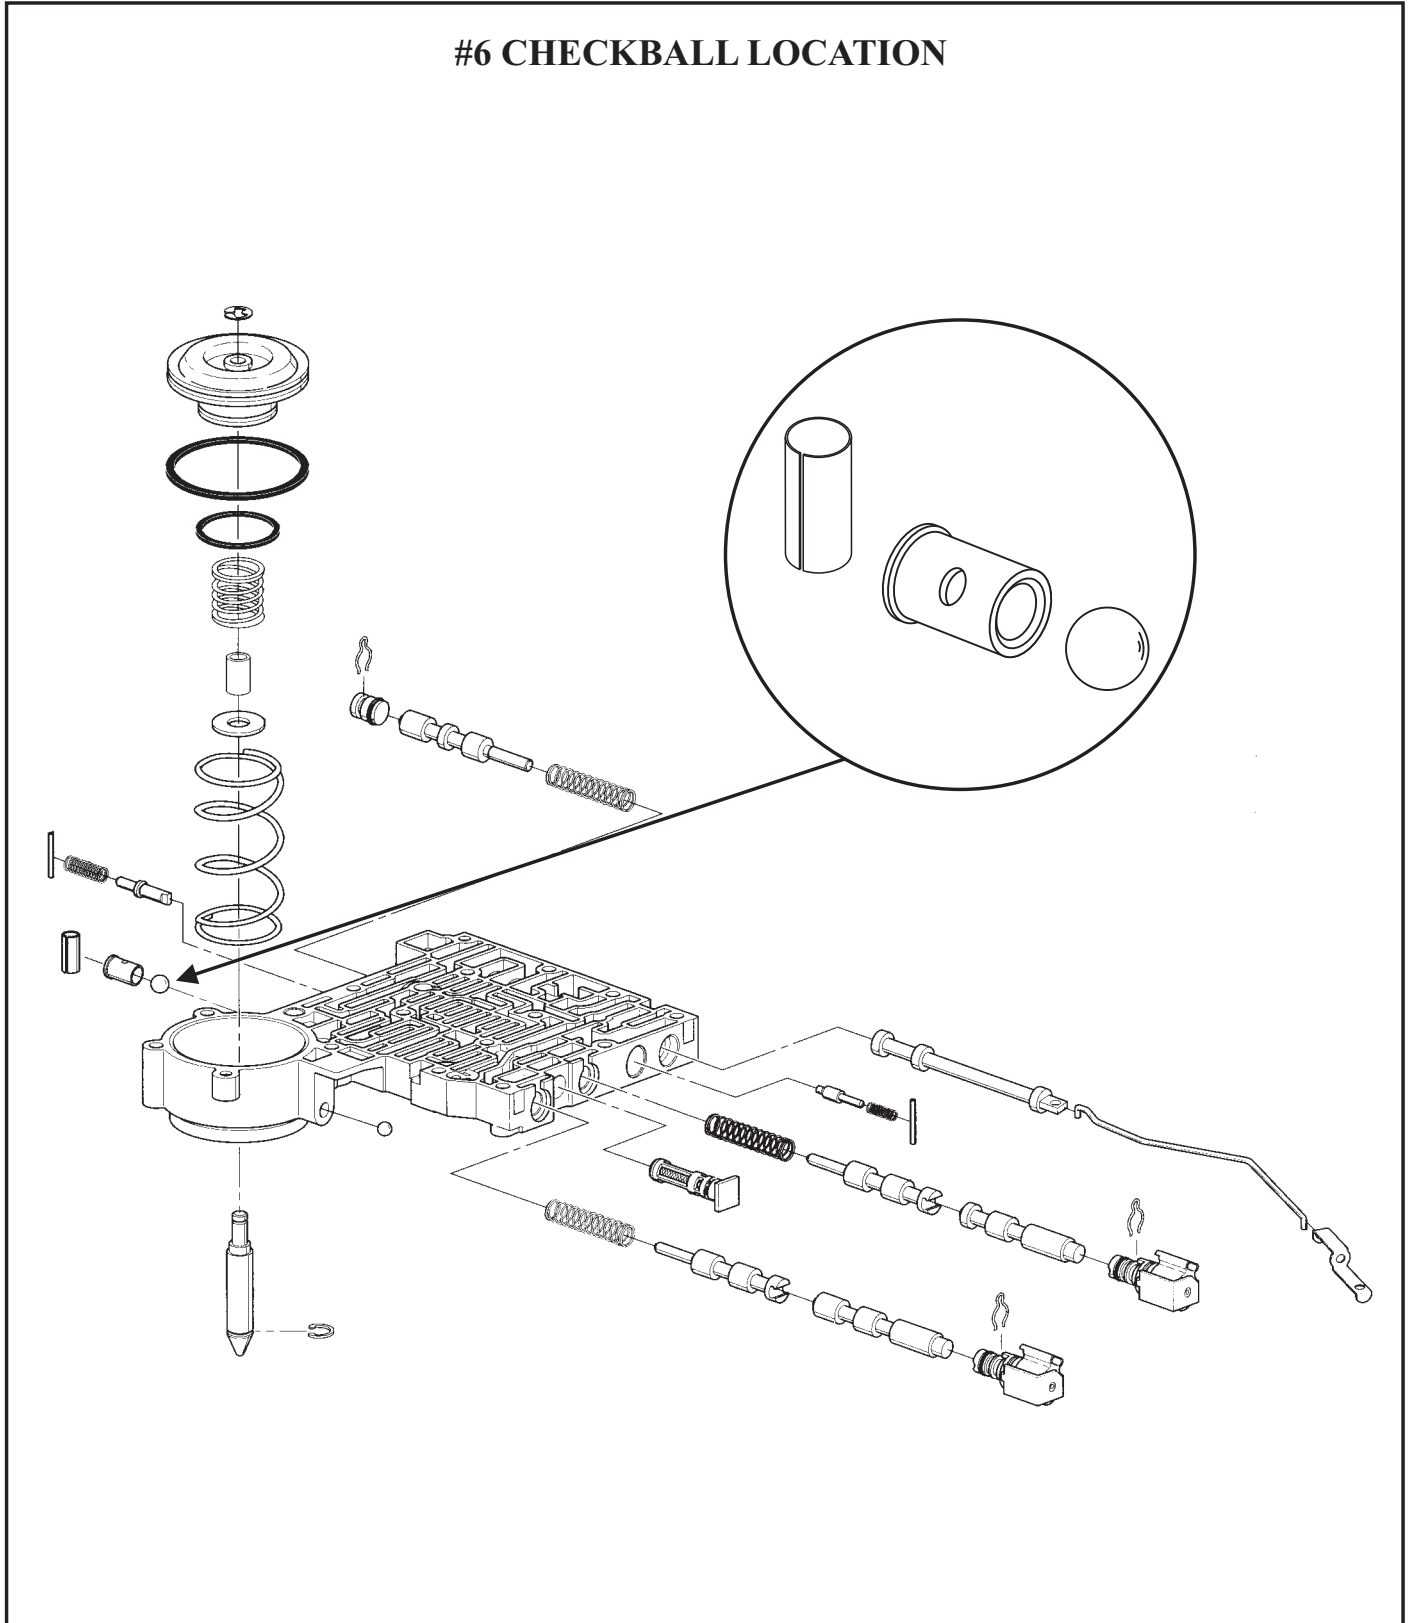
#6 CHECKBALL LOCATION

CORRECTION: Remove the lower valve body and inspect the capsule for material, then repair or replace as necessary. Refer to Figure 2 for location of number six check ball capsule in the lower valve body.
