Technical Service Information

CHRYSLER A500/518 OVERDRIVE/DIRECT CLUTCH DRUM

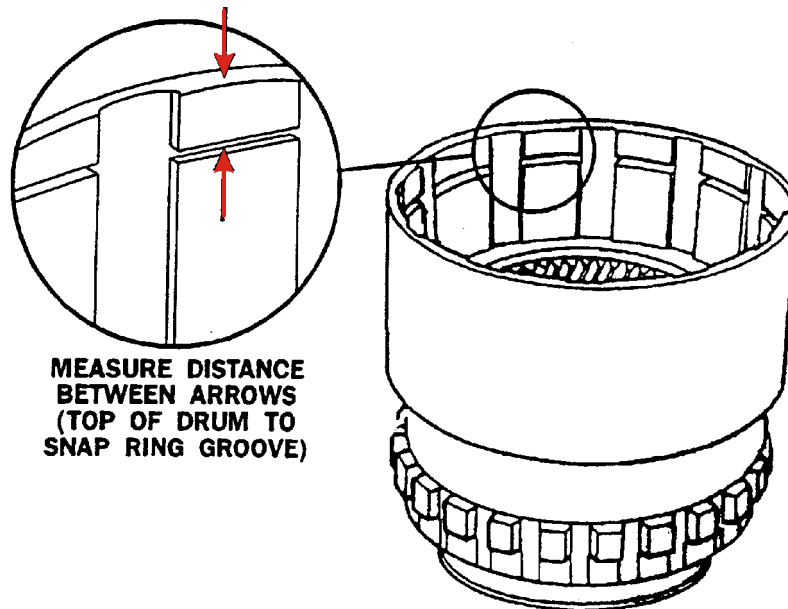
Figure 1

COMPLAINT: Cannot adjust overdrive piston shim correctly, no reverse after overhaul, or bind up on 3-4 shift.

CAUSE: Incorrect number of clutches in the overdrive/direct drum.

MEASURE DISTANCE
BETWEEN ARROWS
(TOP OF DRUM TO
SNAP RING GROOVE)

CORRECTION: Use the chart and illustration below to determine the correct number of clutches in the overdrive/direct drum. See bulletin 92-37 for correct drum stack up.

TRANSMISSION	LINED	STEEL	MEASUREMENT
A500 (40RH) 3.9L	5	4	Approx. .430 in.
A500 (42RH) 5.2L	6	5	Approx. .350 in.
A518 (46RH)	8	7	Approx. .150 in.
