"2005" SEMINAR INFORMATION

AUTOMATIC TRANSMISSION SERVICE GROUP

"Out by Five in 2005" Seminar Information

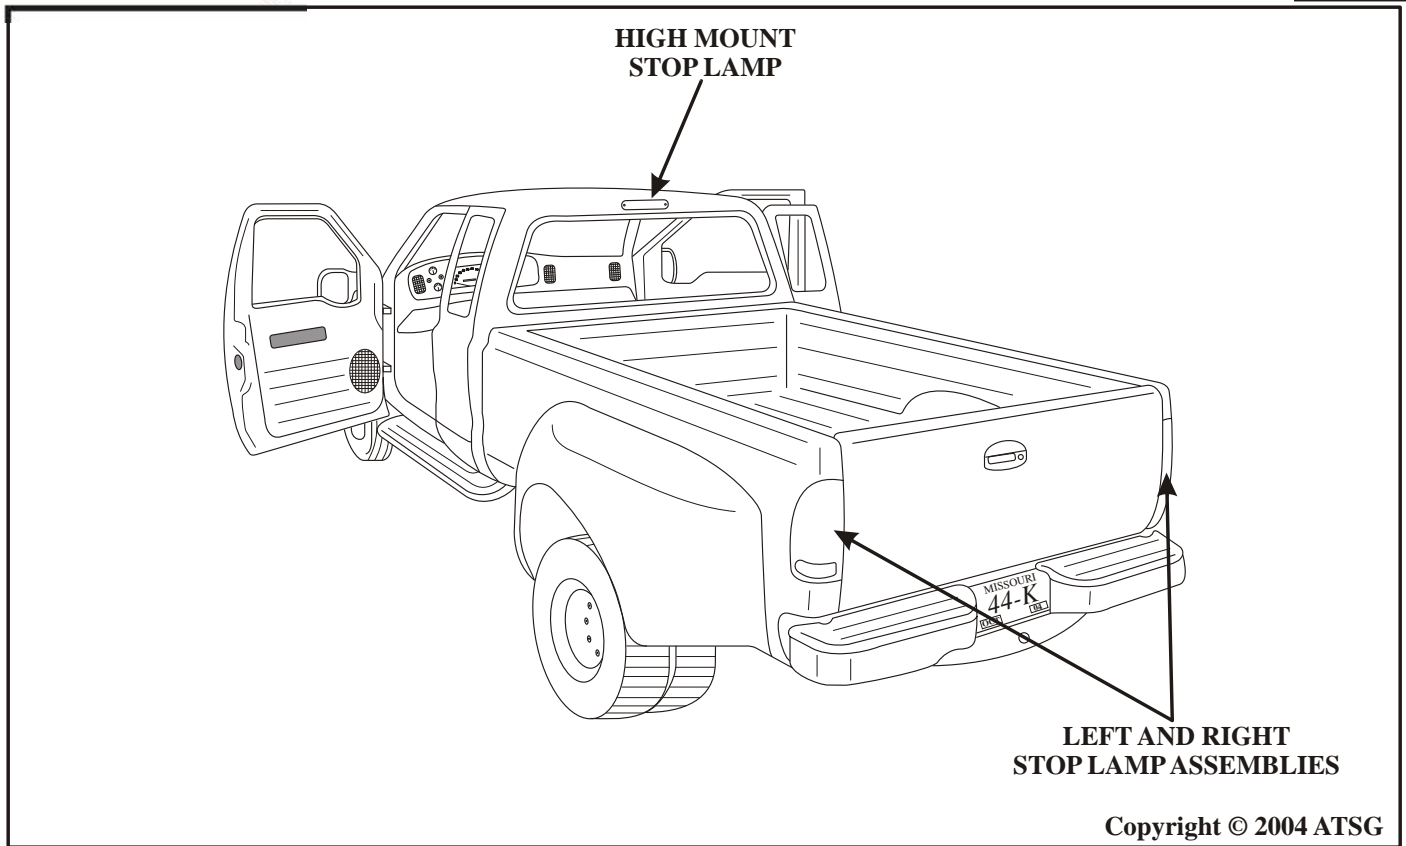
Figure 1

CAUSE NO. 1: One cause for this condition may be that one or more of the vehicle brake light bulbs, including the High Mount brake light may be burned out, or have a damaged filament (See Figure 1). When this condition is present, the PCM will detect an open in the brake lamp circuit, and due to a pull-up resistor in the PCM, will output voltage from PCM terminal 92 to the brake on-off switch (See Figure 2). As a result, the Torque Converter Clutch will not be applied at less than 30 percent throttle.

Replace any burned out brake lamp bulbs, including the High Mount brake lamp bulb, as shown in Figure 1. It is also important to note, that a bad ground for the rear lamp assembly, has also been known to cause the identical symptom. Refer to Figure 5 for the rear lamp assemblies ground location.

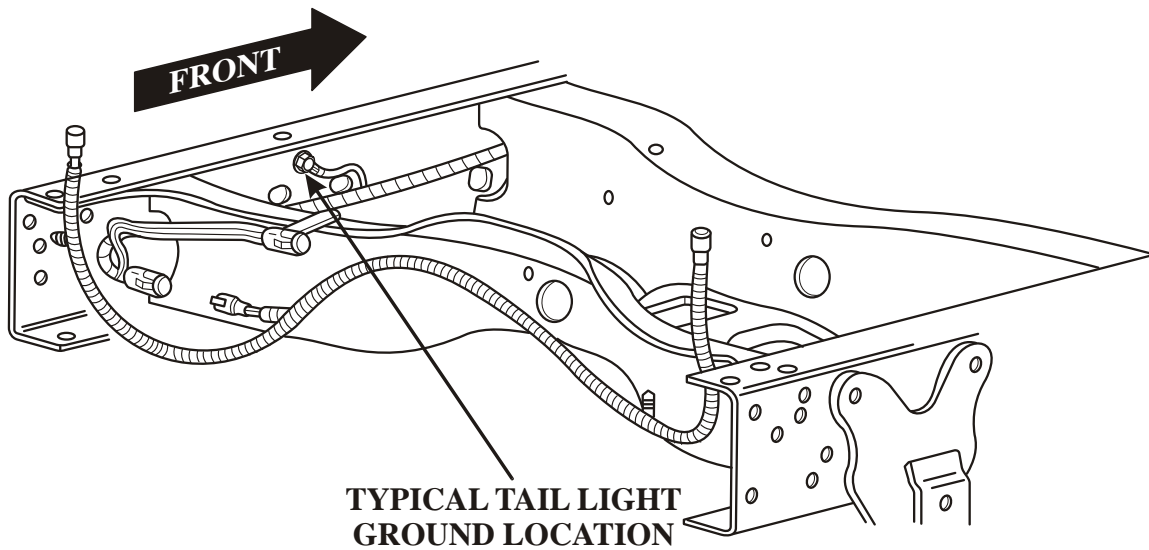
Figure 5

GROUND LOCATION

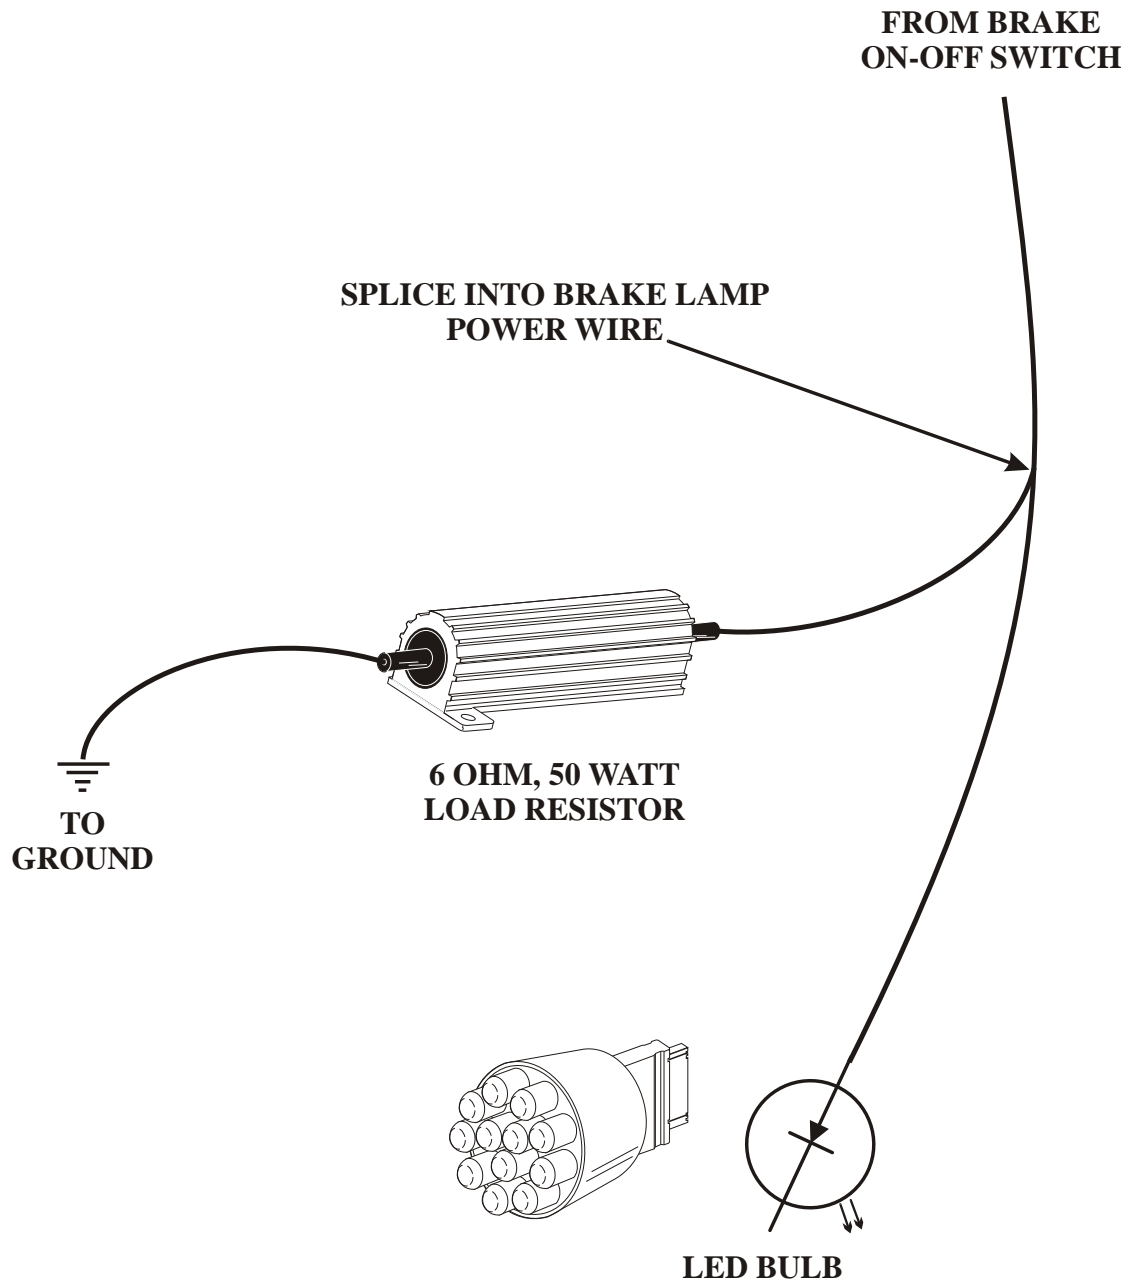
Figure 6

LOAD RESISTOR INSTALLATION

For those vehicles that have had the stock incandescent bulbs replaced with aftermarket LED bulb assemblies, it *may* be necessary to install a 6 ohm- 50 watt Load Resistor across the brake light power wire to simulate the load of the regular stock incandescent bulb (See Figure 6). **Note:** *One resistor is required for use on each LED bulb assembly.*

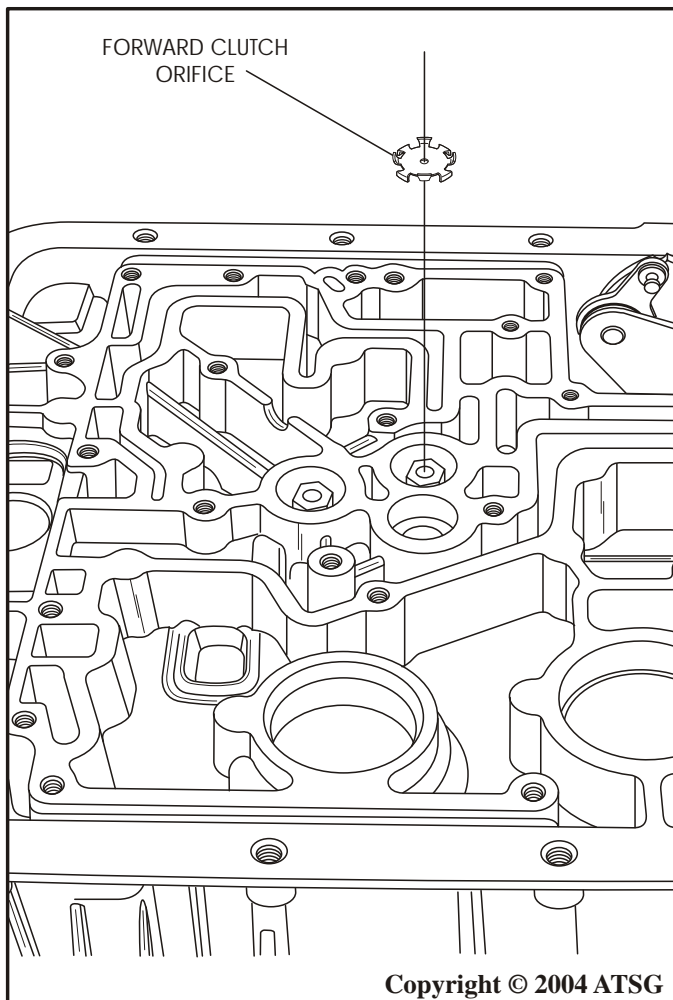
COMPLAINT: After rebuild or repair, the vehicle exhibits a harsh forward engagement, or possibly a harsh engagement along with a soft mushy 1-2 shift.

CAUSE: The cause may be, the forward clutch orifice missing, or misplaced into the intermediate clutch feed instead of the forward clutch feed. (See Figure 1 and 2).

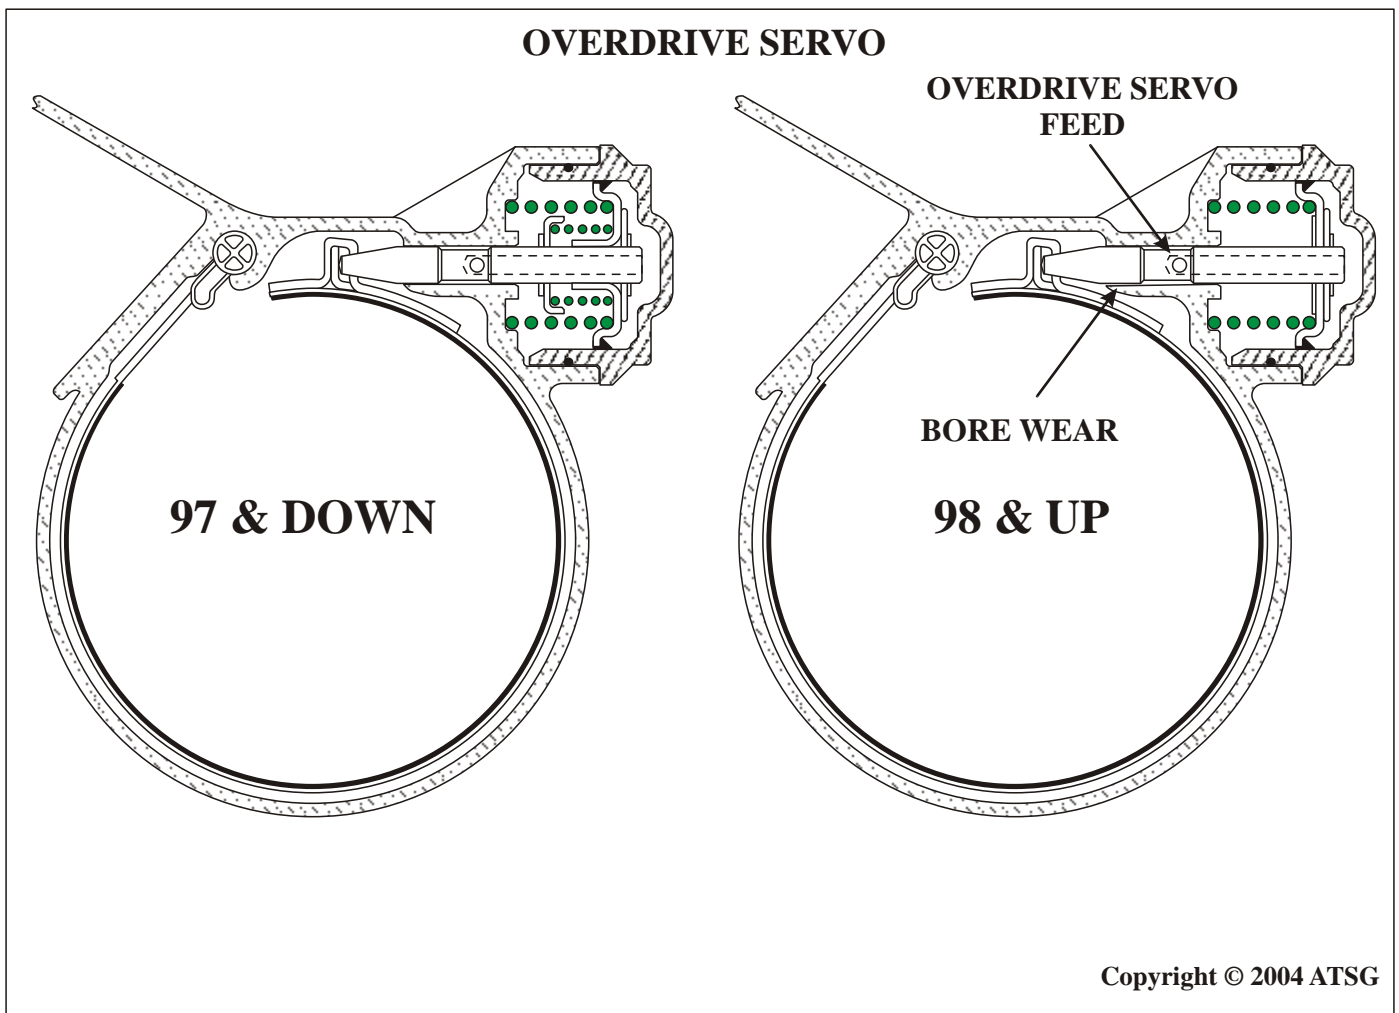
Figure 1

COMPLAINT: Vehicles equipped with the AX4S transaxle may exhibit premature Overdrive band failure.

CAUSE: The cause may be, a worn servo bore. The Overdrive servo is fed thru the center of the apply pin. Wear in the case, where the servo pin rides, may cause a pressure loss, creating the band failure. See Figure 1. *NOTE: ATSG has found that this is very common on 98&up models.*

CORRECTION: To correct this condition there are currently two options, replace the case or re-sleeve the case where the pin rides and install a bushing for a new sealing surface. *Northland transmission Inc. has a Re-boring kit available to repair the case bore, with a bushing, to fix the leak.*
Phone: 715-458-2617

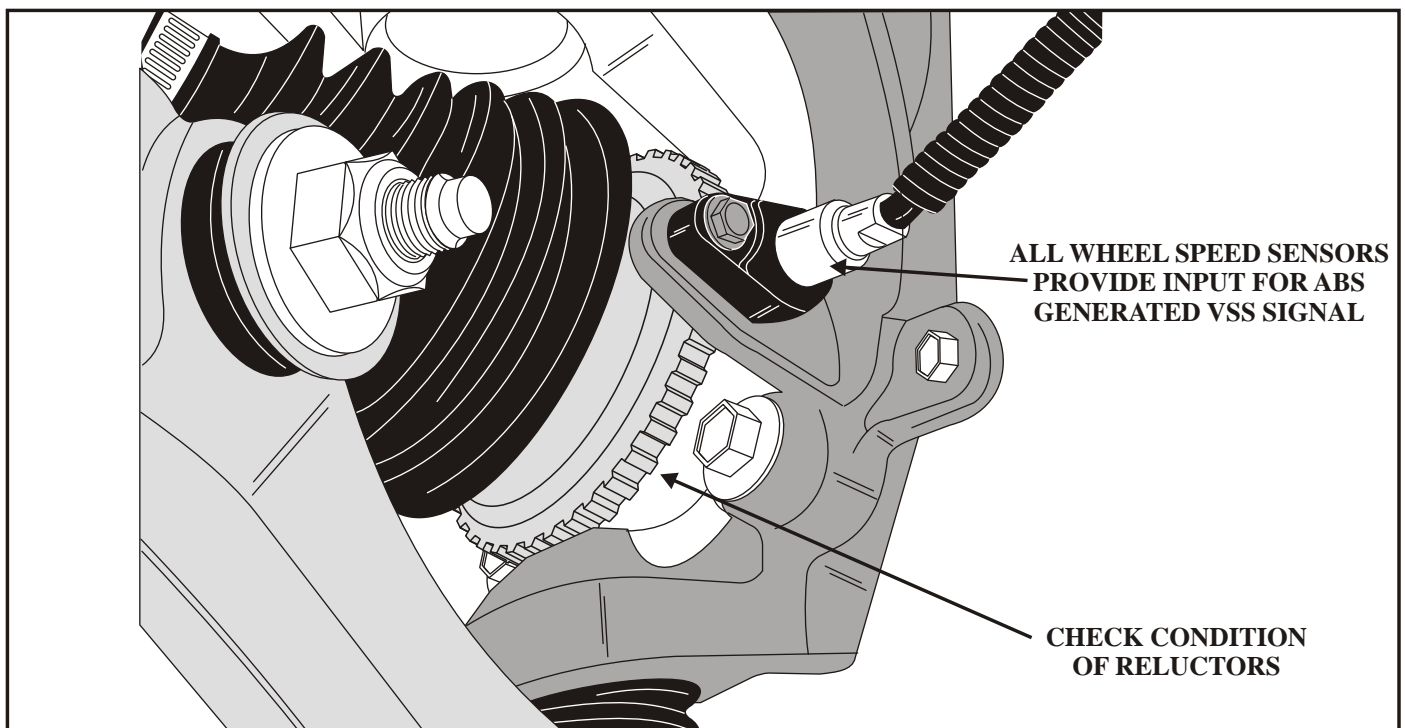
Figure 2

CAUSE: These vehicles obtain the VSS signal from the Antilock Brake Control Module. This means that the raw signal the ABS Module is receiving comes from all four (4) Wheel Speed Sensors (WSS), Refer to Figure 2.

CORRECTION: The ABS Module will have to be scanned for wheel speed sensor codes in order to find the one, or more, wheel speed sensor(s) that are faulty. It would also help to view the ABS data to see if all four (4) wheel speeds are the same when driving in a straight line, (no turns).
Note: The reluctors at each wheel can become caked with mud or rust resulting in an erratic or no signal condition, be sure to check for this or any other condition that might cause a problem with the wheel speed sensor to reluctor relationship.

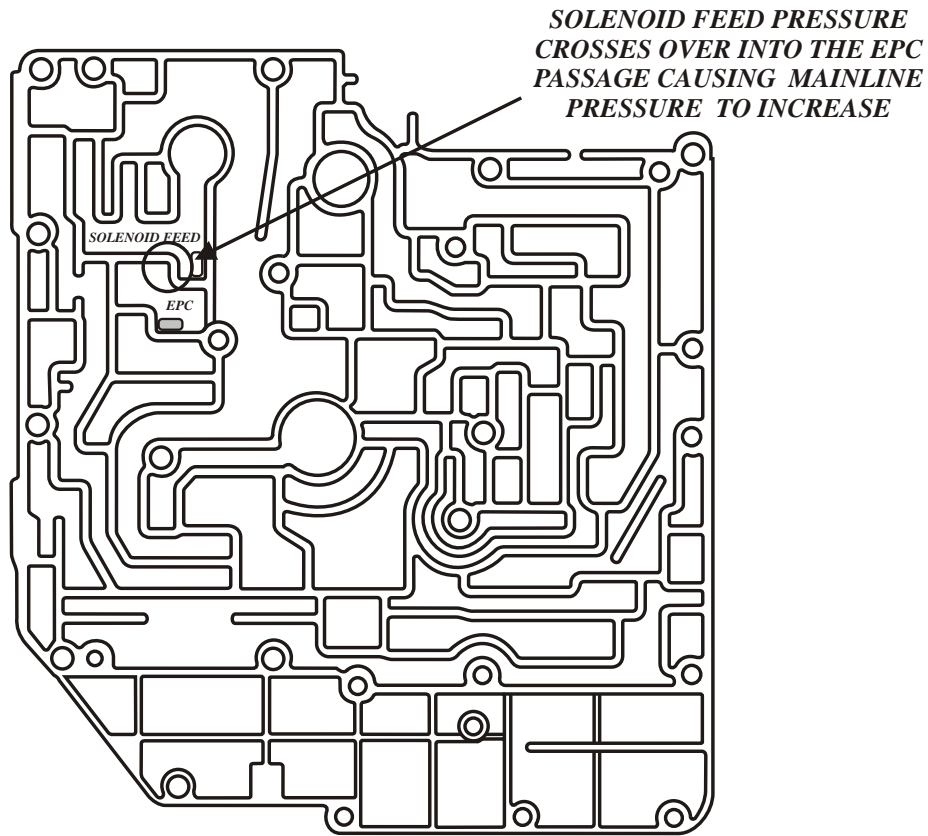
- CAUSE:** One possible cause may be, that during the overhaul procedure the 1998 & up Pump Plate to Valve Body Gasket may have been installed on a 1994 - 1997 Valve Body. When this happens, an opening between the Solenoid Feed circuit and the EPC circuit will allow Solenoid Feed oil to go over a worm track and enter the EPC circuit at the end of the Pressure Failsafe Valve as shown in Figure 1. This additional oil entering the EPC circuit will increase the amount of pressure in the circuit causing increased movement of the Pressure Failsafe Valve, which allows an increase of EPC pressure to enter the TV Boost Valve assembly, thus increasing the Mainline pressure. See Figure 2 for a partial hydraulic schematic. *Note: Typically when the 1998 - up gasket is installed, the gauge reading has shown to be 100 - 110 psi. engine idling, and the shift selector in the OD position.*

INCORRECT GASKET

1998 and up gasket on a 94-97 Valve body

- CORRECTION:** Ensure that the correct Pump Plate to Valve body gasket is being used. For reference, Figure 3 shows the 1994 - 1997 Pump Plate to Valve Body gasket and the 1994 - 1997 Valve Body casting. Figure 4 shows the 1998 and up Pump Plate to Valve body gasket and the 1998 and up Valve Body casting.

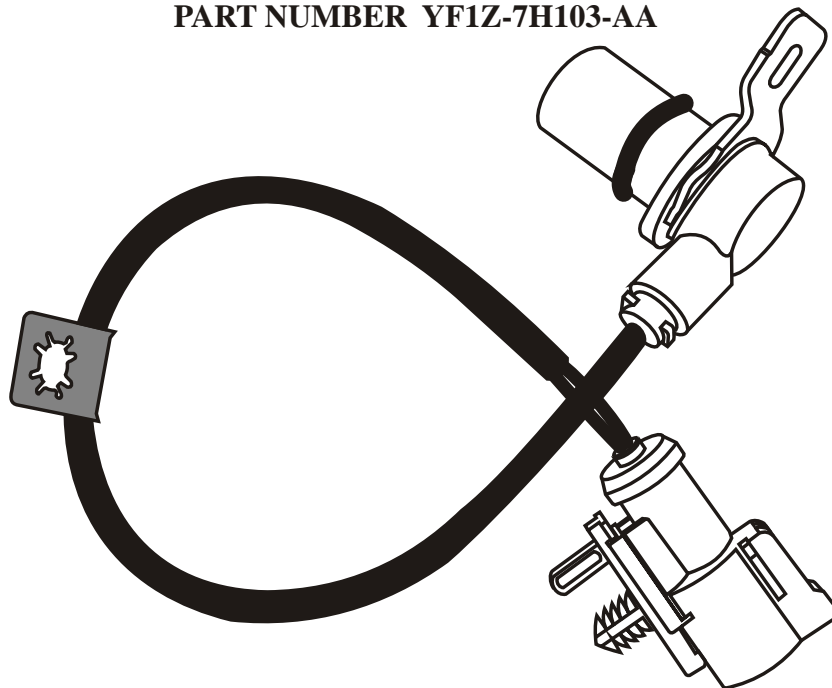
Figure 1
Automatic Transmission Service Group

CAUSE: The cause may be that a faulty Vehicle Speed Sensor is causing this complaint. See Figure 1. It is a new design Vehicle Speed Sensor that is a Permanent Magnet Sensor that reads off the park gear. See figure 2. **Reason:** when the neutral feeling occurs it is a fault in the signal that is sent to the PCM, telling it that the vehicle speed has just increased from approximately 15 mph to approximately 35 to 40 mph. When this happens the trans is still in first gear, the PCM turns on Shift Solenoid 3 momentarily and then turns it back off again. At the time that Shift Solenoid 3 is on it allows the Forward Clutch Control Valve to move to a downshifted position, at which time the Forward Clutch exhausts causing the trans to slip into a neutral condition. Figure 3 shows Shift Solenoid 3 off, and the Forward Clutch applied. Figure 4 shows Shift Solenoid 3 on, and the Forward Clutch off.

CORRECTION: Replace the Vehicle Speed Sensor with Ford Part Number YF1Z-7H103-AA

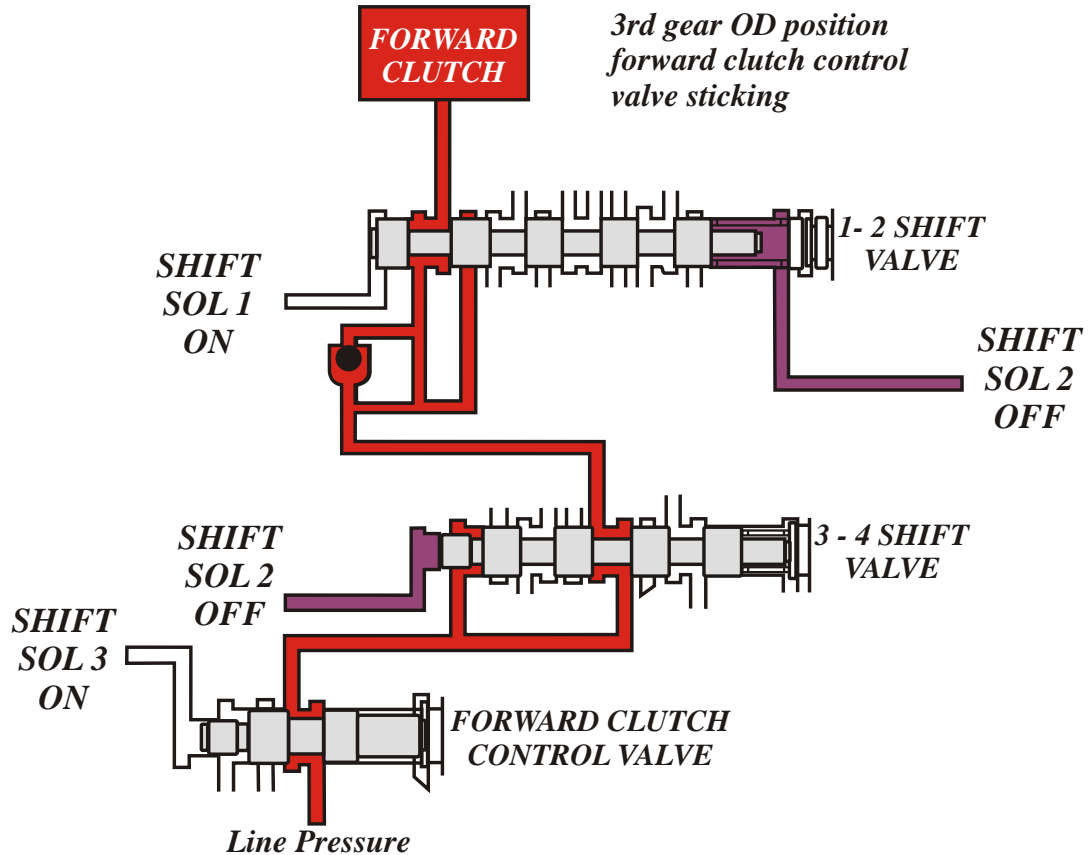
CAUSE: **Cause number 1:** No upshift to fourth. One common cause for this condition is that the Forward Clutch Control Valve sticks in an upshifted position. Figure 1 shows the transaxle in 3rd gear with the shift selector in the OD position, with the Forward Clutch Control Valve sticking in an upshifted position. This will leave the Forward Clutch applied. With mainline pressure present at two locations of the 3-4 Shift Valve keeping the Forward Clutch applied, this will not allow the 3-4 Shift Valve to stroke, thus preventing the 3-4 shift from taking place. Figure 2 shows what takes place when the Forward Clutch Control Valve operates normally when the transaxle shifts to 3rd gear. You will notice that the valve has moved to the left, allowing the Forward Clutch pressure to exhaust, leaving the 3-4 Shift Valve free to stroke into an upshifted position when the PCM commands the shift to fourth gear.

CORRECTION: If it is found that the Forward Clutch Control Valve is sticking, cleaning up any debris, and checking the valve and the valve bore for any damage is recommended. If the valve retainer is bent or broken, it can be replaced with Ford Part Number F8DZ-7F194-AA. If the Forward Clutch Control Valve shows any signs of damage either on the valve nose or on the valve spools, it should be replaced. Sonnax has a replacement Forward Clutch Control Valve kit available. The TransGo AX4N Shift Kit also supplies a replacement Forward Clutch Control Valve.

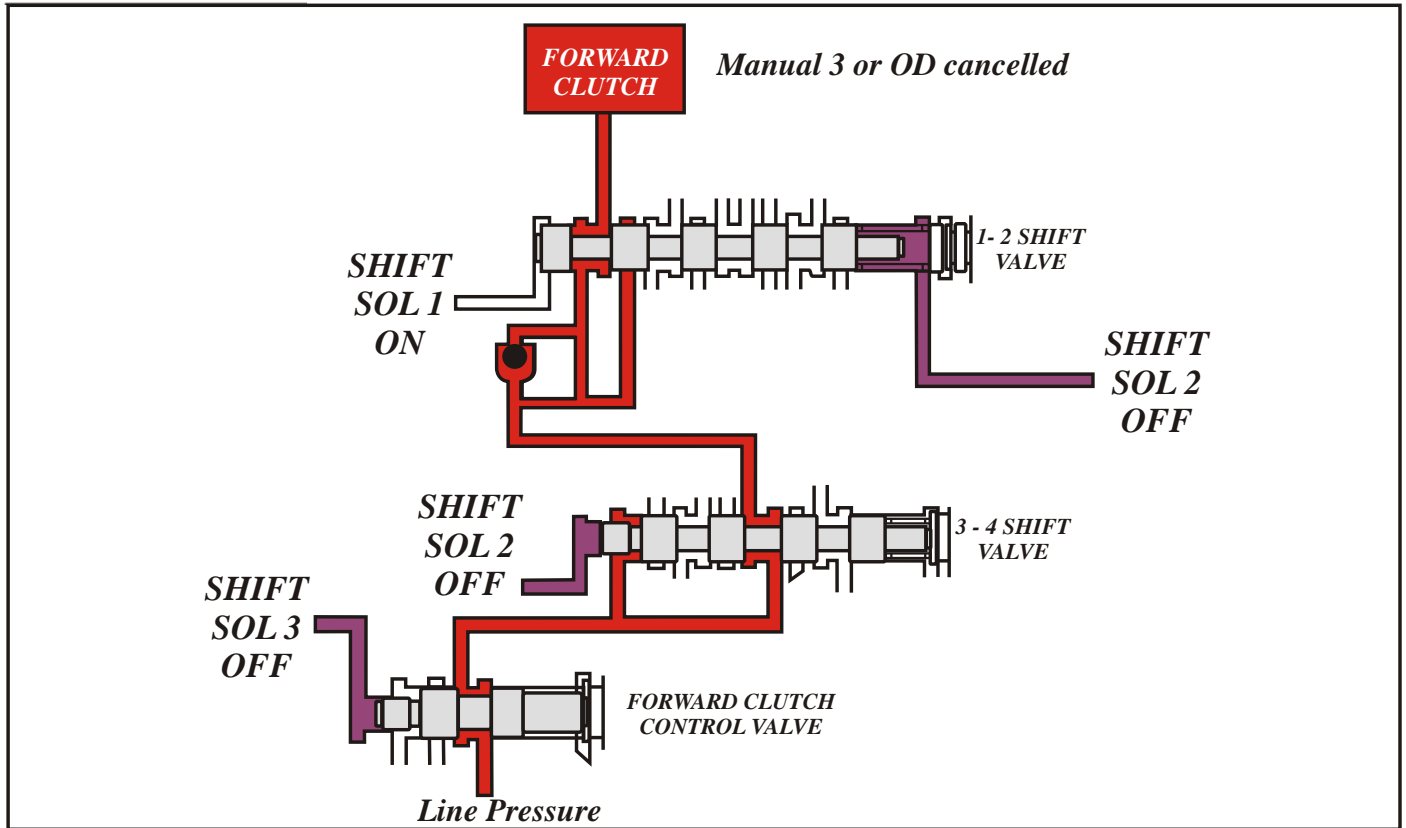
Figure 5

Road test: Try this simple test to help you to determine if the Forward Clutch Control Valve is causing the transaxle to neutral at a stop. Drive the vehicle with the shift selector in the D range, or press the OD Cancel Switch so that it indicates OD OFF. If when road testing the vehicle this way, you find that the neutral condition at a stop does not occur, then it is very likely that the Forward Clutch Control Valve is sticking. The reason that this is helpful is that when OD is not selected, the PCM does not energize Shift Solenoid 3 during the upshift to 3rd. gear, which will leave the Forward Clutch Control Valve in the upshifted position, leaving the Forward Clutch applied. See figure 5.

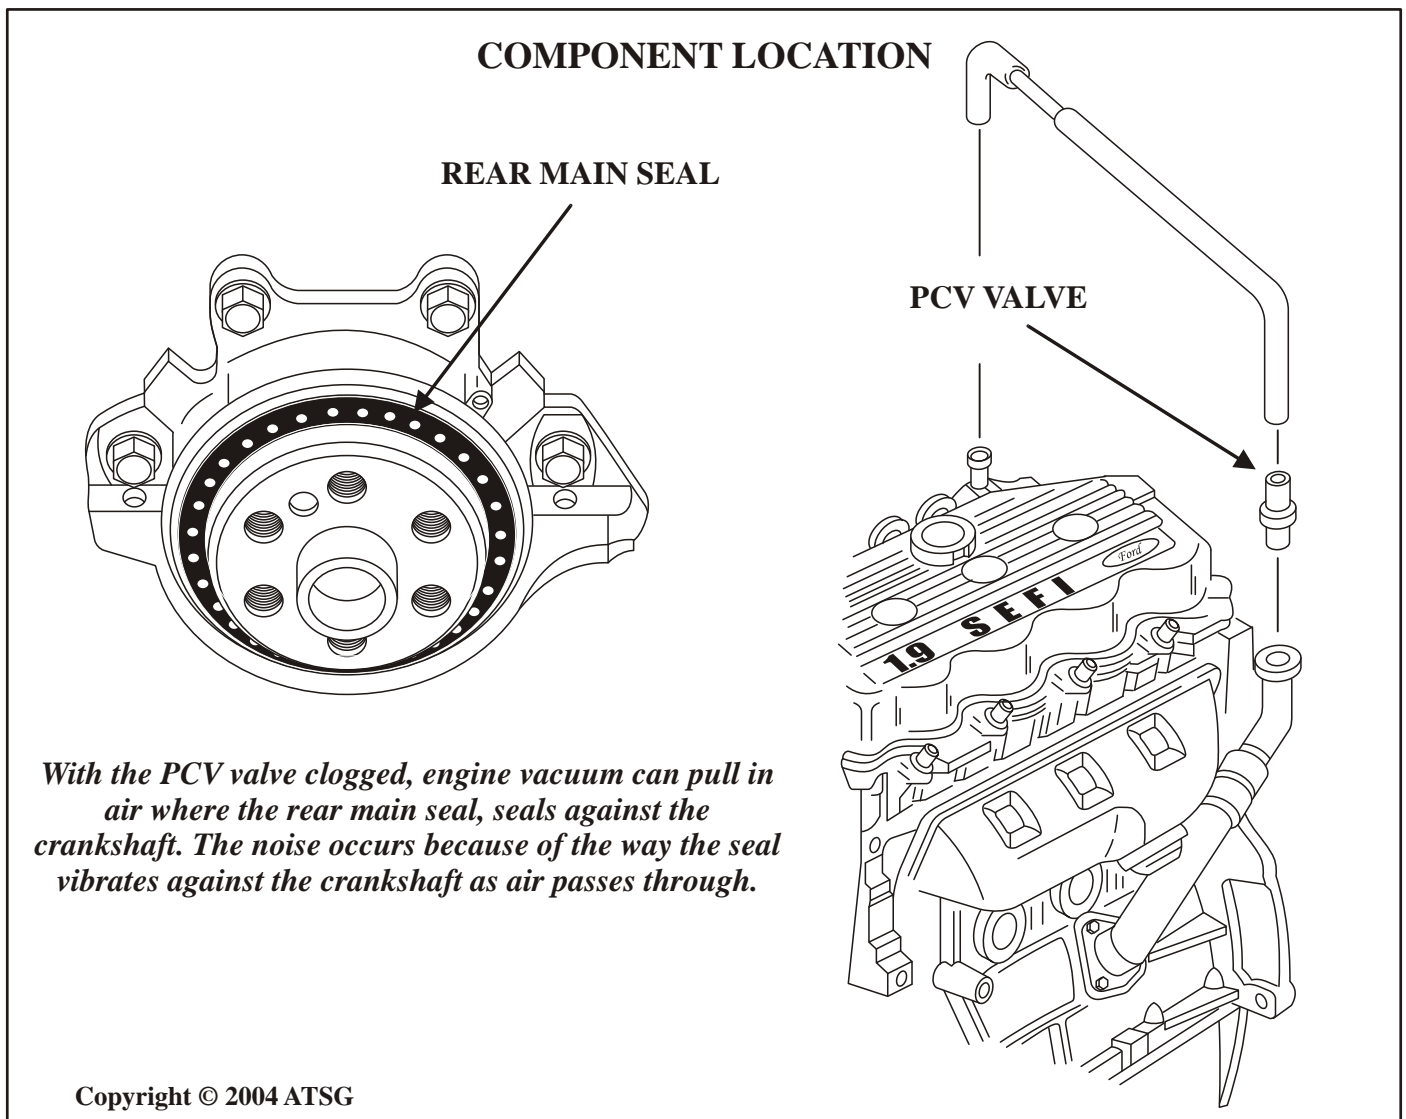
Figure 1

COMPLAINT: Ford Escort with F4EAT transaxle exhibits a squealing type noise that is coming from the bell housing and converter area. This may be mis-diagnosed as a Torque Converter noise. After Torque Converter replacement, the noise remains.

CAUSE: This condition may be caused by a clogged PCV Pollution Control Valve. If the PCV valve won't allow air to be drawn through it, engine vacuum may become strong enough to pull in air through the rear main engine seal. If this occurs, a high pitched squealing noise may result from the vibration of the seal against the crank as air is pulled through the seal into the engine. See Figure 1.

CORRECTION: Replacing the PCV valve will correct this problem. See Figure 1.

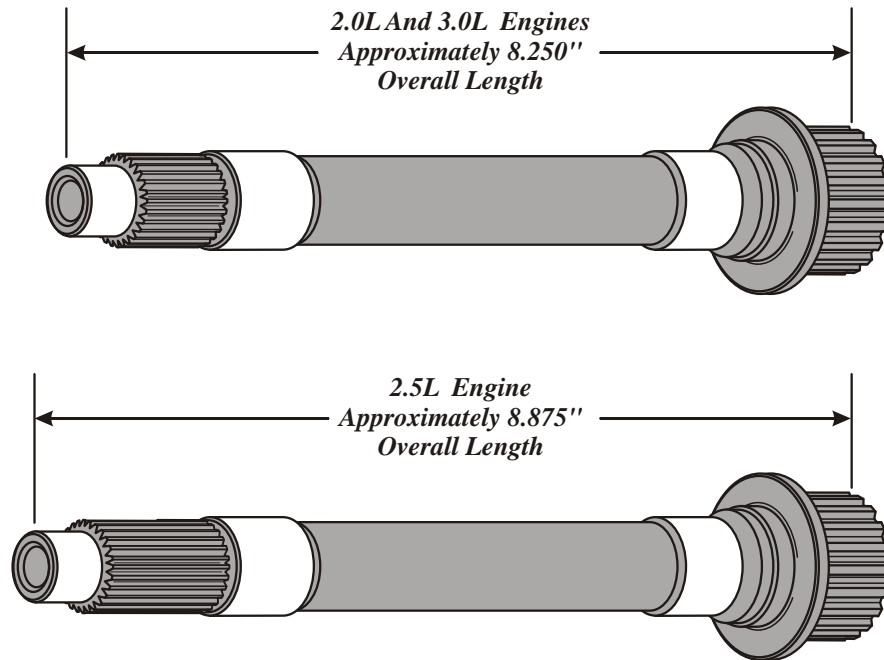
Figure 1

- CAUSE:** One cause may be, a mis-matched turbine shaft and torque converter that was mistakenly installed in the vehicle. The turbine shaft and oil pump drive shaft for the 2.0L and 3.0L engines are approximately 5/8" shorter than the turbine shaft and oil pump drive shaft for the 2.5L engine as shown in Figures 1 and 2. If the short turbine shaft is installed into the 2.5L and converter, the vehicle will exhibit the above concerns. Torque converter identification is provided for you in Figure 3, and as you can see in the height dimension chart, there is approximately 5/8" difference.

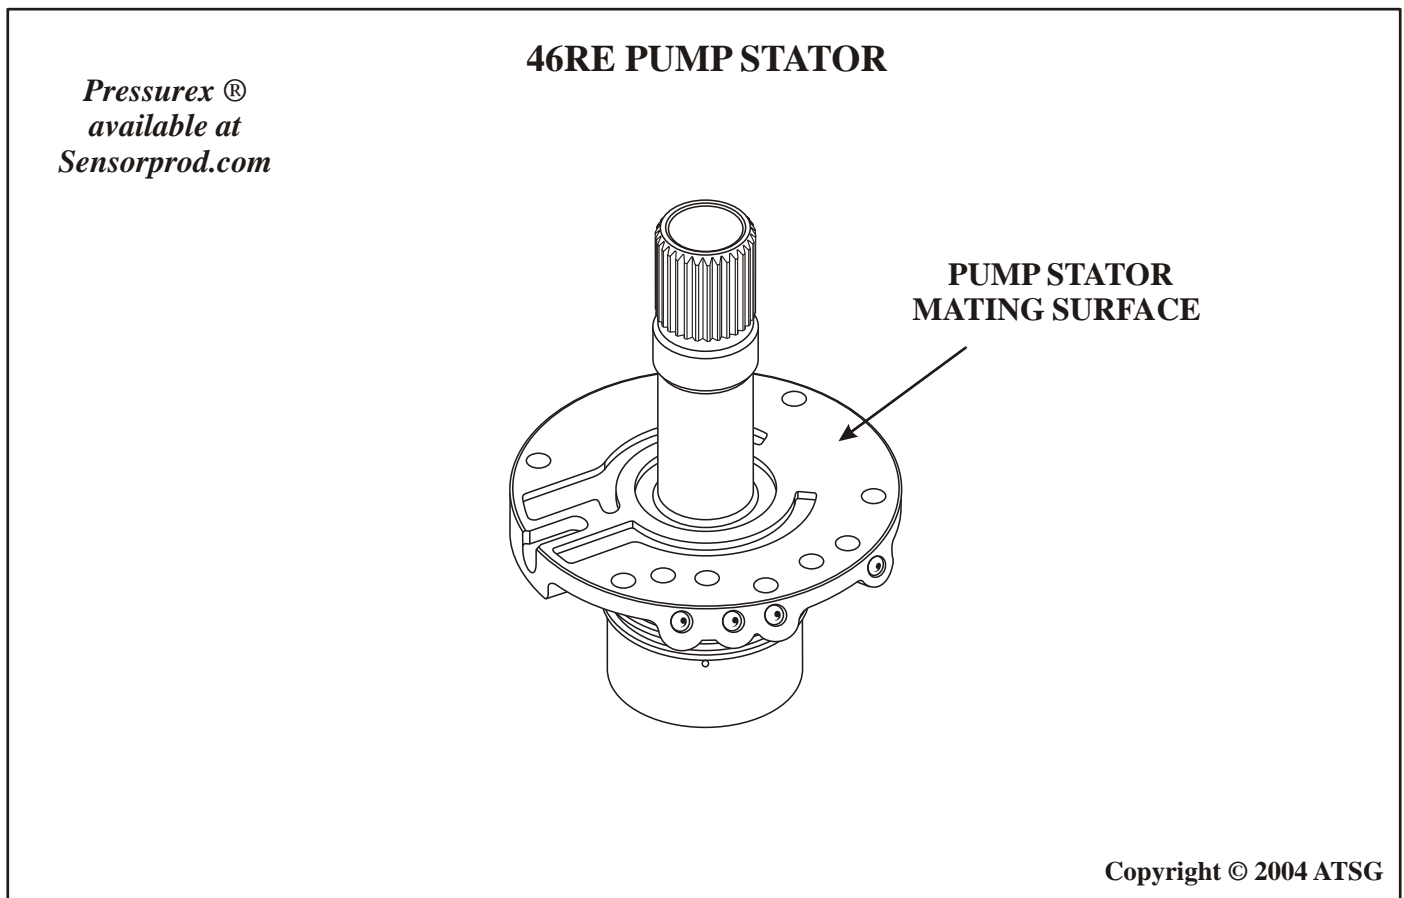
Figure 1

CAUSE : The cause may be, that the mating surface, as shown in Figure 1, between the Pump Body and the Pump Stator is not flat, causing a loss of line pressure and Torque Converter apply pressure. Refer to Figure 2 for port identification of the Pump Body and Pump Stator.

CORRECTION: To verify that the stator surface is flat, Pressurex[®] Film may be used. This is a product from Sensor Products Inc., which uses microcapsules of a paint like substance that changes color intensity depending on pounds per square inch. The higher the psi., the brighter the color. To repair this condition, have the face of the stator machined so that it is flat.

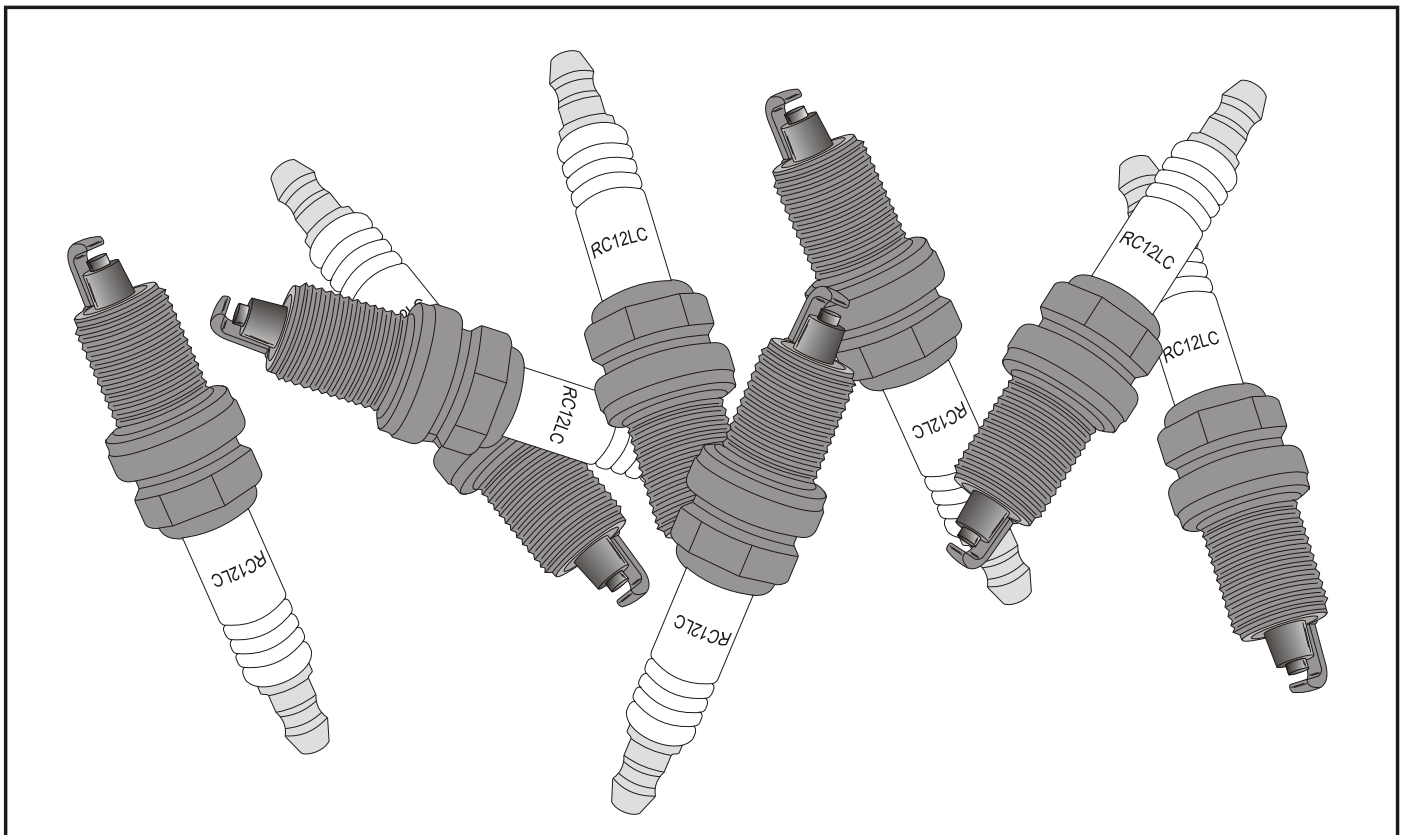
Figure 1

CAUSE: This 1999 Dodge 4x4 with 5.2L engine and 46RE transmission had 126,923 miles (204,264 kilometers) on the odometer. Worn spark plugs (See Figure 1) were the cause of the above mentioned complaints.

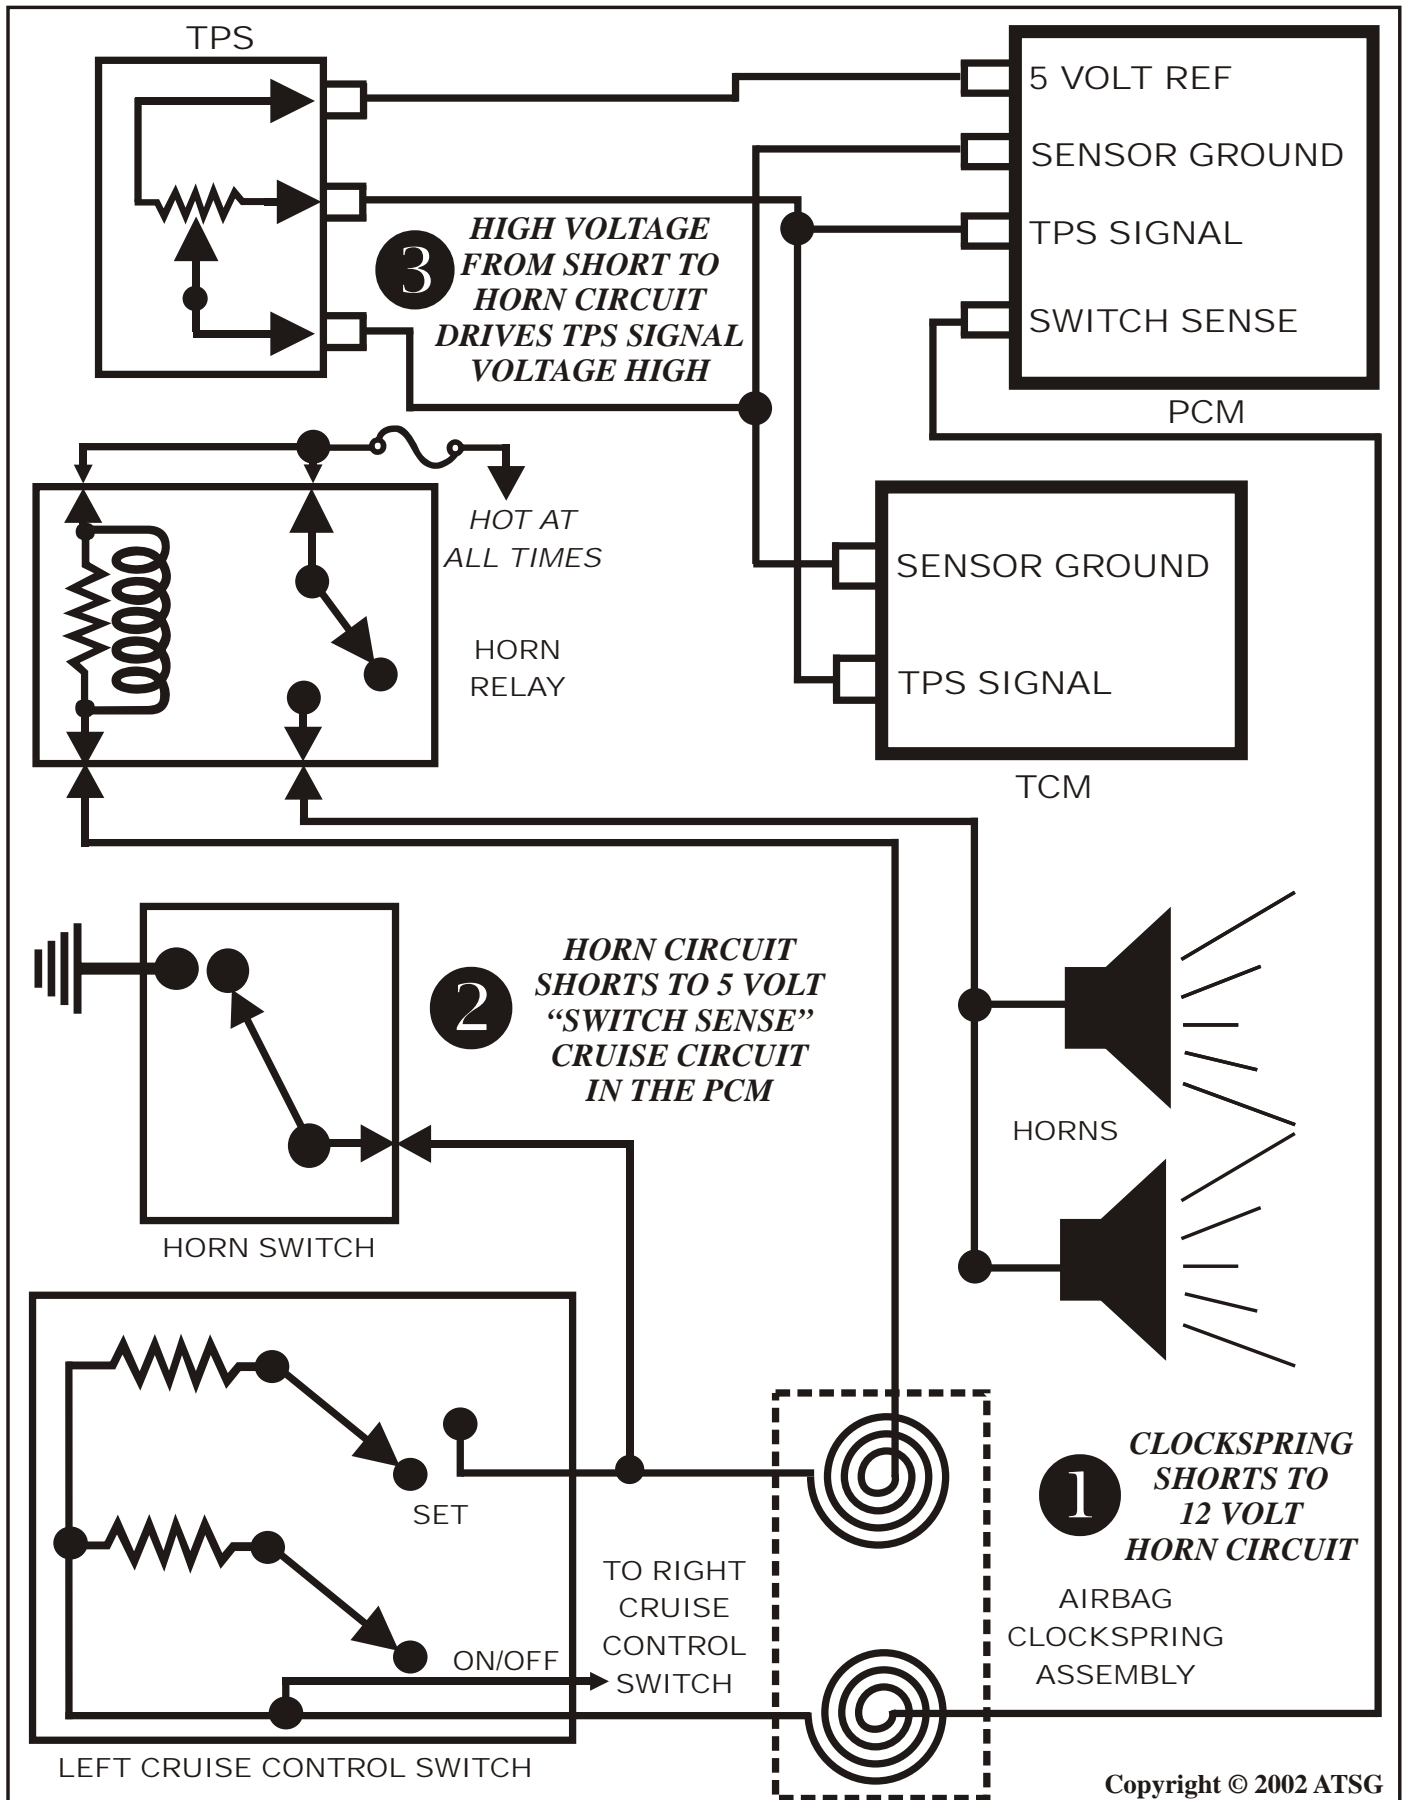
Figure 1
Automatic Transmission Service Group

CAUSE: The Airbag Clockspring in the steering wheel hub has shorted to power! The horn button, Cruise Control Switch and the Airbag Clockspring are both located in the steering wheel hub. When the Clockspring shorts to the 12 volt HORN circuit which in turn shorts to the 5 volt CRUISE Control "Switch Sense" circuit, the TPS signal voltage is driven high and remains there as shown in Figure 1.

CORRECTION: Replace the Airbag Clockspring assembly. Once the Clockspring has been replaced, be sure to check the sensor 5volt reference voltage at the PCM to insure that circuit has not been damaged by the short to power. Also check the TPS signal range to insure the TPS has not been fried.

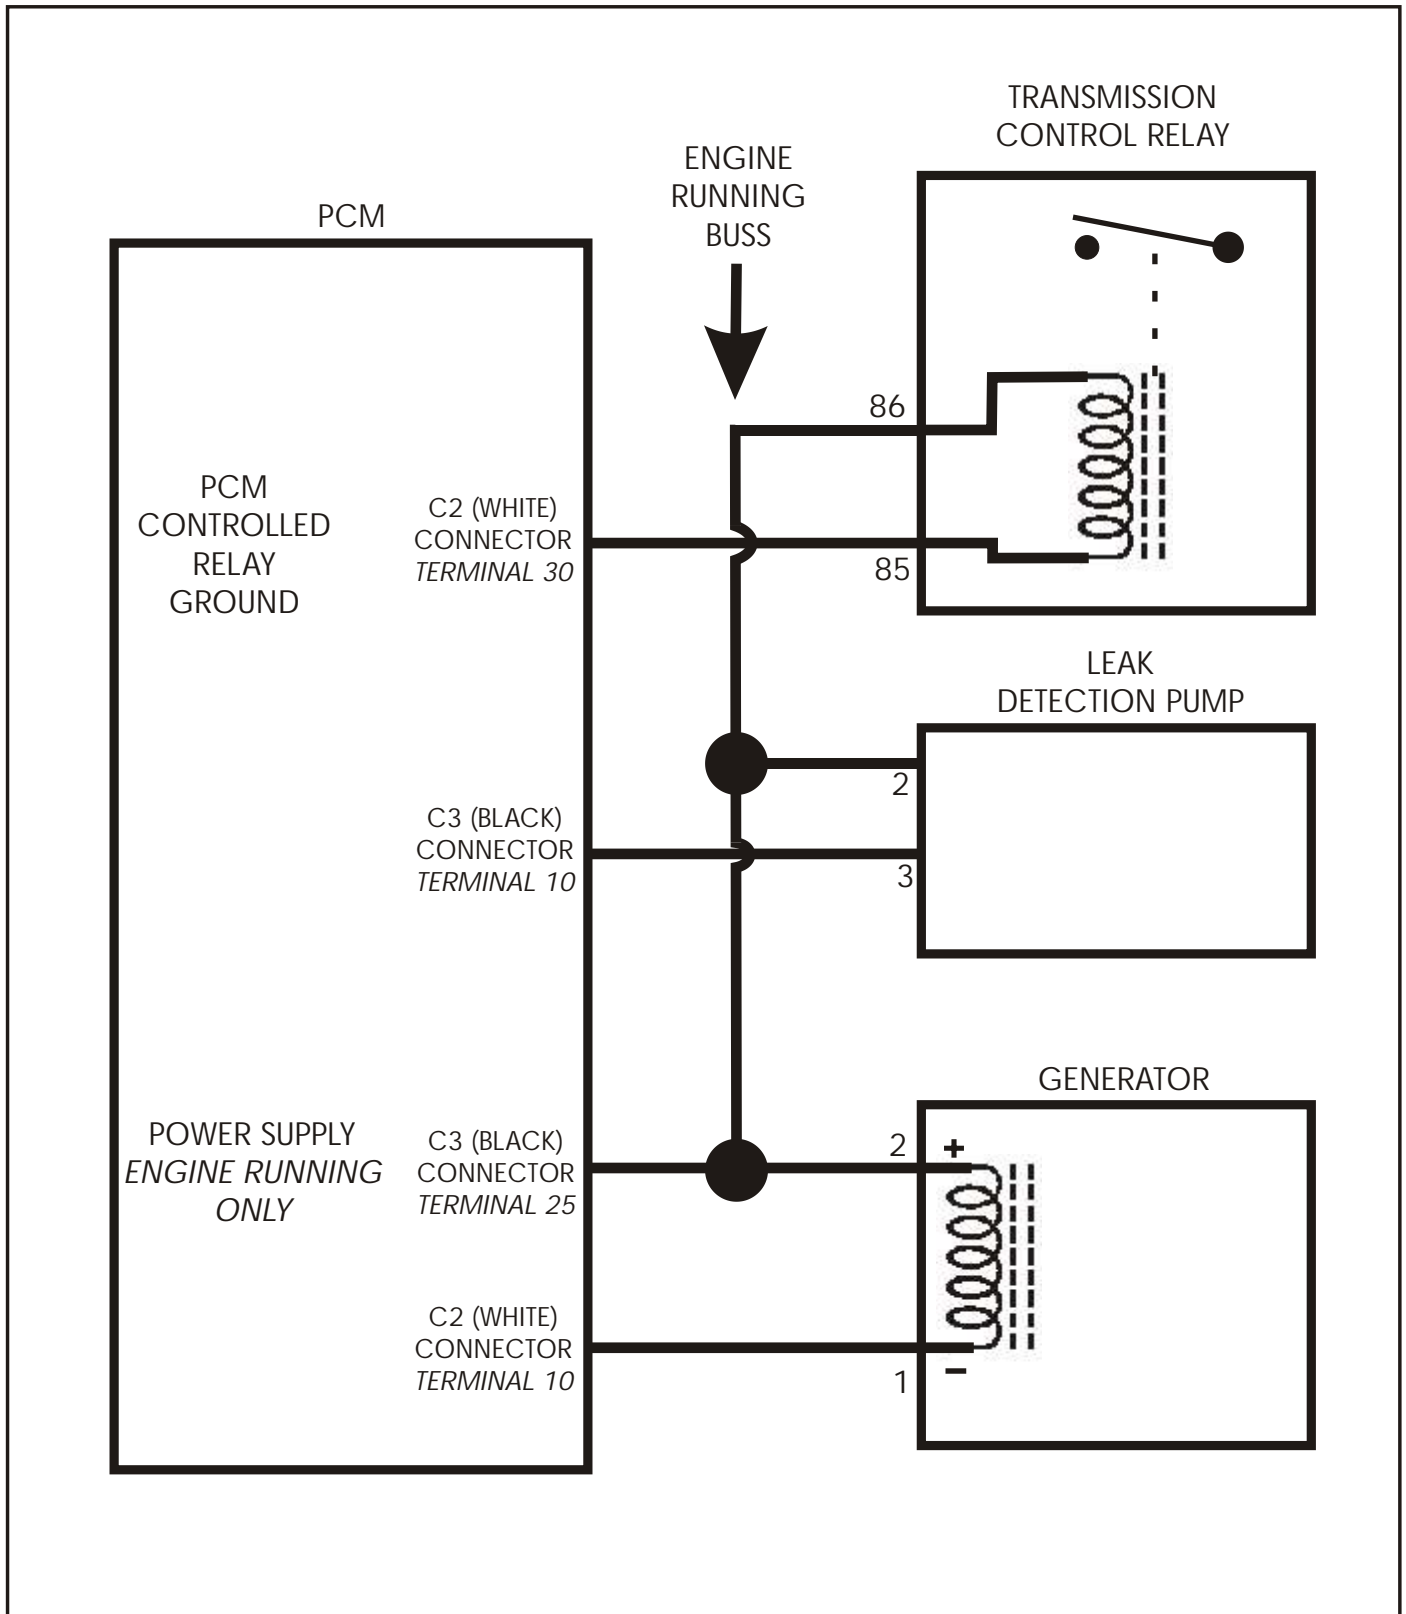
Figure 1

CAUSE: The result of all these complaints is what A.T.S.G. will identify as an Engine Running Bus System, loss of power. Power for the "ERB" is provided by the PCM at terminal 25 of the C3 (Black) connector, (Refer to Figure 1) ***but only when the engine is running.*** This is usually labeled "Generator Source in most wiring diagrams because it actually is the source voltage for the generator's field winding. The "ERB" also supplies power to the Leak Detection Pump and to the Transmission Control Relay. The ground circuits for the generator as well as the leak detection pump are controlled by the PCM at PCM terminals 10 in the C2 (White) and terminal 10 in the C3 (Black) connector respectively. The Transmission Control Relay's PCM ground controlled circuit is PCM terminal 30 in the C2 (White) connector. This is the circuit that is shut down by the PCM when the transmission control system is in default, such as when a transmission related code is stored. ***The real cause of all these complaints is a faulty Crankshaft Position Sensor!***

CORRECTION: It seems that Chrysler/Jeep Computer strategy dictates that when the crank sensor signal is corrupt the PCM "Engine Running Bus" will not power up. Disconnect the crank sensor and see if these circuits power up, if they do, the crank sensor is faulty. It seems that when the crank sensor is disconnected the PCM will ignore it and use another sensor value as a back up signal. This sensor is a Hall Effect Sensor and when it shorts its 5 volt reference source it will cause the above mentioned complaints. It may even "pull down" the 5 volt reference voltage supply to the Governor Pressure Sensor or other sensors using the reference voltage supply as well. In many cases the sensor checks good with a voltmeter. Use a scope to see if the signal amplitude is adequate, in many cases it will not be. The next time one of these vehicles comes in with the transmission stuck in third gear check to see if the plus side of the Transmission Control Relay has power. If it does not, disconnect the crank sensor and check it again. ***Remember, the engine must be running.***
