# Technical Service Information

## SUBARU 3 SPEED SLUGGISH AFTER SITTING OVERNIGHT

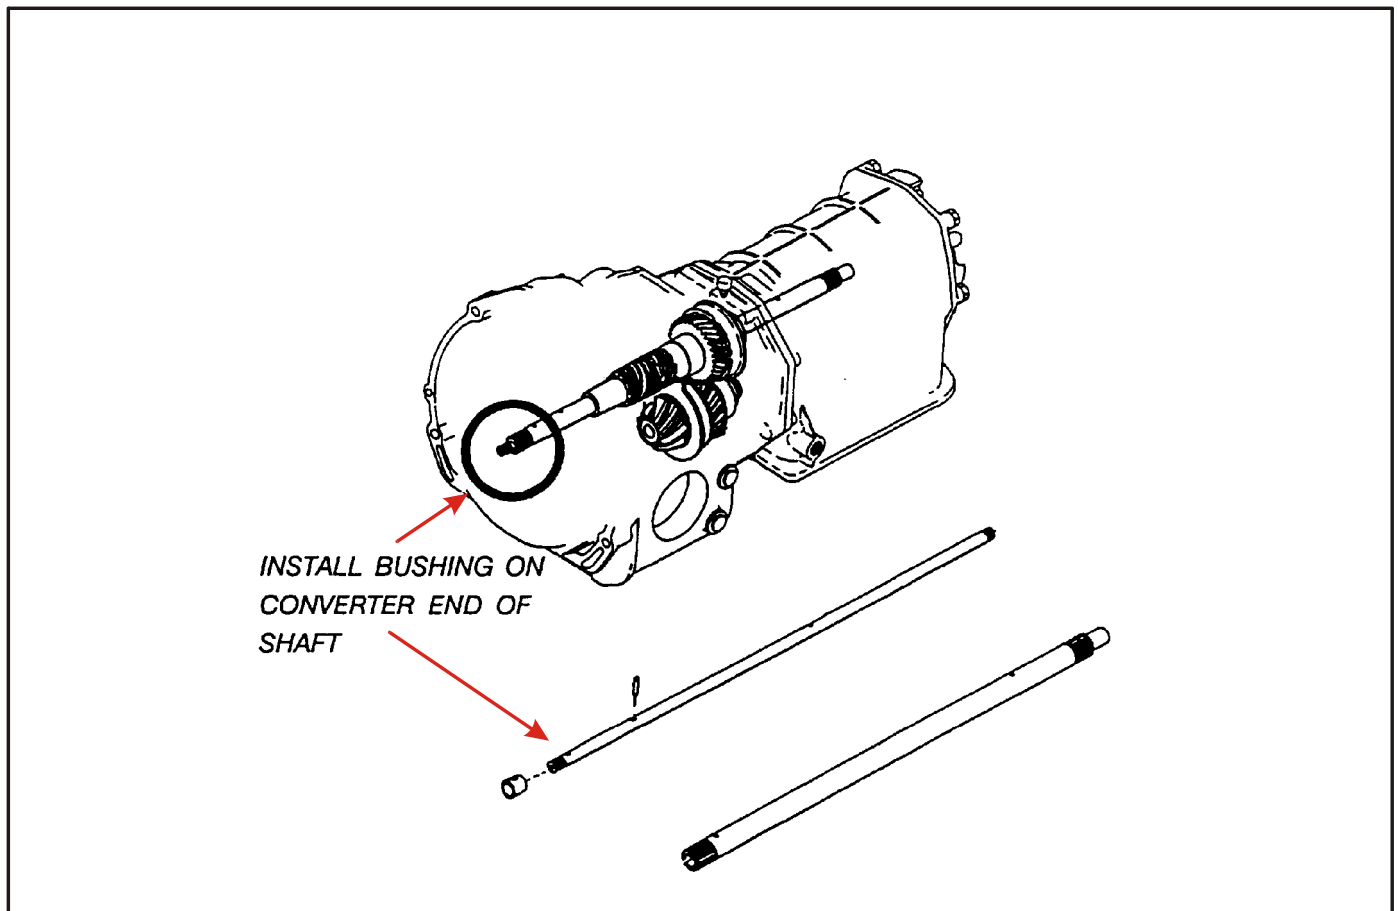
Figure 1

- COMPLAINT:** Transmission works fine until it sits, with the engine off, for a period of an hour or more. When started you have a slip and/or extreme sluggishness.
- CAUSE:** Oil pump drive shaft bushing has been installed on the wrong end of the shaft, or is missing, creating converter drain back and requiring fill time for the pump to refill torque converter.
- CORRECTION:** Install the oil pump drive shaft bushing into "Converter End" of turbine shaft, between turbine shaft and oil pump drive shaft (Refer to figure 1).
