Technical Service Information

ZF 5HP-24

SLIPPING OR NO FORWARD ENGAGEMENT

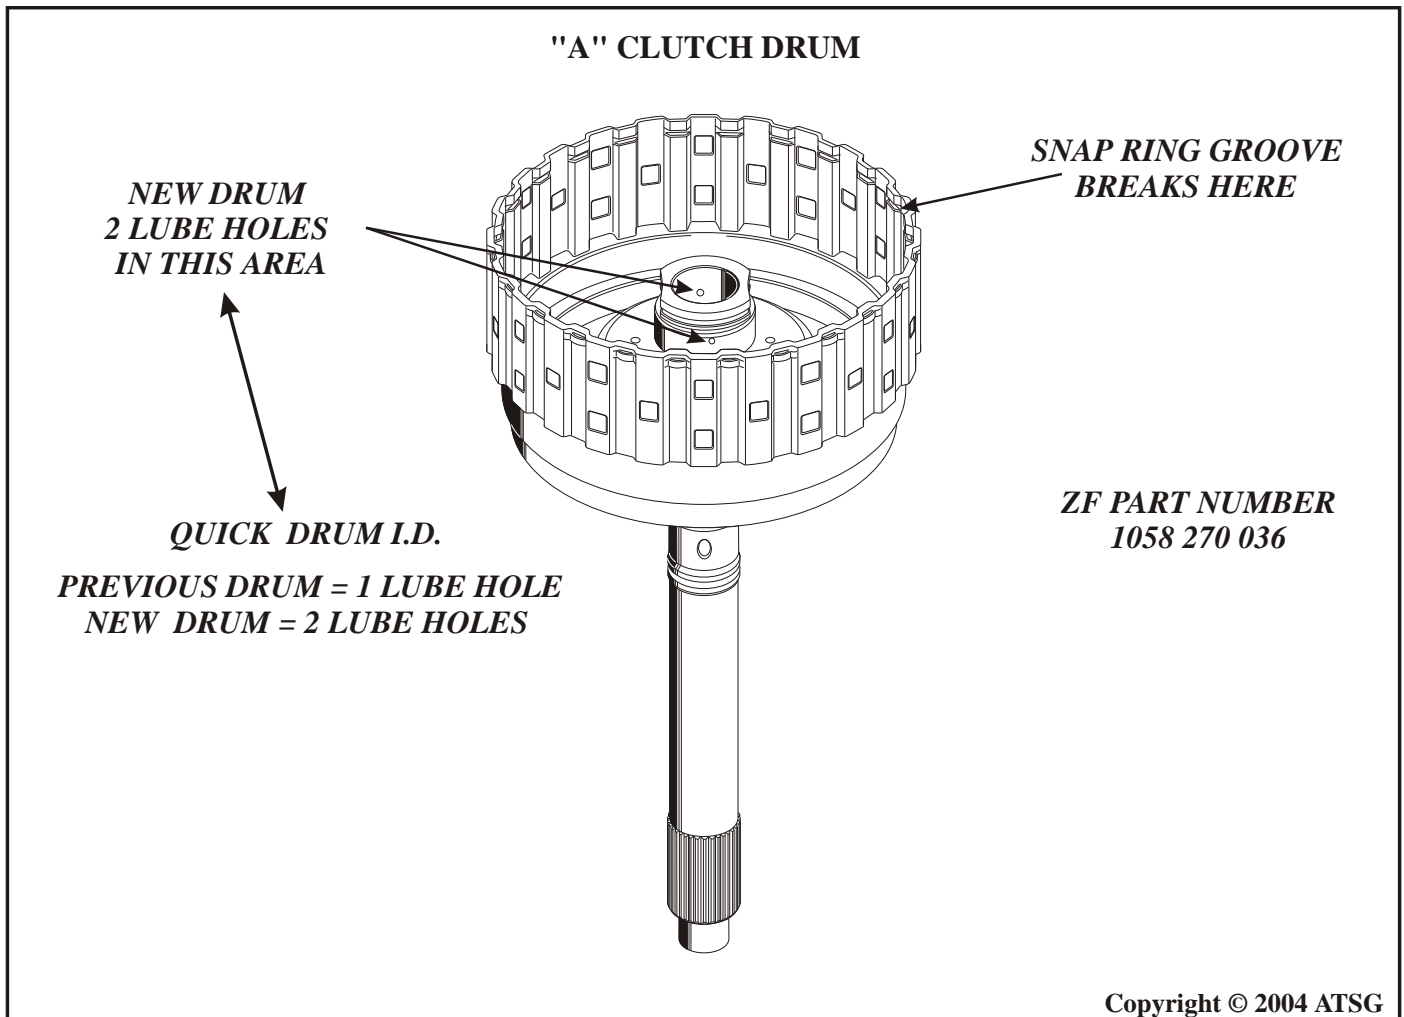
Figure 1

CAUSE: The cause may be, a broken snap ring groove in the "A" Clutch Drum allowing the "A" Clutch to slip, as shown in Figure 1.

CORRECTION: Replace the "A" Clutch Drum with the updated drum available from ZF.
