Technical Service Information

FORD AX4N

VEHICLE SPEED SENSOR ELIMINATED

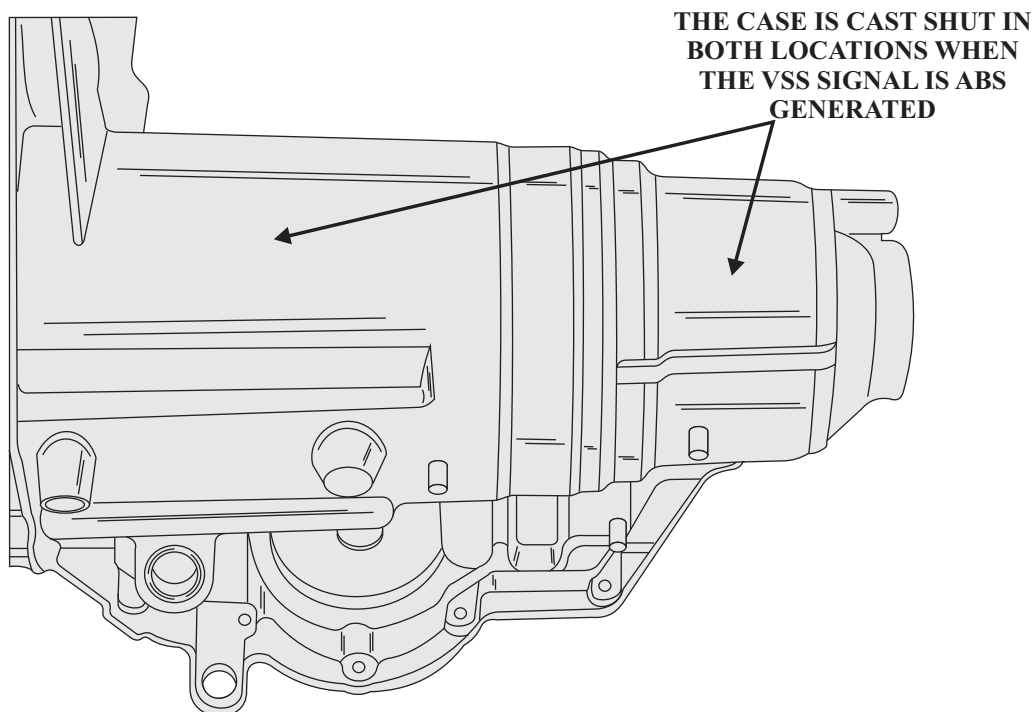
Figure 1

A visual check of the VSS reveals that no VSS is located in either of the two locations it would normally be found! (Refer to Figure 1)

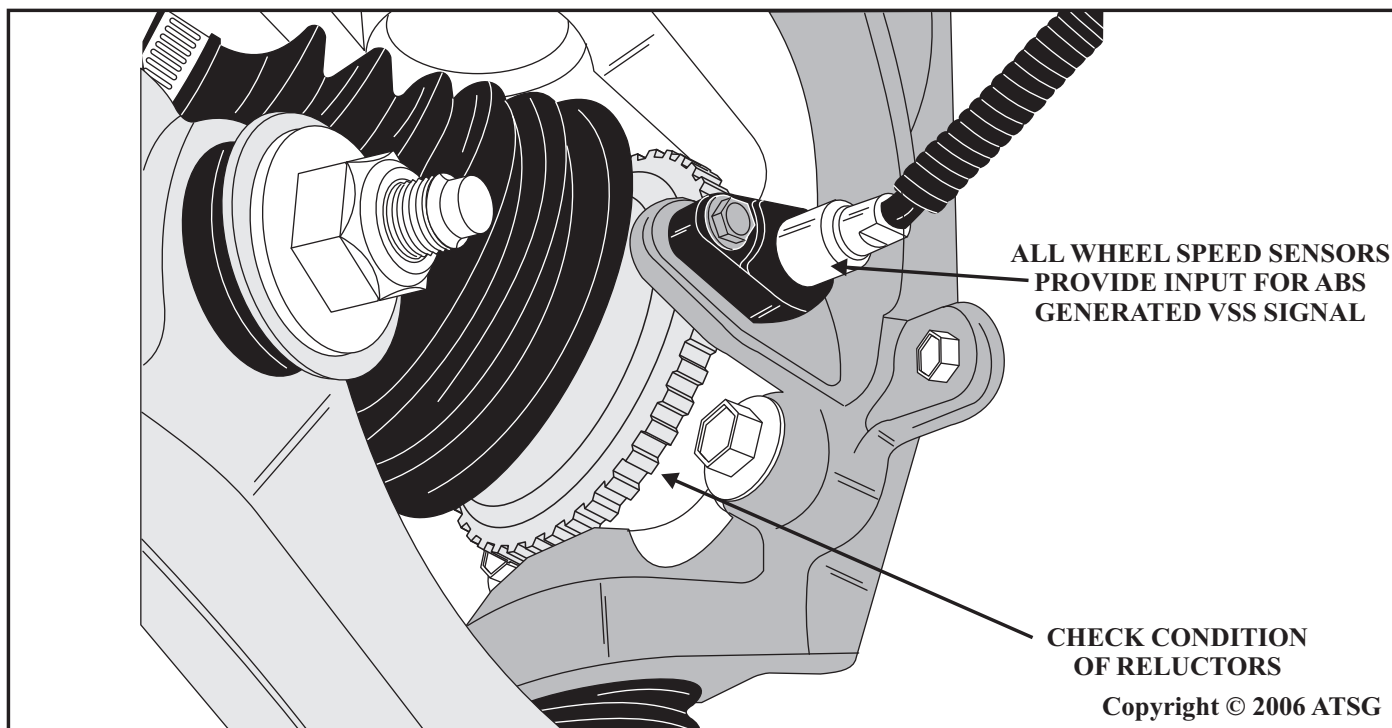
Figure 2

CAUSE: These vehicles obtain the VSS signal from the Antilock Brake Control Module. This means that the raw signal the ABS Module is receiving comes from all four (4) Wheel Speed Sensors (WSS), Refer to Figure 2.

CORRECTION: The ABS Module will have to be scanned for wheel speed sensor codes in order to find the one, or more, wheel speed sensor(s) that are faulty. It would also help to view the ABS data to see if all four (4) wheel speeds are the same when driving in a straight line, (no turns).

Note: The reluctors at each wheel can become caked with mud or rust resulting in an erratic or no signal condition, be sure to check for this or any other condition that might cause a problem with the wheel speed sensor to reluctor relationship.

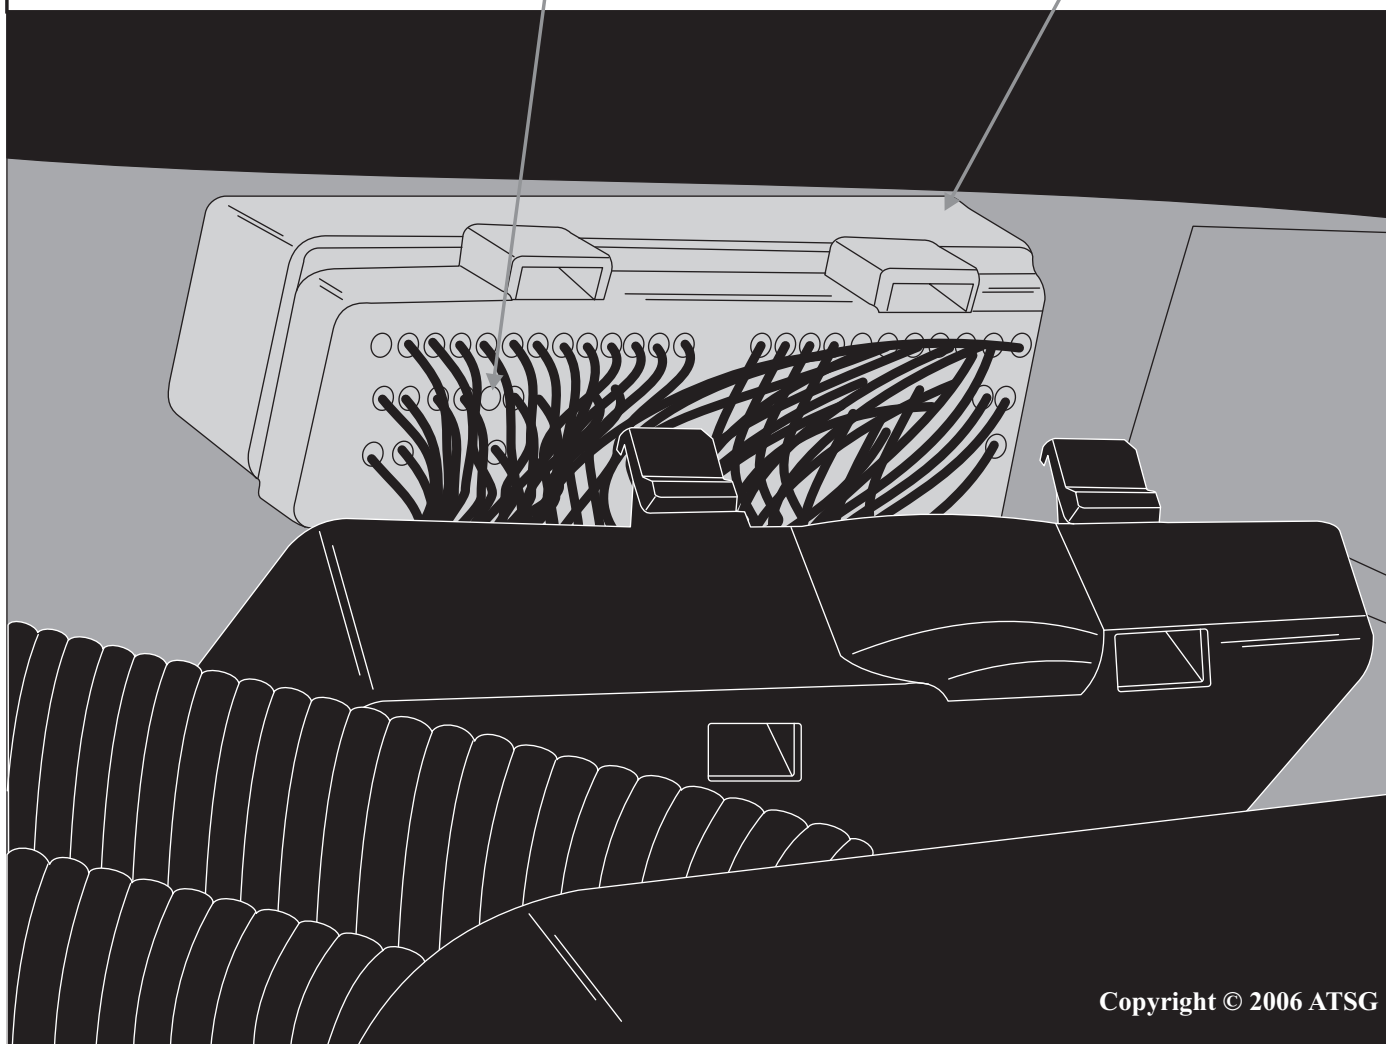
Figure 3

Systems using the gear driven or permanent magnet type of VSS, will have a wire at PCM terminal 58, with the ground circuit found at PCM terminal 33. Systems using the ABS Module to generate the VSS signal will not have a wire at PCM terminal 58 as shown in Figure 3. The VSS signal is sent from the ABS Module over the vehicles Multiplex Communication Network to the Speed Control Module (cruise control) and then to other modules that require a VSS signal as illustrated in the electrical schematic shown in Figure 4.

PCM TERMINAL 58 WILL BE EMPTY WHEN
THE VSS SIGNAL IS ABS GENERATED
