# Technical Service Information

## **FORD CD4E INTERMITTENT TROUBLE CODE 628 OR P0741**

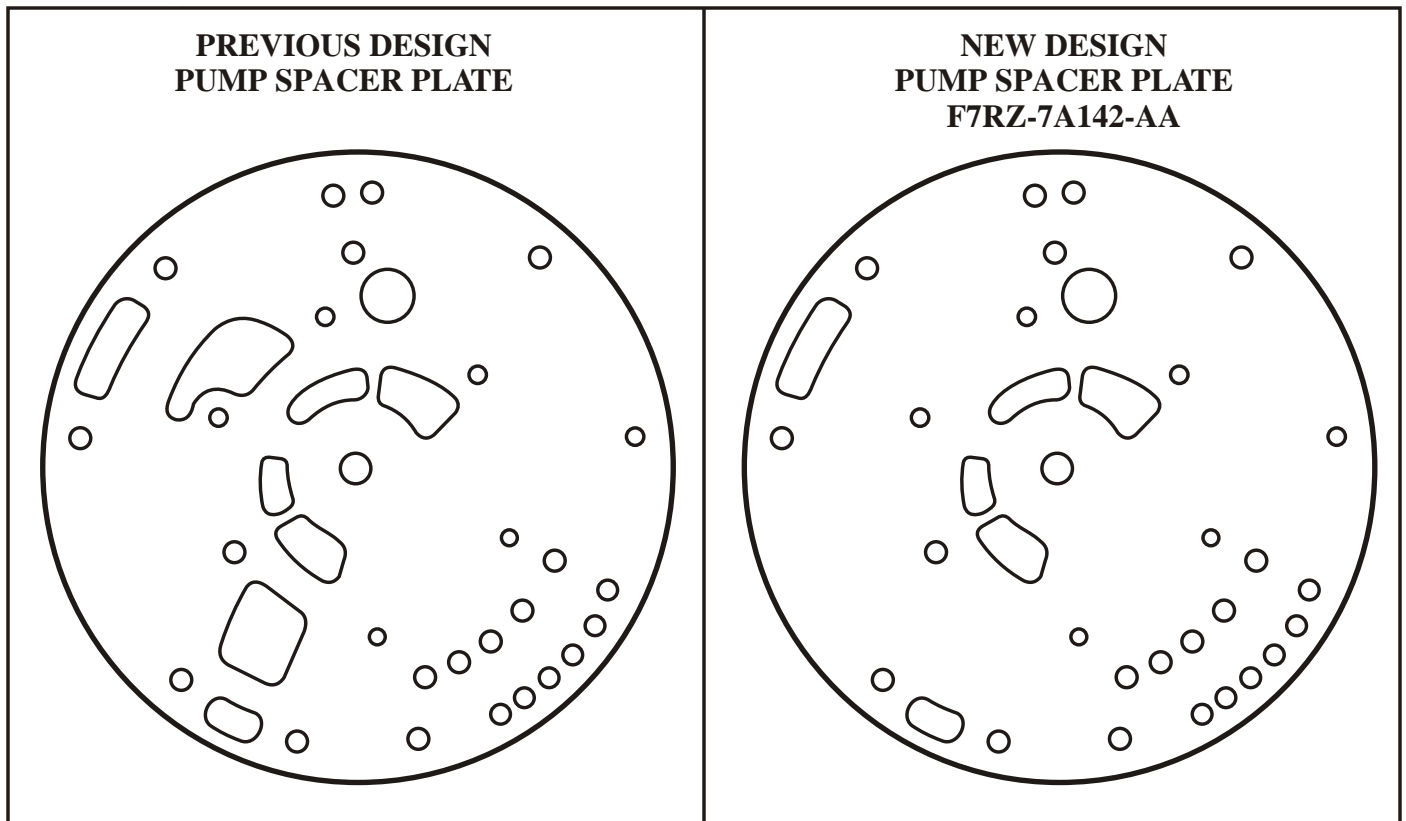
Figure 1

**CAUSE:** The cause may be, a "Blown" pump body gasket

PUMP SPACER PLATE - New design level has two less holes, as shown in Figure 1.

**CORRECTION:** Beginning in January 1997, all CD4E transaxles will contain a new design level Oil Pump Assembly which includes a revised Pump Support, revised Pump Body Gasket and a revised Pump Separator Plate. Refer to Figures 1, 2, and 3. This new design Pump Assembly will eliminate the "Blown" gasket concern. We have included all OEM part numbers in "Service Information" below to acquire the new design level parts.

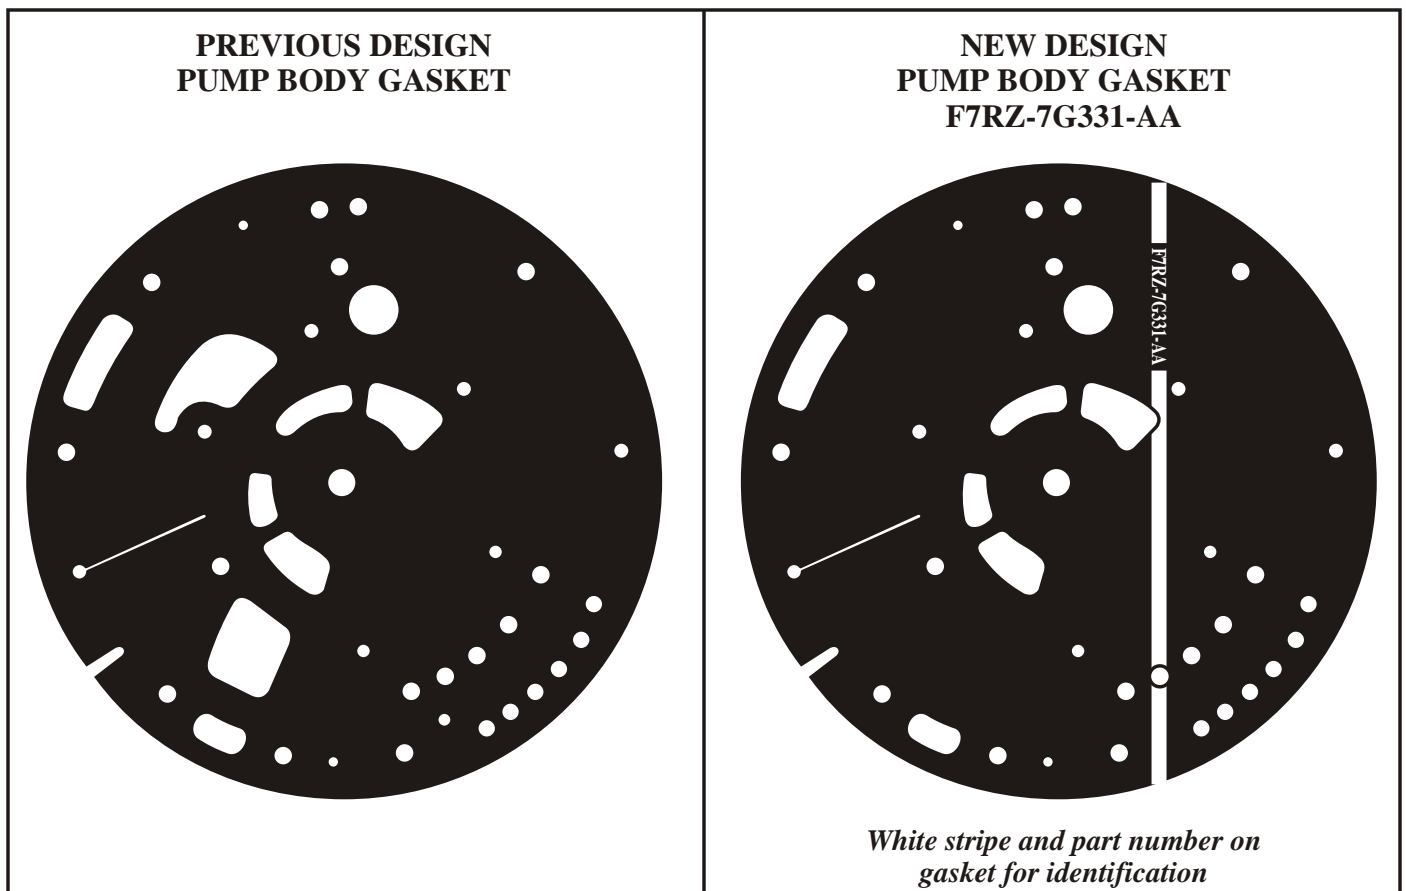
Figure 2

PUMP BODY GASKET - New design level has two less holes and is identified with a White stripe and part number on the gasket, as shown in Figure 2.

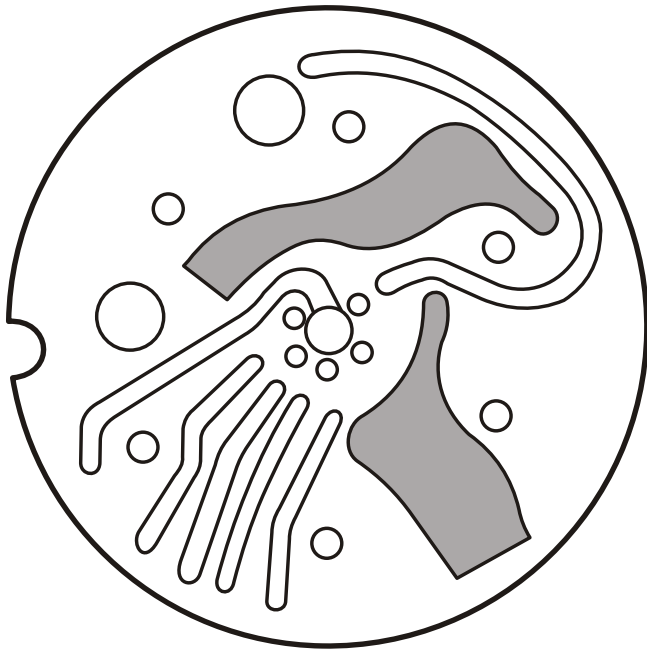
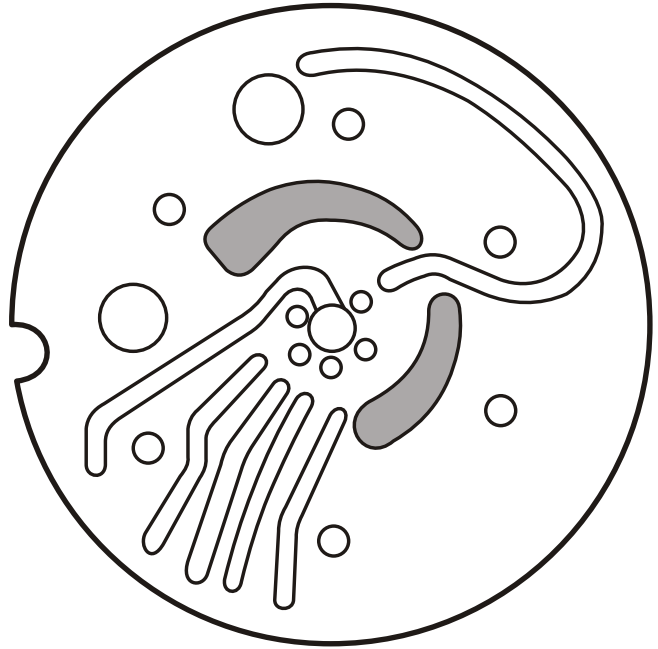
Figure 3

PUMP SUPPORT - New design level has different cavities and we have highlighted the cavities that are different for identification purposes, as shown in Figure 3.
