Technical Service Information

THM 3T40 (125C) COASTDOWN CLUNK

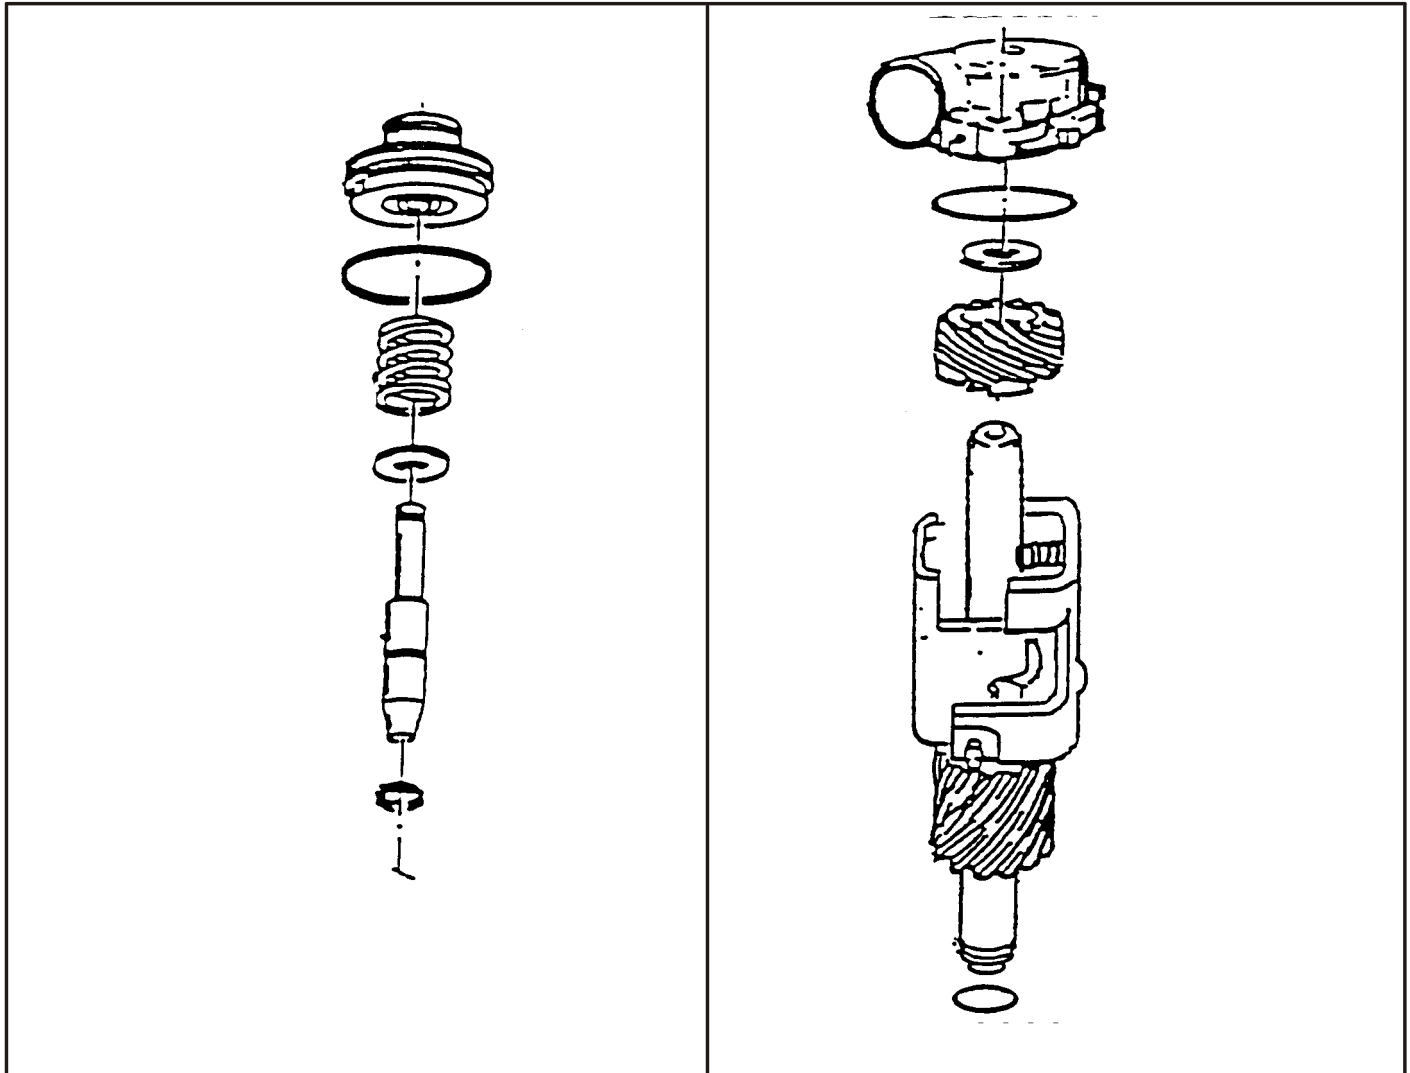
COMPLAINT: A 3-2 coast downshift clunk or bump may occur on some THM 125 Or 125C transmissions.

CAUSE: This can be caused by a broken spring on the intermediate servo piston. Figure 1 Or governor oil not exhausting properly..

CORRECTION Replace broken servo spring as shown in figure 1. If servo spring is okay then remove the primary Spring from the governor. Figure 2.
