Technical Service Information

THM 440-T4 REPEATED REVERSE BAND FAILURE

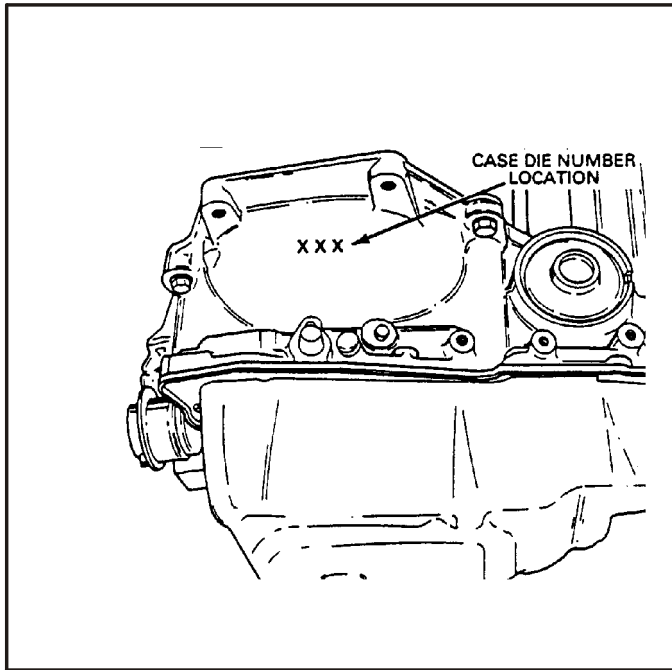
Figure 1

(1) Inspect the case "DIE" number, located on top of the transaxle bell housing, as shown in Figure 1. IF, the case "DIE" number matches the suspect numbers listed below, proceed to number 2.

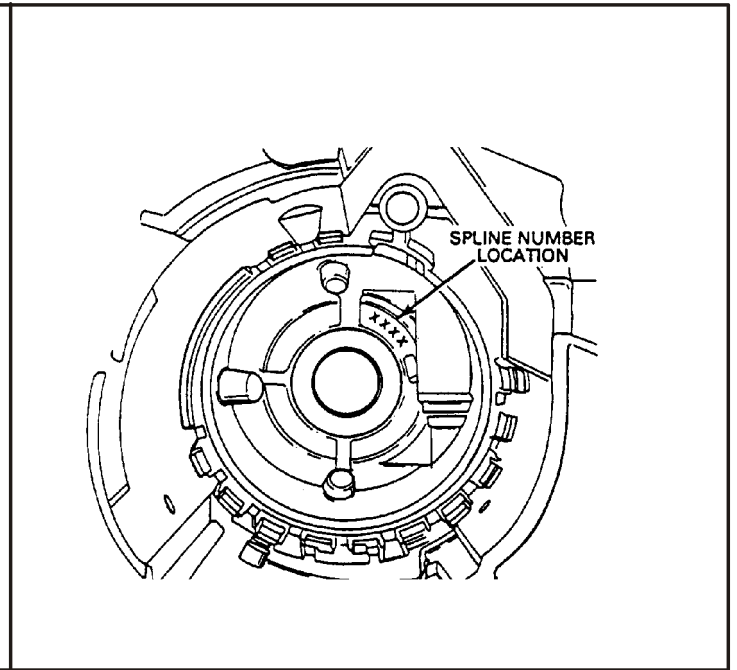
Figure 2

(2) Disassemble the transaxle and inspect the case "SPLINE" number, located deep inside the barrel of the case next to the right axle seal, as shown in Figure 2.
