Technical Service Information

NISSAN E/L4N71B OVERDRIVE SECTION FAILURE

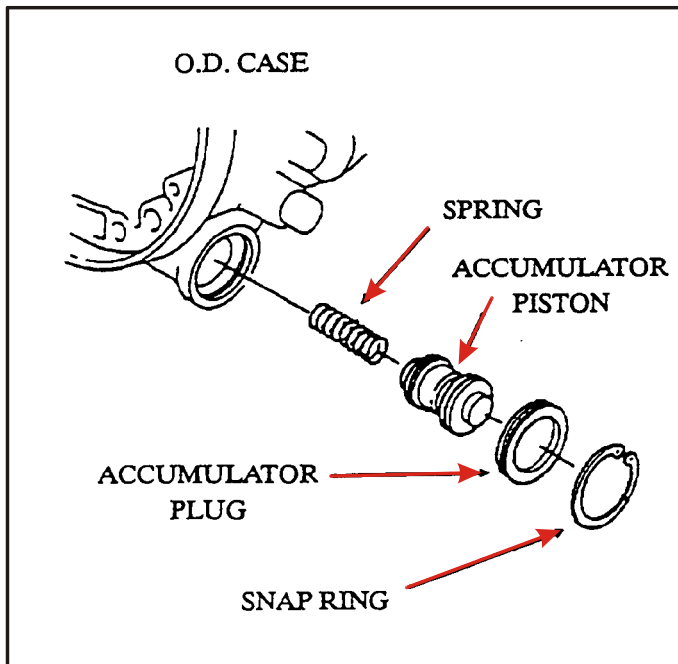
Figure 1

COMPLAINT: Overdrive section wiped out - overheating evident after rebuild.

CAUSE: The overdrive accumulator ring is cutting off lube flow to the O.D. case (Figure 1).
