Technical Service Information

SUBARU 3 SPEED FRONT SEAL POPS OUT

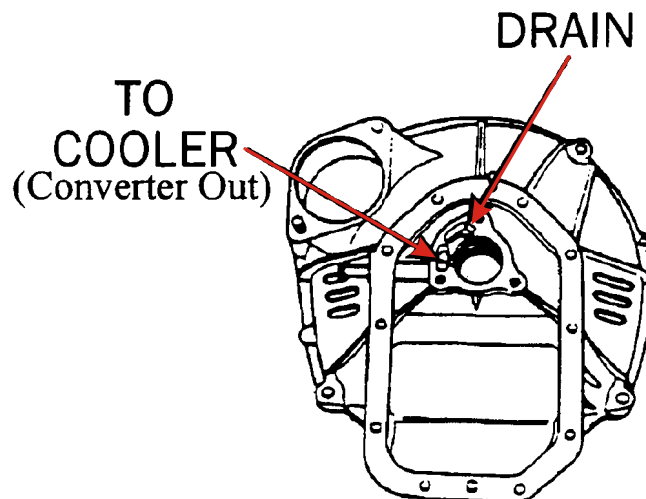
Figure 1

COMPLAINT: After a reseal or overhaul, the front seal pushes out of the converter housing.

The converter bushing may be pushed back in the converter housing preventing the oil coming out of the converter from getting past the stator shaft and out to the cooler. When the bushing is replaced, it can easily be pushed in so far that it can block the "converter out" passage. See figure 1. Also the stator support gasket may block fluid to the "converter out" passage due to mis-assembly or use of excessive sealant.

CORRECTION: 1. Check converter hub to bushing clearance. It should be no more than .0045 in. If it is more, then the bushing **MUST BE REPLACED**.

2. When replacing the converter bushing, check that you leave sufficient clearance between the bushing and the rear of the stator support.
