Technical Service Information

THM 4T60-E 1-2 ROLLER CLUTCH FAILURE

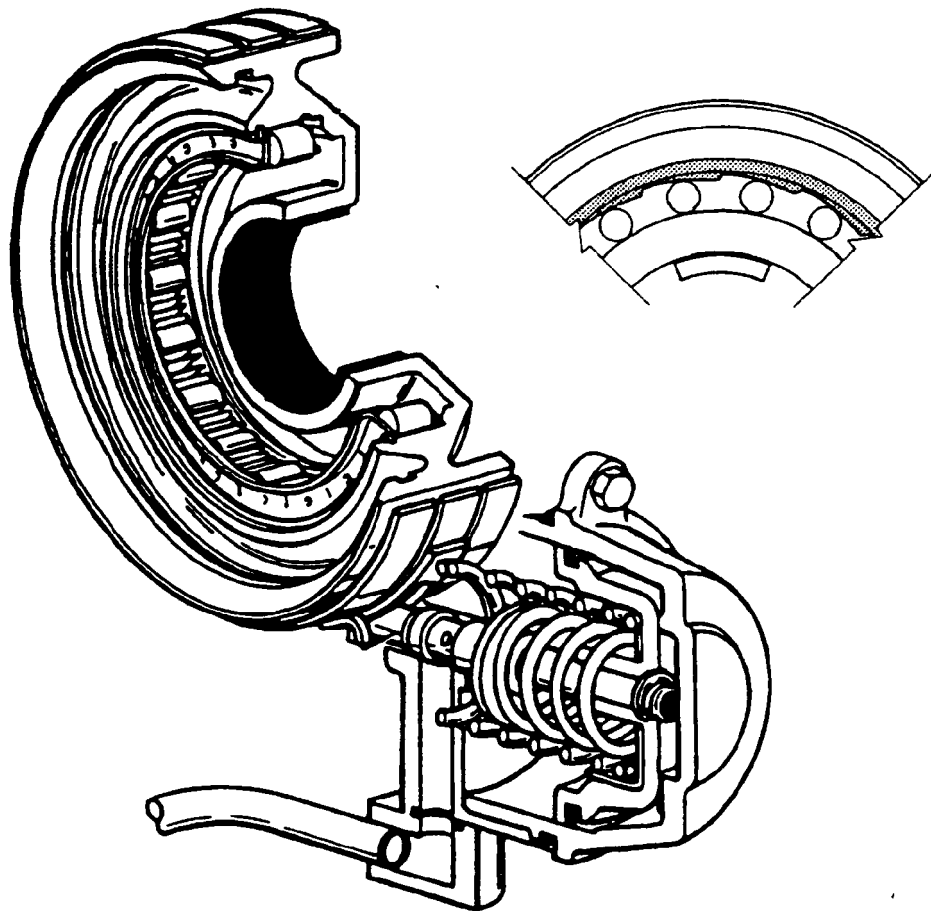
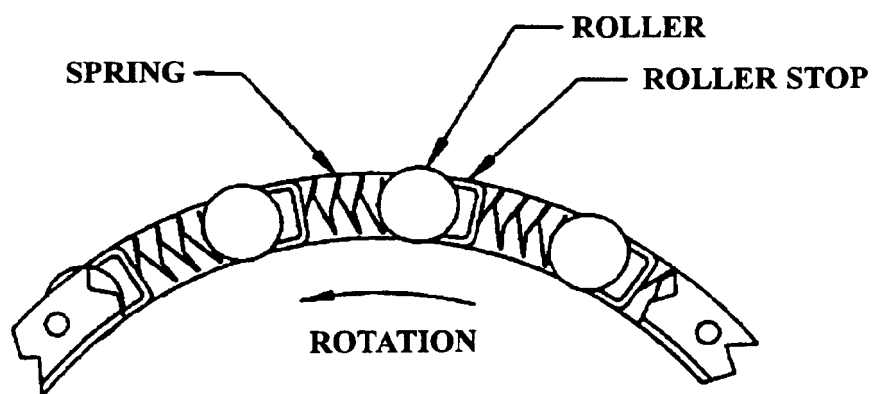
Figure 1

CAUSE: The cause for both complaints listed above is a 1-2 roller clutch failure.

1-2 ROLLER CLUTCH ASSEMBLY

CORRECTION: Replace the 1-2 Roller Clutch Assembly and any related parts that may be damaged or 1 broken (See Figure 1). Before installing into the transaxle, always replace the OEM 1-2 roller clutch springs with Sonnax part number K84956-Sp, which contains 16 stronger springs and is available from your aftermarket parts supplier (See Figure 1).

***ALWAYS REPLACE THE 1-2 ROLLER CLUTCH SPRINGS
WITH SONNAX PART NUMBER K84956-SP***
