Technical Service Information

FORD 4R44E 2-3 UPSHIFT FLARE

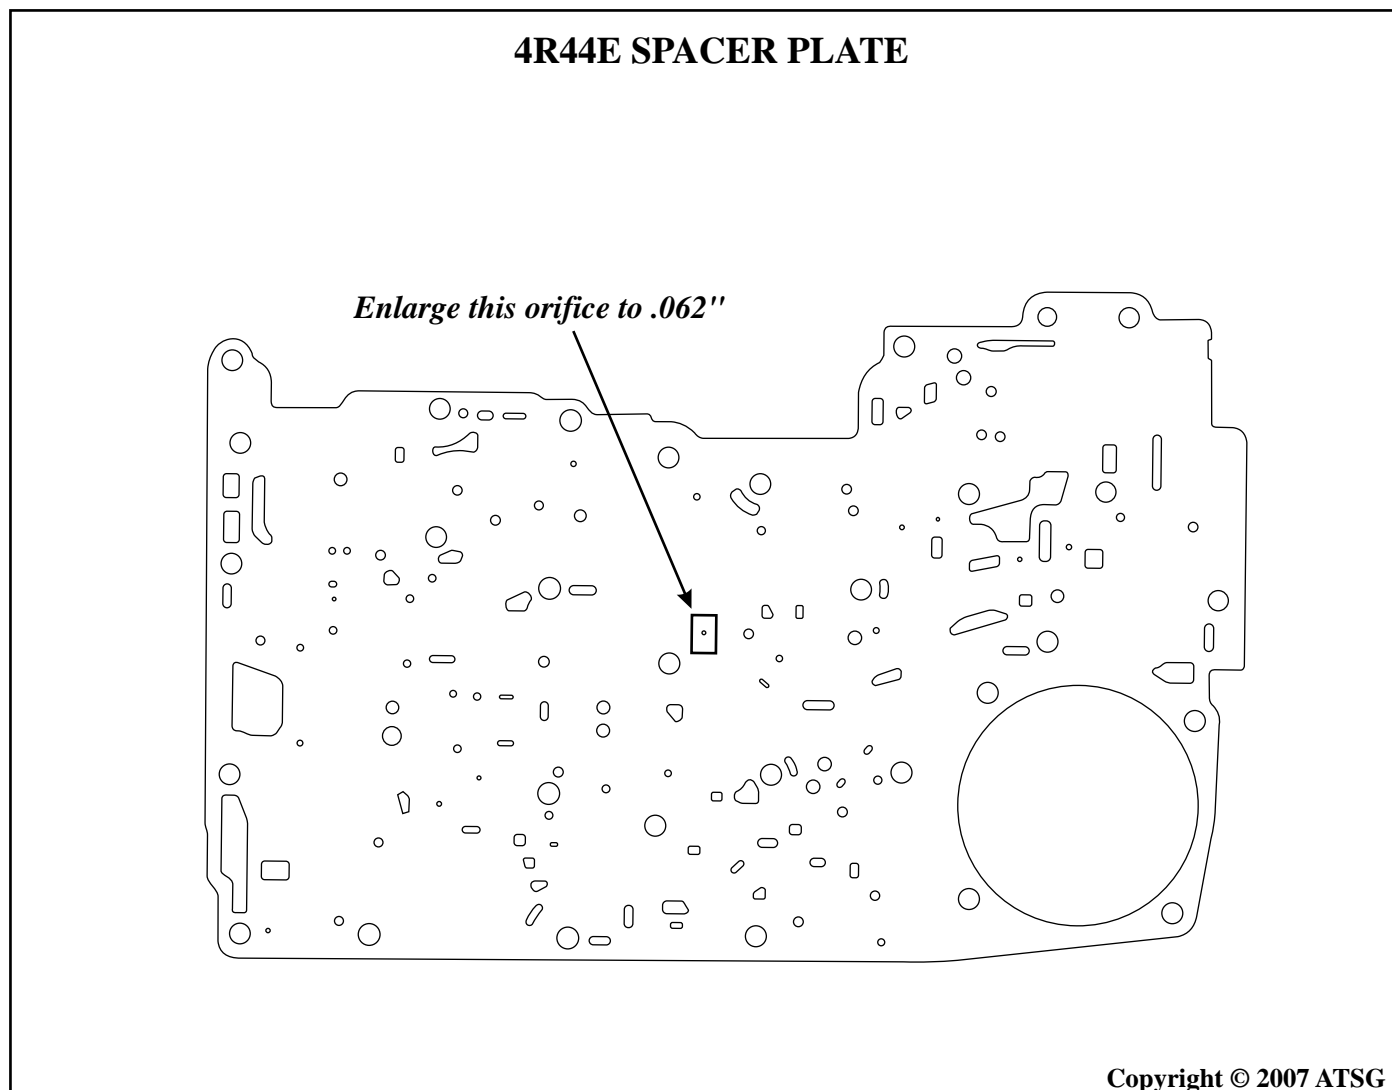
COMPLAINT: Vehicles equipped with the 4R44E transmission, may exhibit a 2-3 upshift flare before or after overhaul.

CAUSE: The cause may be, insufficient Direct Clutch pressure during the 2-3 upshift transition.

CORRECTION: Locate the orifice, as shown in Figure 1 and enlarge the hole to .062."
