1996 SEMINAR INFORMATION

## "THE BEST FIX IN '96"

AUTOMATIC TRANSMISSION SERVICE GROUP  
9200 S. DADELAND BLVD. STE 720  
MIAMI, FLORIDA 33156  
(305) 670-4161

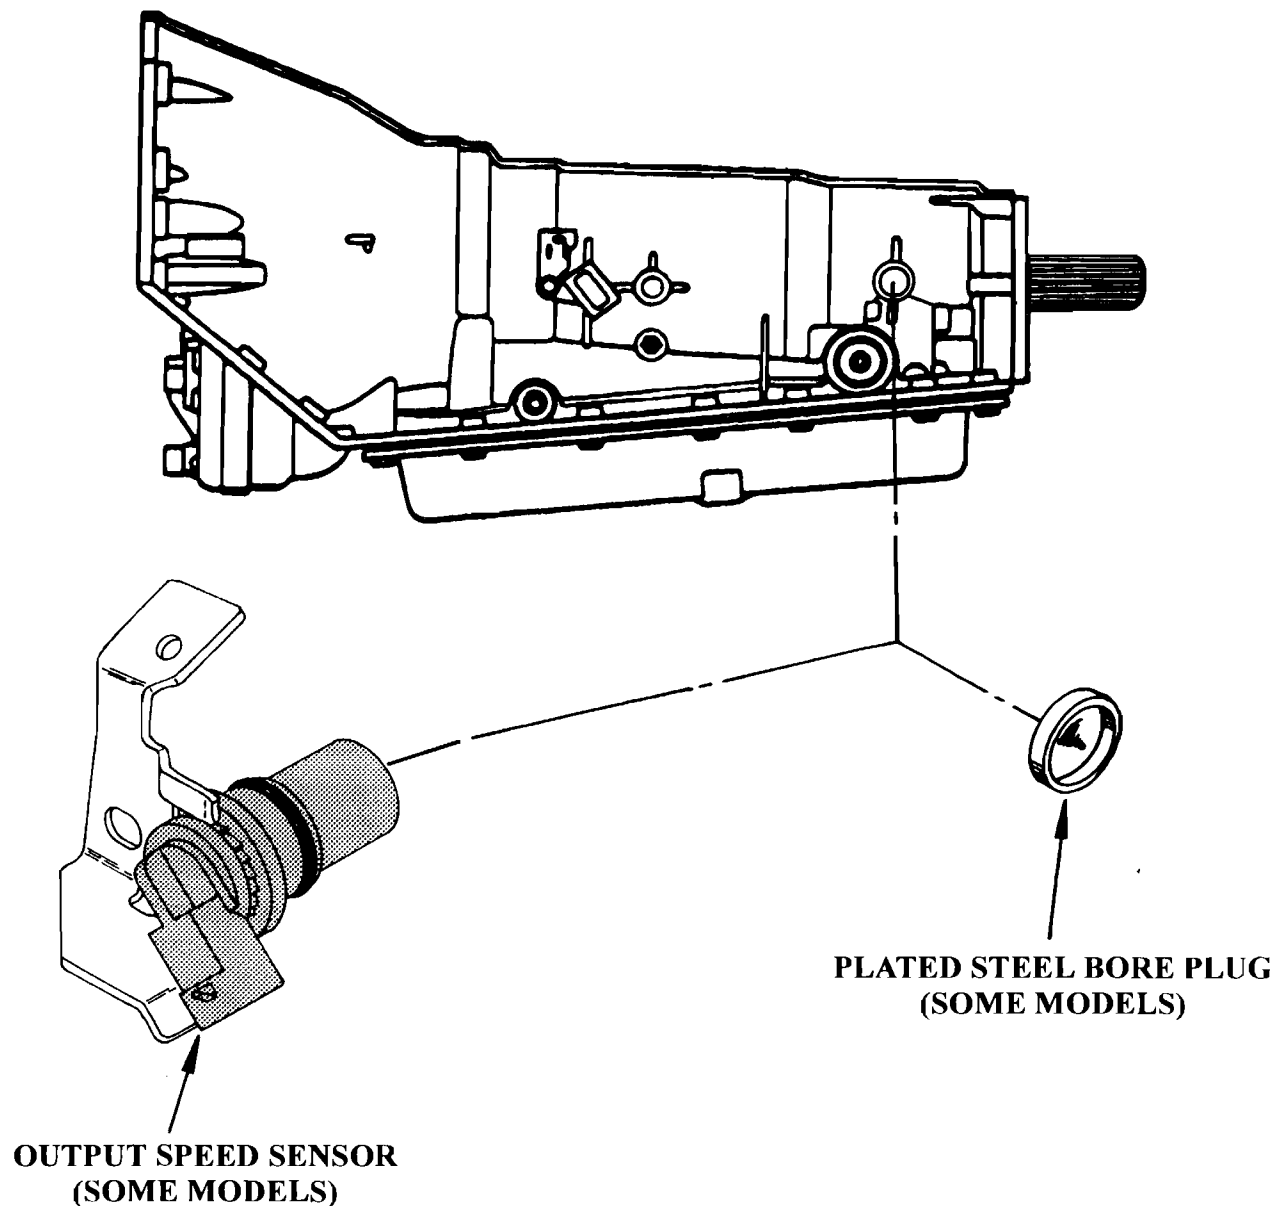
Figure 60

**CAUTION:** The Output Speed Sensor Bore Plug may *fall out*, or fluid may leak past the bore plug. Beginning on January 21, 1994, 4L80-E 4WD models will have a speed sensor installed in the output speed sensor bore in the transmission case.

**THE SPEED SENSOR IS USED AS A PLUG ONLY.  
IT WILL NOT BE ELECTRICALLY CONNECTED.**

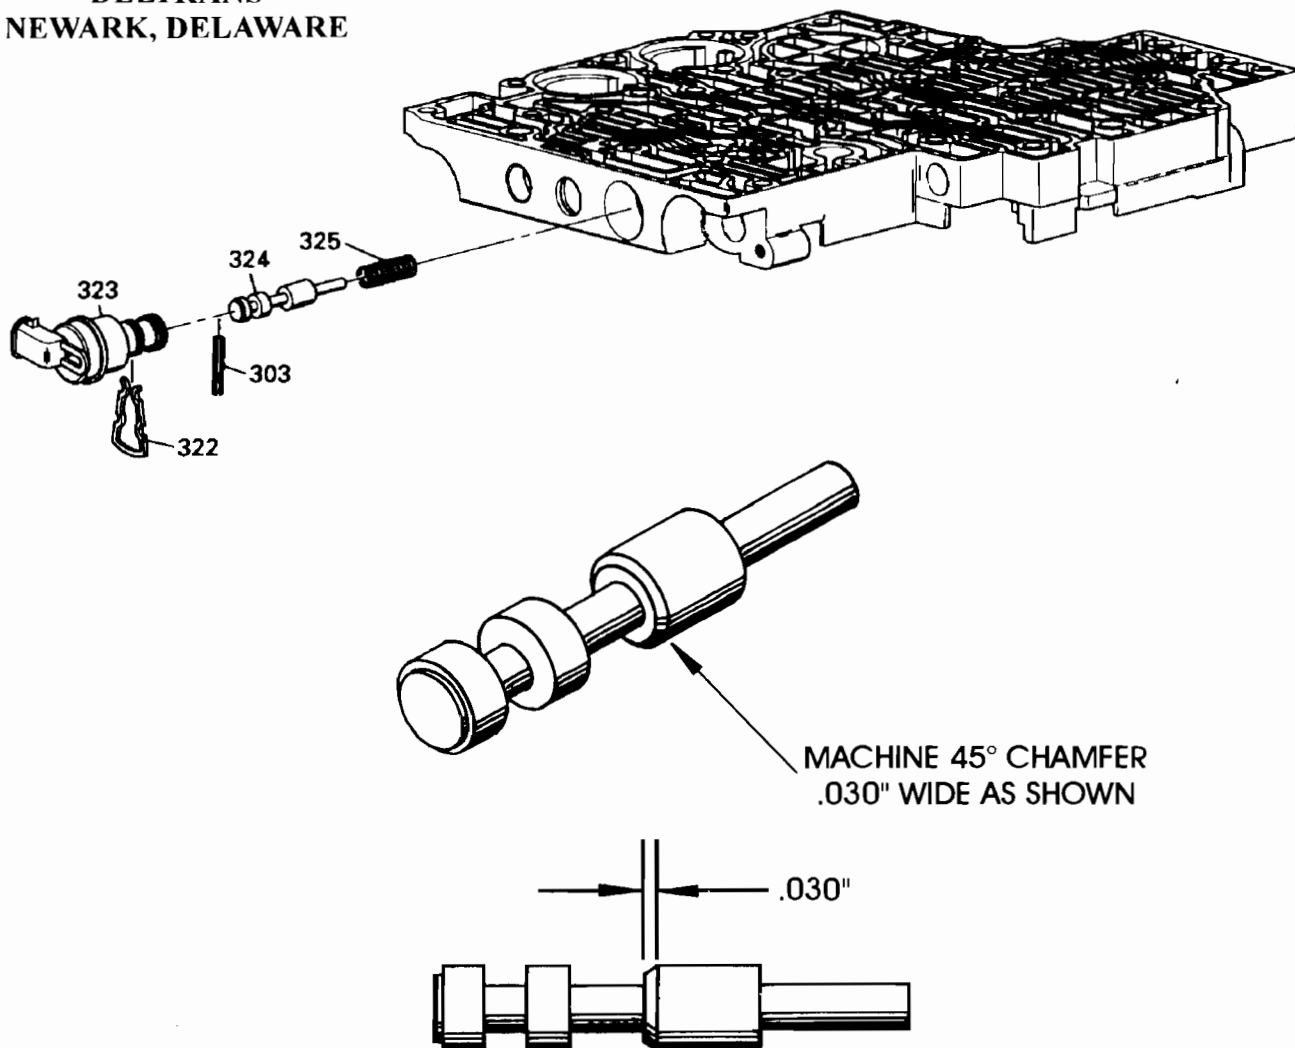
Figure 64

**COMPLAINT:** Before and/or after rebuild, the vehicle displays a Converter Clutch Shudder condition as the torque converter clutch is applying.

**CAUSE:** The cause may be, an inadequate amount of "Regulated Apply" oil to the converter.

**CORRECTION:** Machine a 45 degree chamfer that is .030" wide, on the TCC Regulator Apply Valve, on the land that is shown in Figure 64. This will allow more line pressure in to the TCC regulated apply circuit. Do not machine any wider than .030".

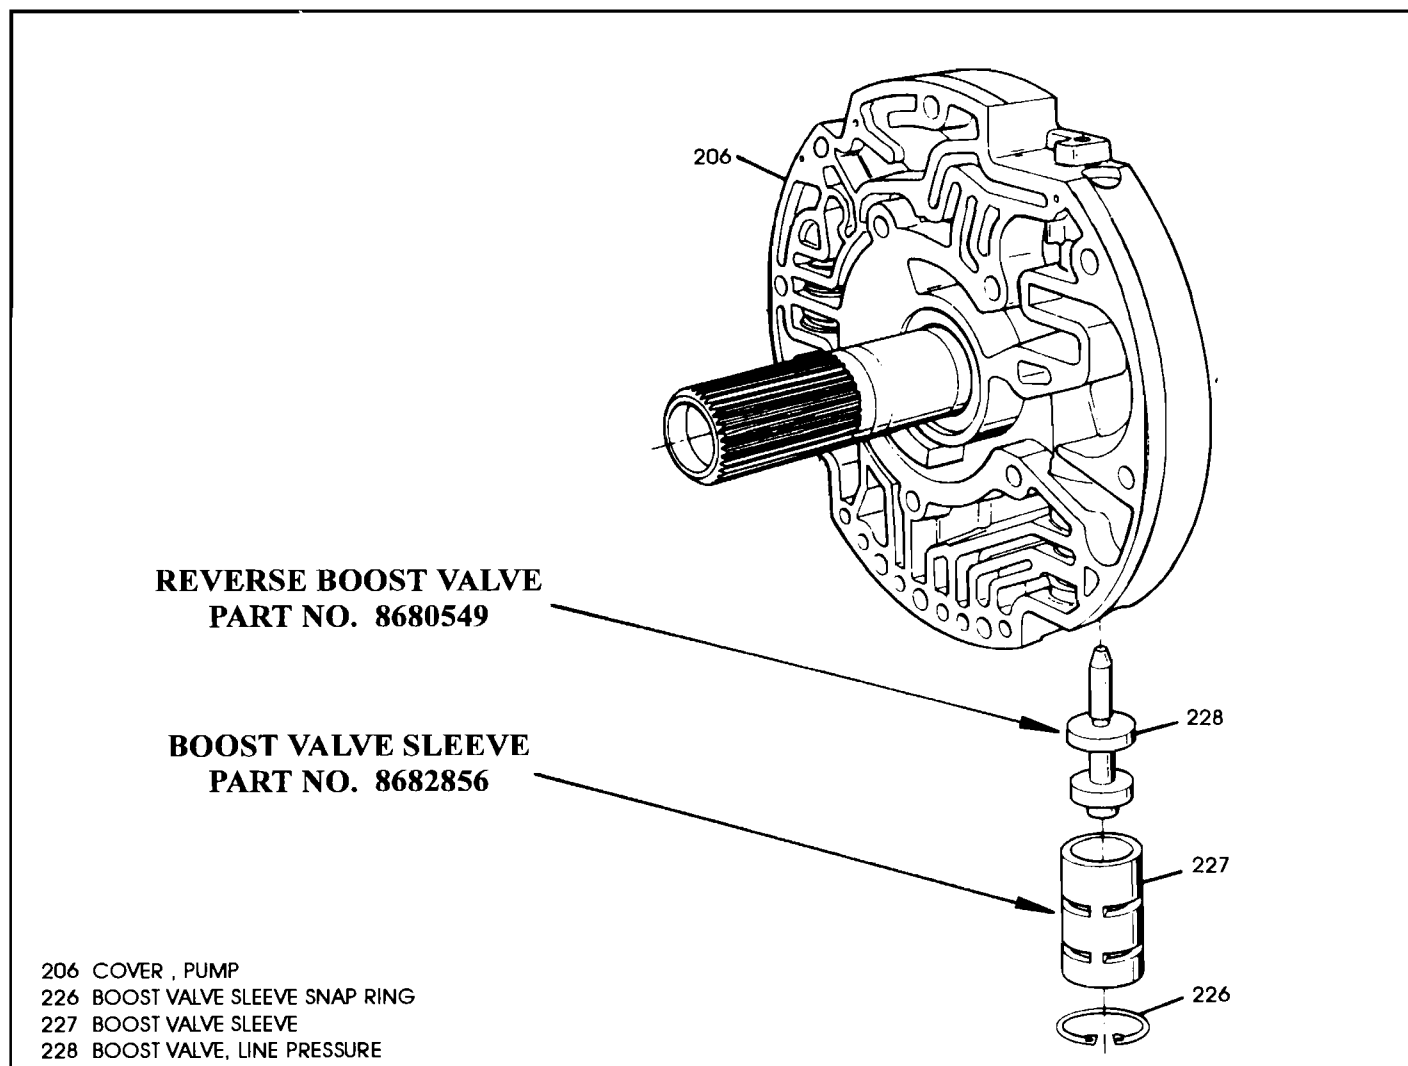
Figure 65

**CAUSE:** The cause may be, a worn boost valve sleeve and/or boost valve in the pump assembly.

**CORRECTION:** Replace the Boost Valve and/or Boost Valve Sleeve, as necessary (See Figure 65). Parts are currently available from G.M. Service Parts, and part numbers are listed below.

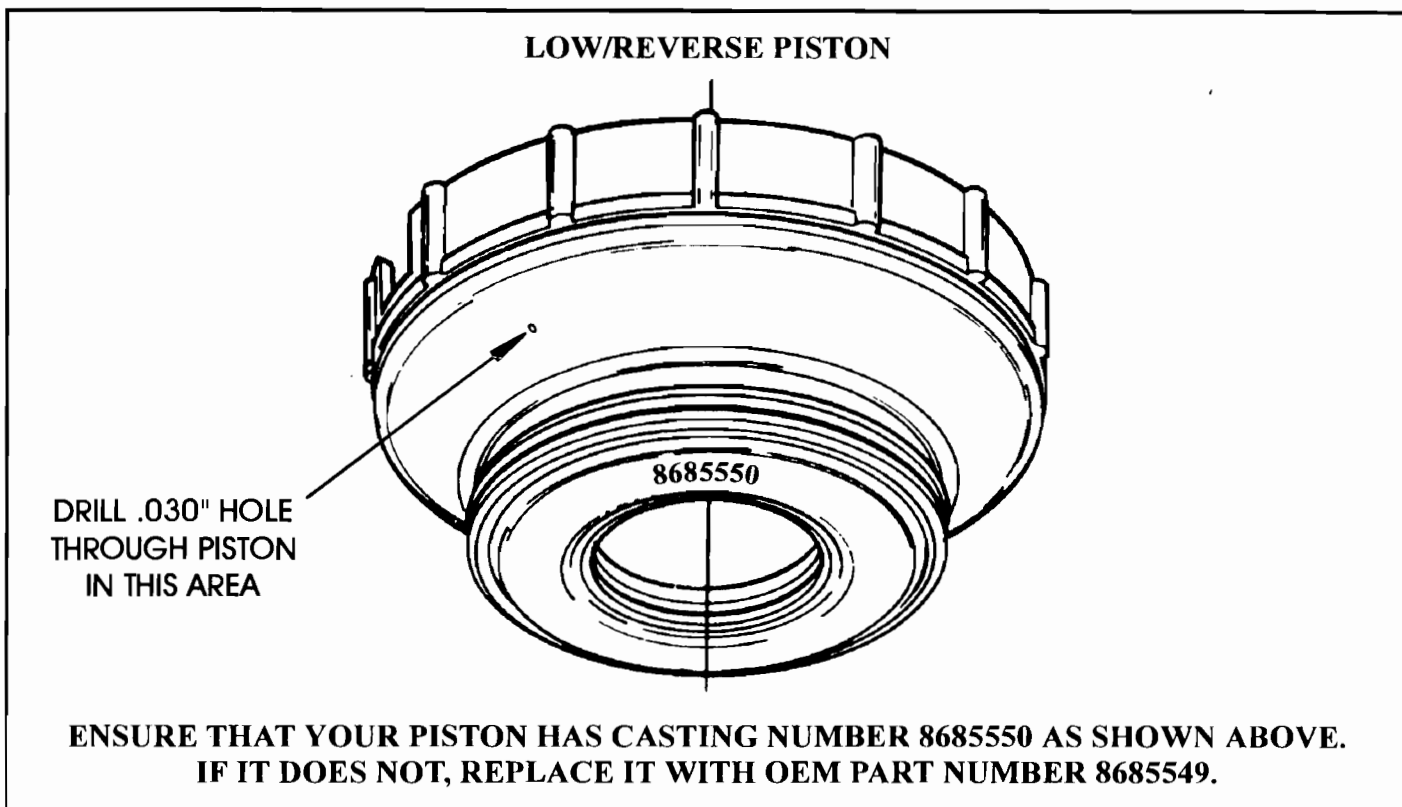
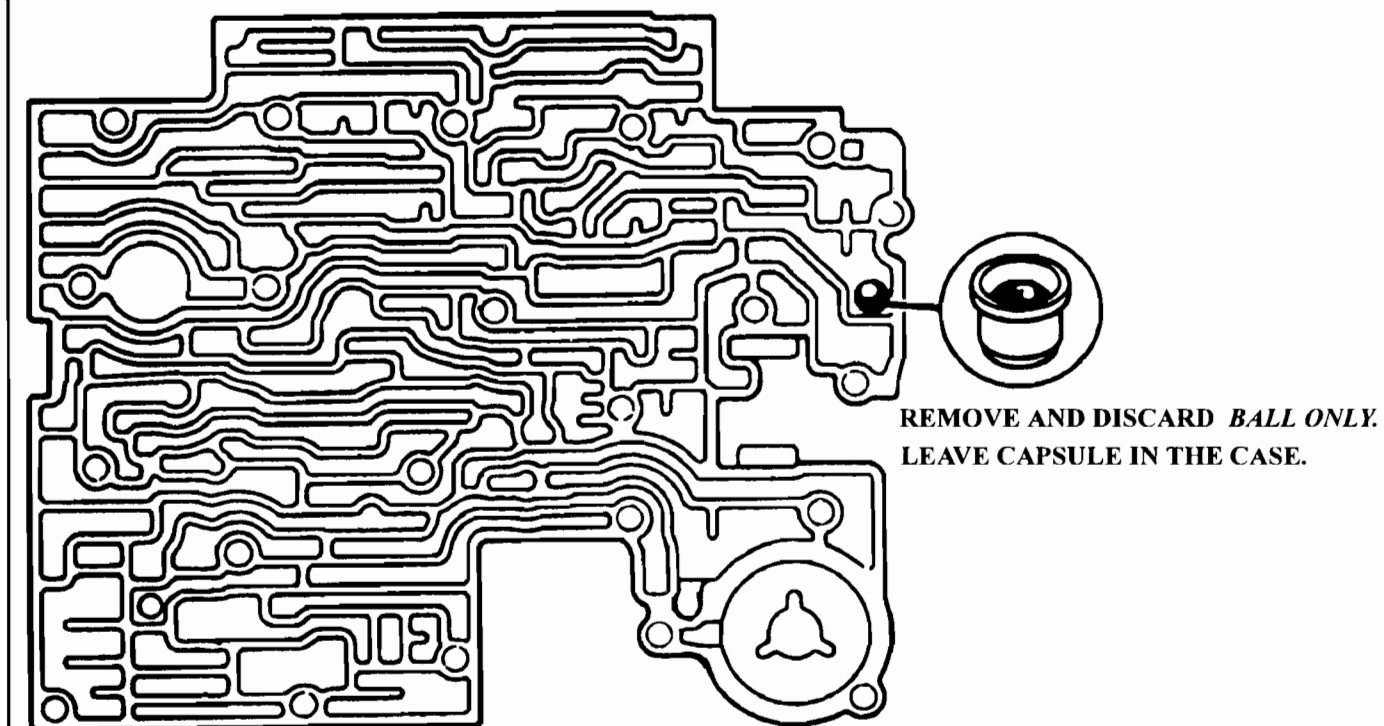
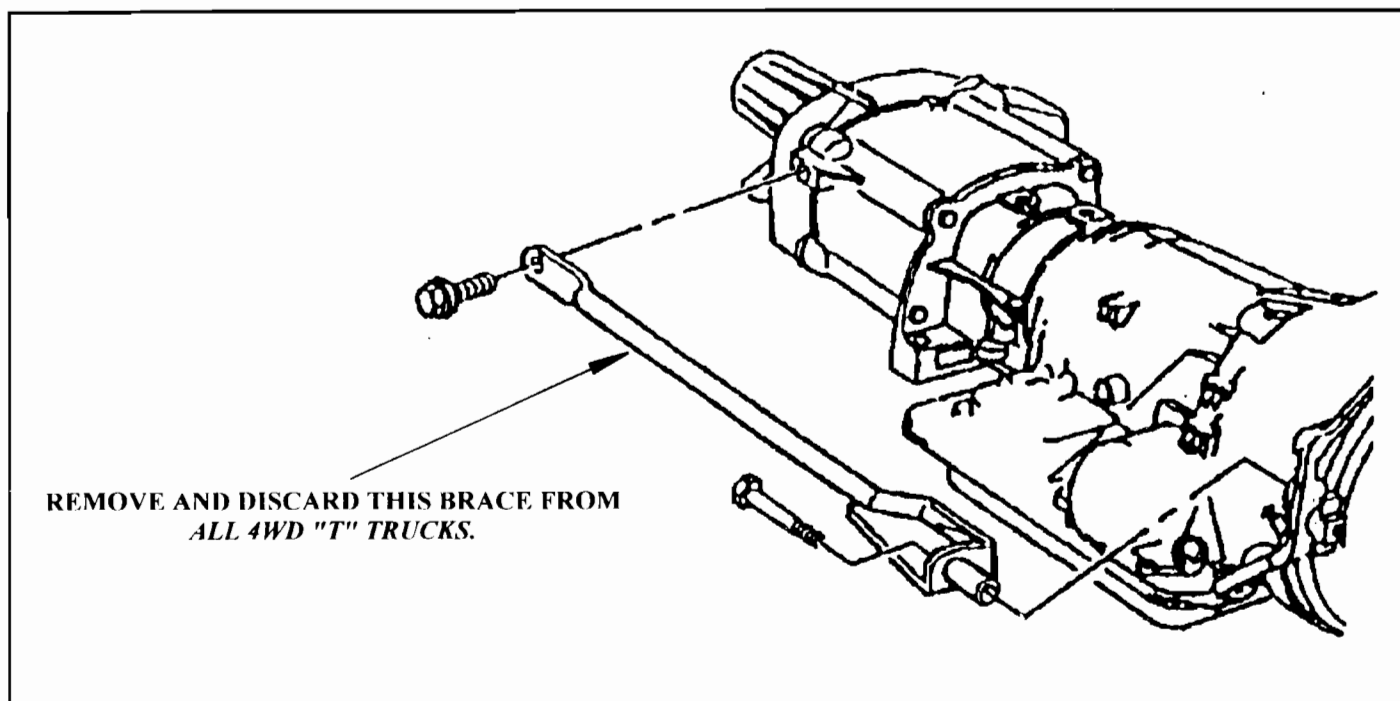
**THM 4L60-E**  
**PREMATURE LOW/REVERSE CLUTCH FAILURE**  
**(1993-1995 MODELS ONLY)**

**COMPLAINT:** Premature and/or repeat failure of the Low/Reverse Clutch pack, on 1993-1995 models only, and may occur in as little as 5000 miles.

**CAUSE:** The cause may be, the Low/Reverse Clutch not totally exhausting the apply oil when the shift lever is moved from Park to the Drive position. On 1993-1995 models, the exhaust path for L/R apply oil is not large enough.

**STEP 2:** Remove the **ball only** from the capsule in the reverse passage at the rear of the case worm track area, as shown in Figure 12. Leave the capsule in the case. This will allow a larger volume of oil to the piston to overcome the leak we have created with the exhaust hole we drilled in the piston. This is now a **feed-bleed** system.

**STEP 3:** *If you have a "T" Truck*, which is the small "S" type truck with 4 wheel drive, **remove and discard the brace from transmission bell to the transfer case**, as shown in Figure 13. This will require a shorter bolt at the bell housing.

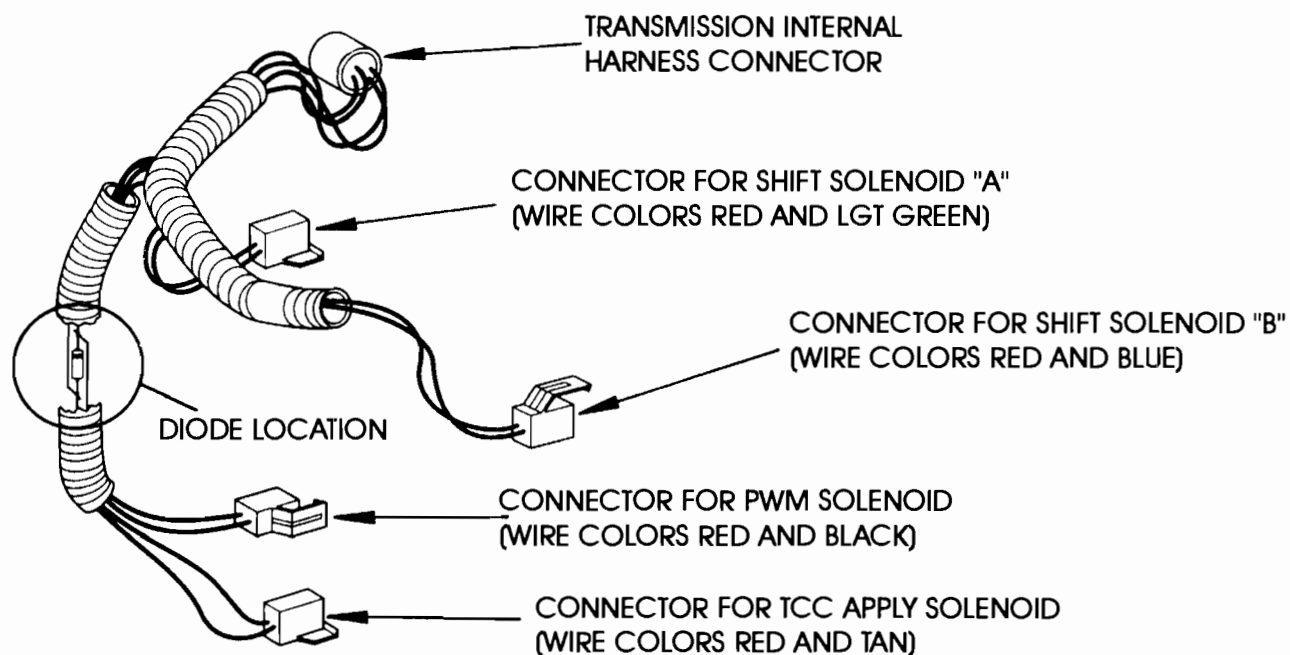
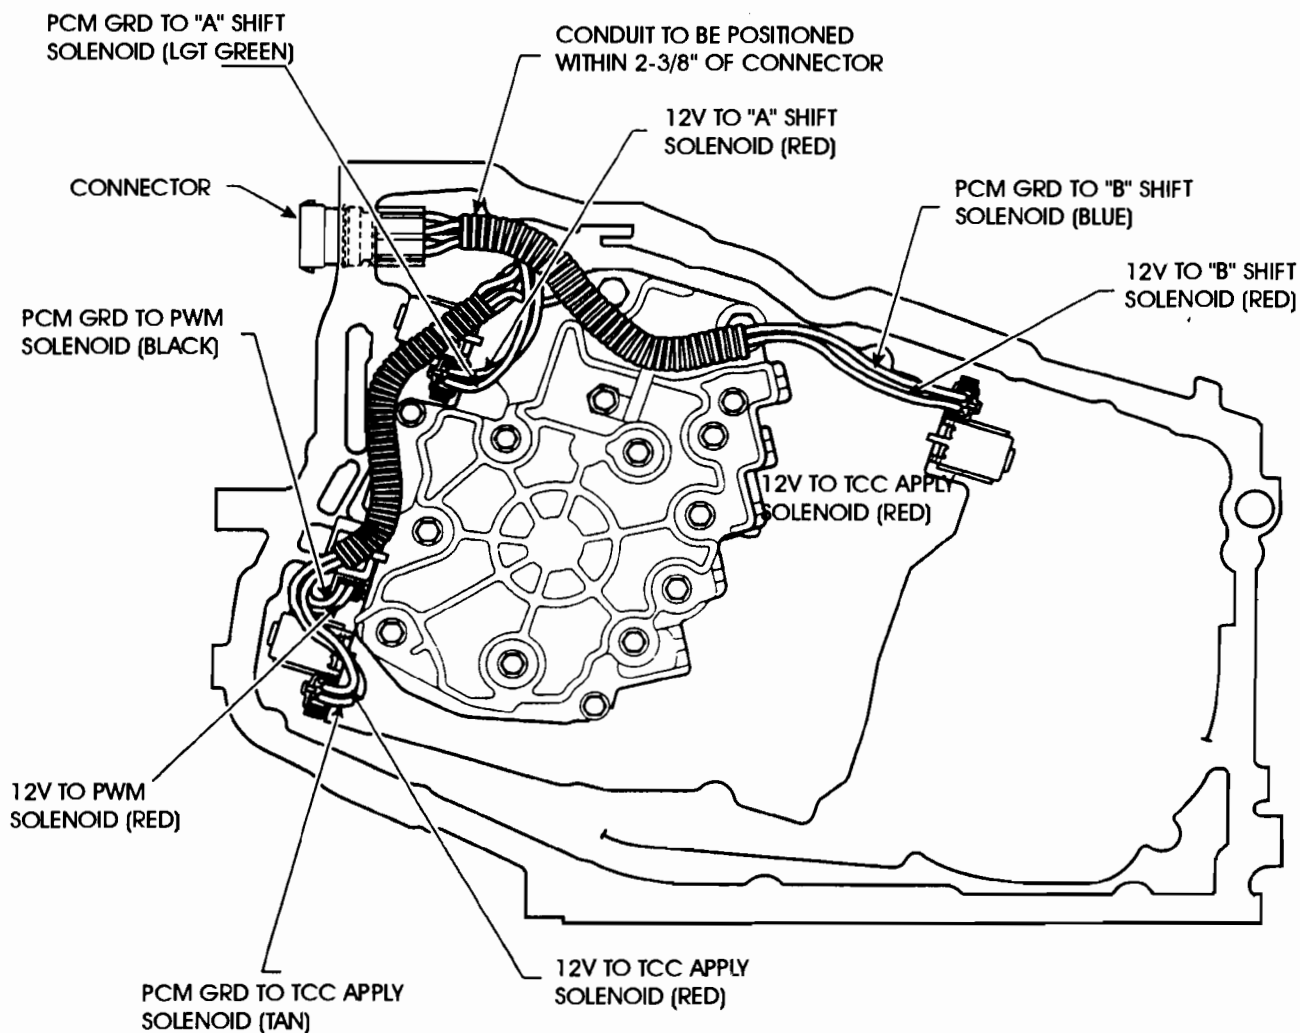
Figure 1

**CAUSE:** The cause may be, the wires and connector for Shift Solenoid "B" and the TCC Apply Solenoid reversed. This can happen very easily when the wire conduit is removed from the internal wiring harness (See Figure 1). In this configuration, the transaxle will be in 4th gear, with the converter clutch applied when the selector lever is placed into Drive.

**CORRECTION:** Install the solenoid connectors in their proper locations. *Most all* of the 4T60-E transaxles, have the wire colors on the internal wire harness as shown in Figure 1. However, some models are different colors. To positively identify the wire and connector that belongs on the TCC Apply Solenoid, look for the diode in the harness (under shrink-wrap), as shown in Figure 1. The other long wires and connector will go to Shift Solenoid "B" *regardless* of the color of the ground wire, which could be Blue, Green, or Yellow, depending on the model.

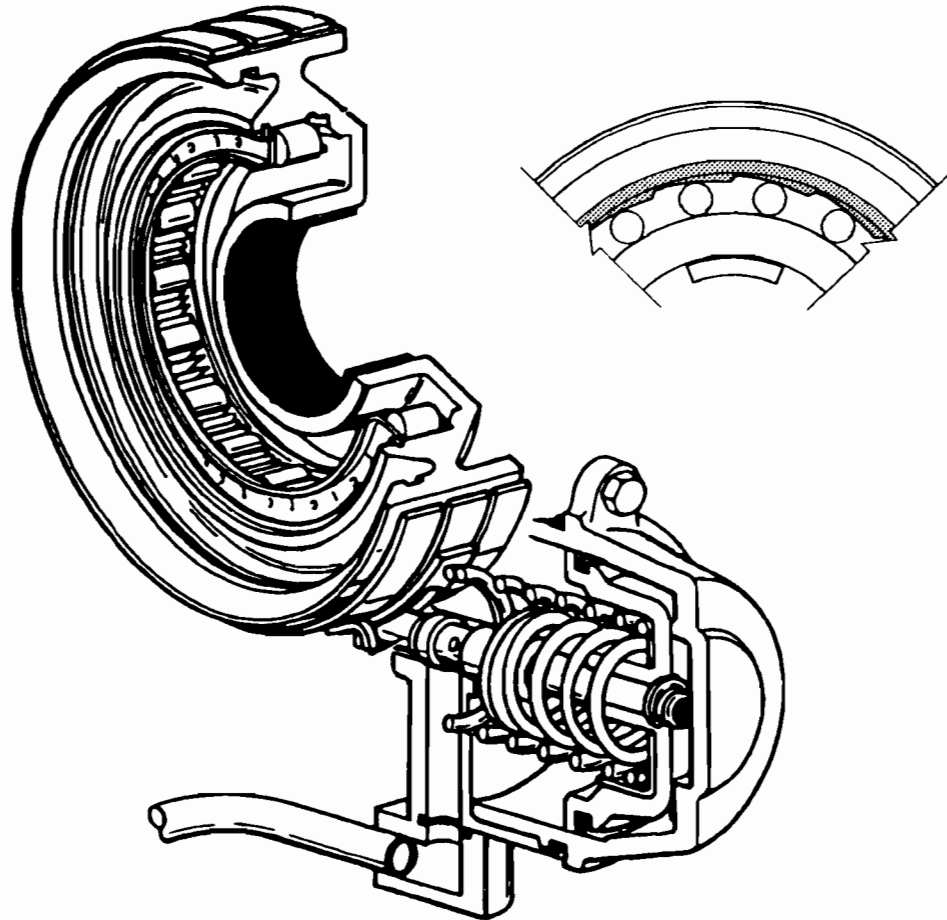
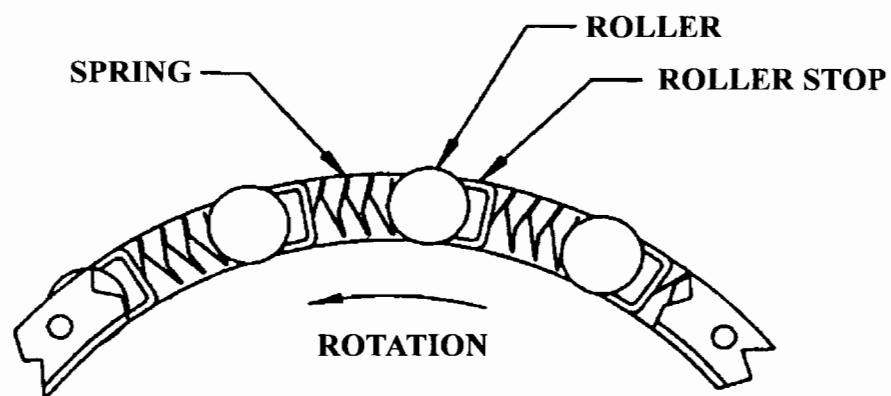
Figure 5

**THM 4T60-E**  
**1-2 ROLLER CLUTCH FAILURE**

**COMPLAINT:** NO. 1: Some 1991-1995 model vehicles equipped with the THM 4T60-E transaxle may exhibit a no movement condition, with the selector lever in the D4 or D3 ranges, but will move when the selector lever is placed into D2 or Lo range.

**CAUSE:** The cause for both complaints listed above is a 1-2 roller clutch failure.

**CORRECTION:** Replace the 1-2 Roller Clutch Assembly and any related parts that may be damaged or broken (See Figure 5).

Before installing into the transaxle, always replace the OEM 1-2 roller clutch springs with Sonnax part number **K84956-SP**, which contains 16 **stronger** accordian springs and is available from your aftermarket parts supplier (See Figure 5).

***ALWAYS REPLACE THE 1-2 ROLLER CLUTCH SPRINGS  
WITH SONNAX PART NUMBER K84956-SP***

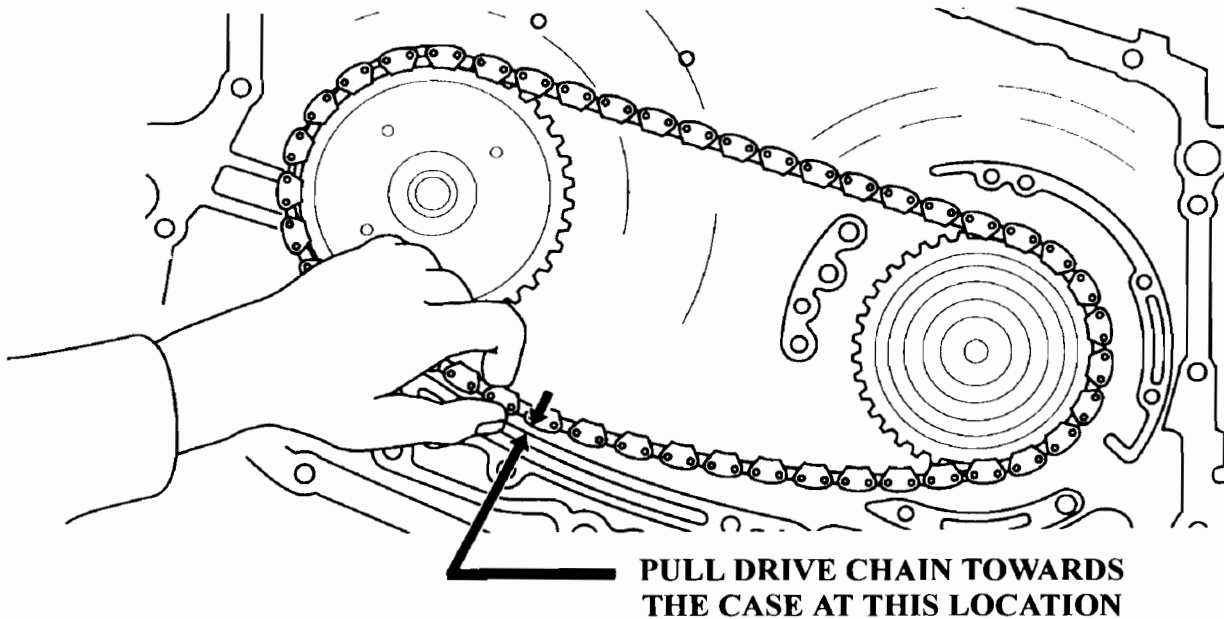
**DRIVE CHAIN MEASUREMENT FOR ALL  
"ROCKER JOINT" DESIGN CHAINS *ONLY*.**

**SPECIAL NOTE:** Only use the drive chain measurement procedure listed in the ATSG Service Manual when checking the "Round Pin Drive Chain" for wear. A **"Good"** Rocker Joint Drive Chain may not check as acceptable, using the procedure in the service manual. Use the following procedure to check all Rocker Joint Drive Chains for wear:

1. Pull the drive chain toward the case at the location of arrows, as shown in Figure 11.
2. Measure the gap between the drive chain and case with a straight edge ruler.
3. If the measurement is 1/8" or greater, the drive chain can be reused. If the measurement is less than 1/8", replace the drive chain (See Figure 11).

**IF MEASUREMENT IS LESS THAN 1/8", REPLACE THE DRIVE CHAIN**

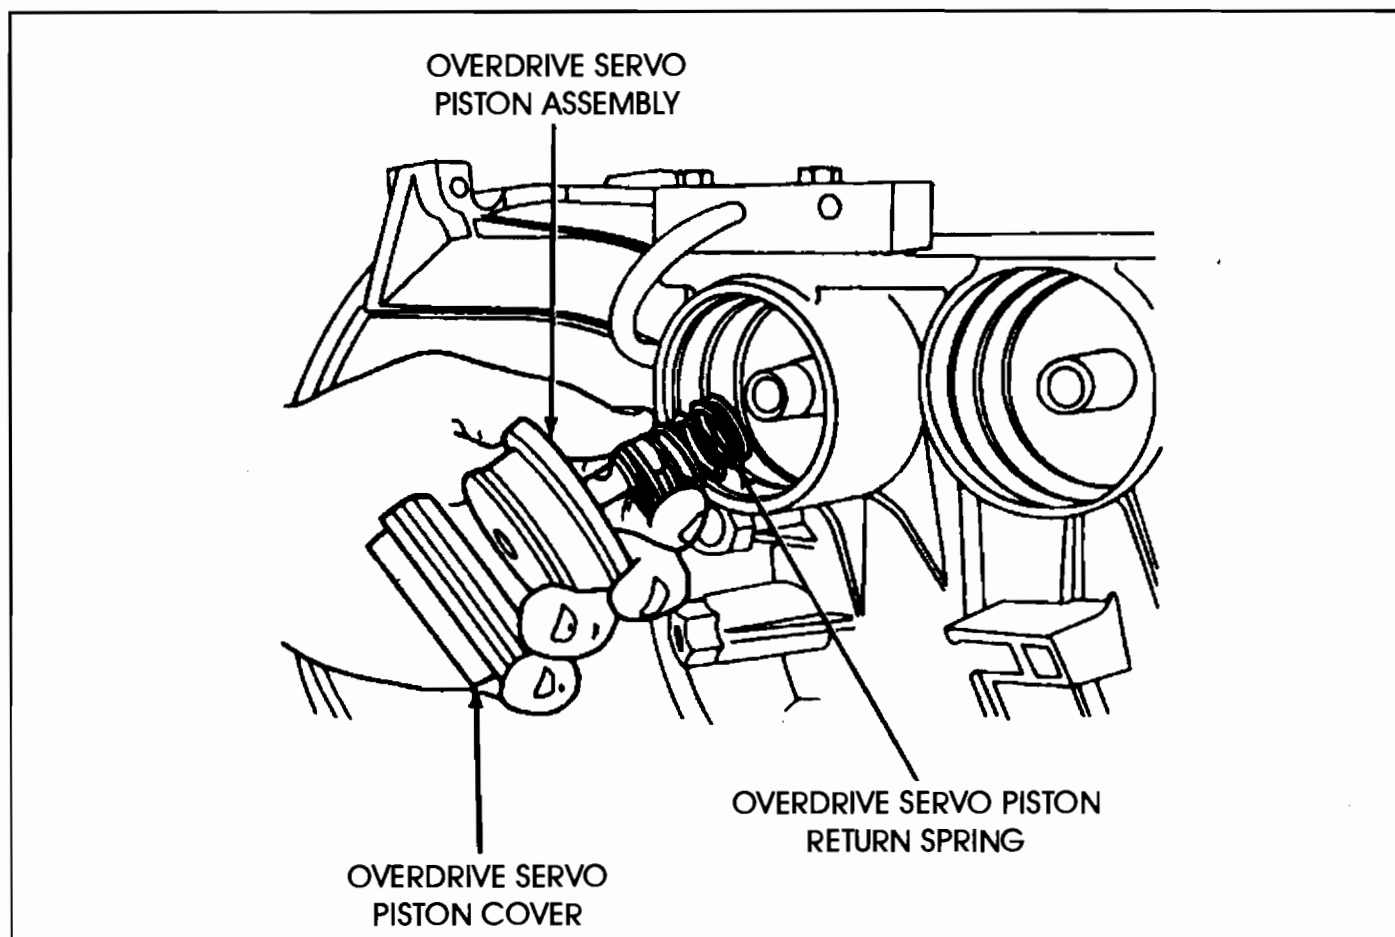
Figure 12

**FORD 4R44E/4R55E**  
**SLIPPING AND/OR NO 1-2, 2-3, 3-4 SHIFT**  
**AND POSSIBLE FLASHING "OD OFF" LAMP**

**CAUSE:** The cause may be, a damaged intermediate and/or overdrive servo piston seal, and may be damaged on the release (Case Bore) side.

**CORRECTION:** Replace the intermediate and/or overdrive servo pistons as necessary (See Figure 12).
