## THM 4L60 (700-R4)

### SLIPPING IN REVERSE - BURNT LO/REVERSE CLUTCHES

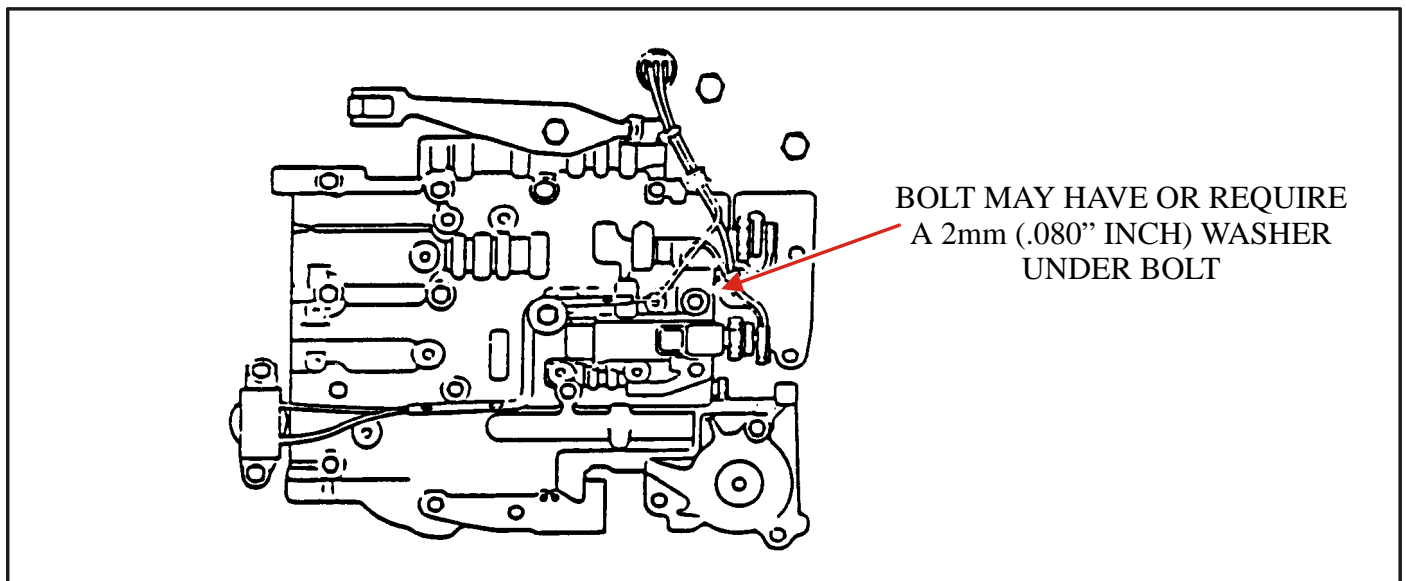
Figure 1

A 1984 Model THM 700-R4 transmission experiences a “slips n reverse” along with burned lo and reverse clutch plates. a possible cause may be an incorrectly machined boss bolt hole al the end of the line bias valve (Fig. 1 ). The boss surface may have been machined off about .040” - .050” too much. Thus allows the valve body attaching bolt that locates through the sleeve at the end of the line bias valve to interfere with the lo and reverse clutch plates. preventing them from releasing properly. When this occurs. the bolt end and the clutch plates will have wear or burrs.

- 1 Remove lo & reverse clutch assembly from transmission.
- 2 Check clutch plates for evidence or burrs caused by boll interference.
- 3 If still not sure. install valve body bath on transmission and check inside case to determine if bolt is protruding through.
- 4 Remove the bolt that is located al the end of the line bias valve.
- 5 Install a 2 mm (.080”) washer under bolt head (rig. 4).

Notice: If the bolt already has a washer, be certain when reassembling the washer that it’s in the correct location.

Notice: Washer is not required, if above conditions does not exist. Adding washer, when not needed. could result in stripping bolt threads in case.
