## NISSAN RL4FO3A

### HARSH 1-2 UPSHIFT

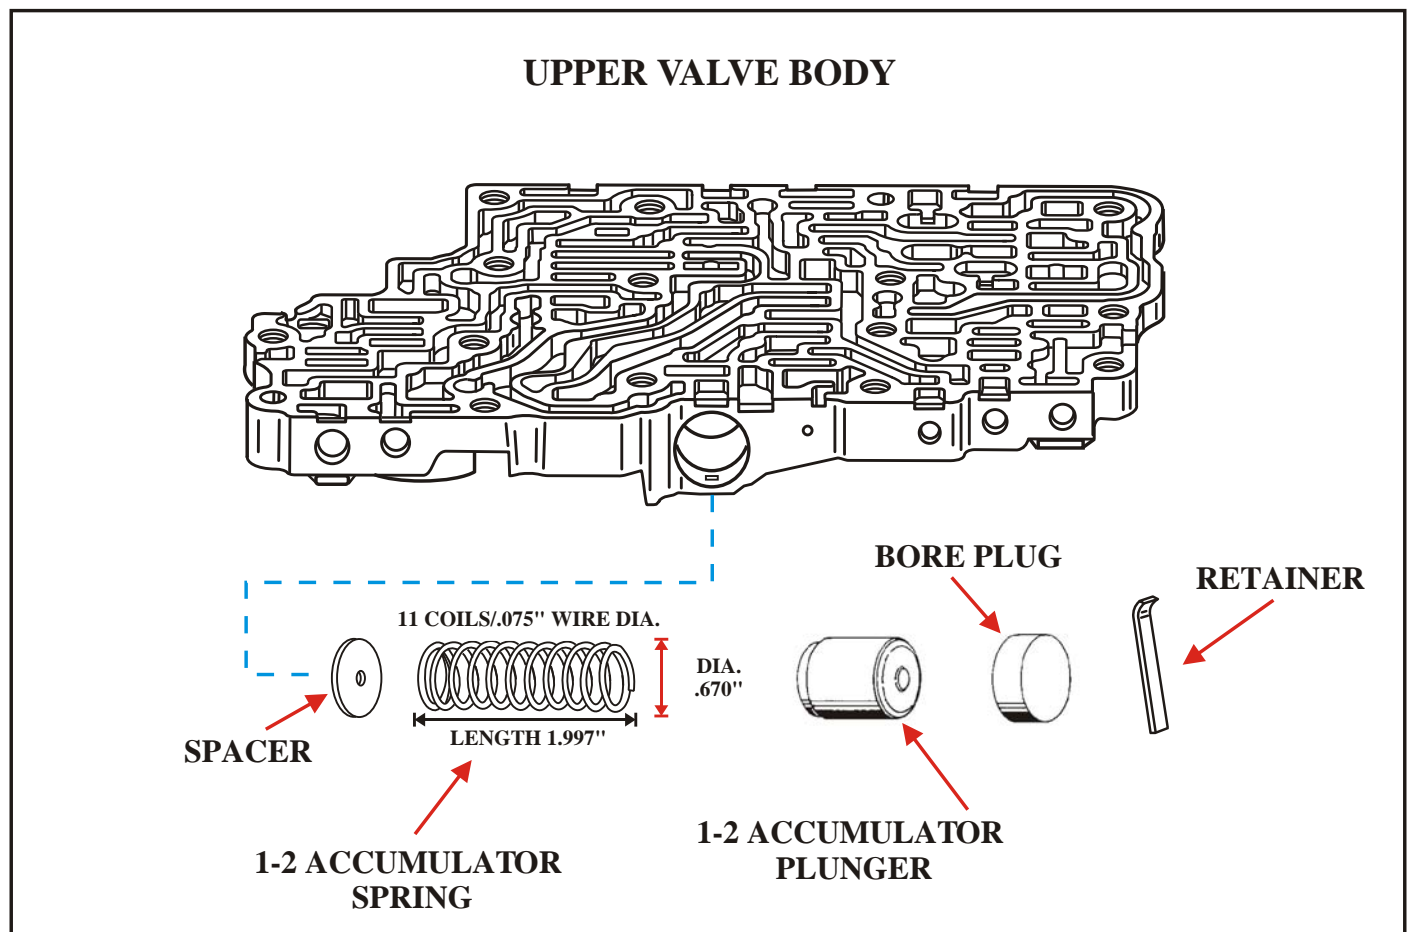
Figure 1

**COMPLAINT:** Vehicles equipped with RL4FO3A transaxles may exhibit a harsh 1-2 upshift at all throttle openings.

**CAUSE:** The cause may be, the 1-2 accumulator spring is broken.

**CORRECTION:** Remove the 1-2 accumulator plunger and spring, shown in Figure 1, and replace the broken spring with NISSAN part no. 31742-31X63.

1-2 ACCUMULATOR SPRING (NISSAN PART NO.).....31742-31X63
