after DC bias sweeping up to 1000 V.

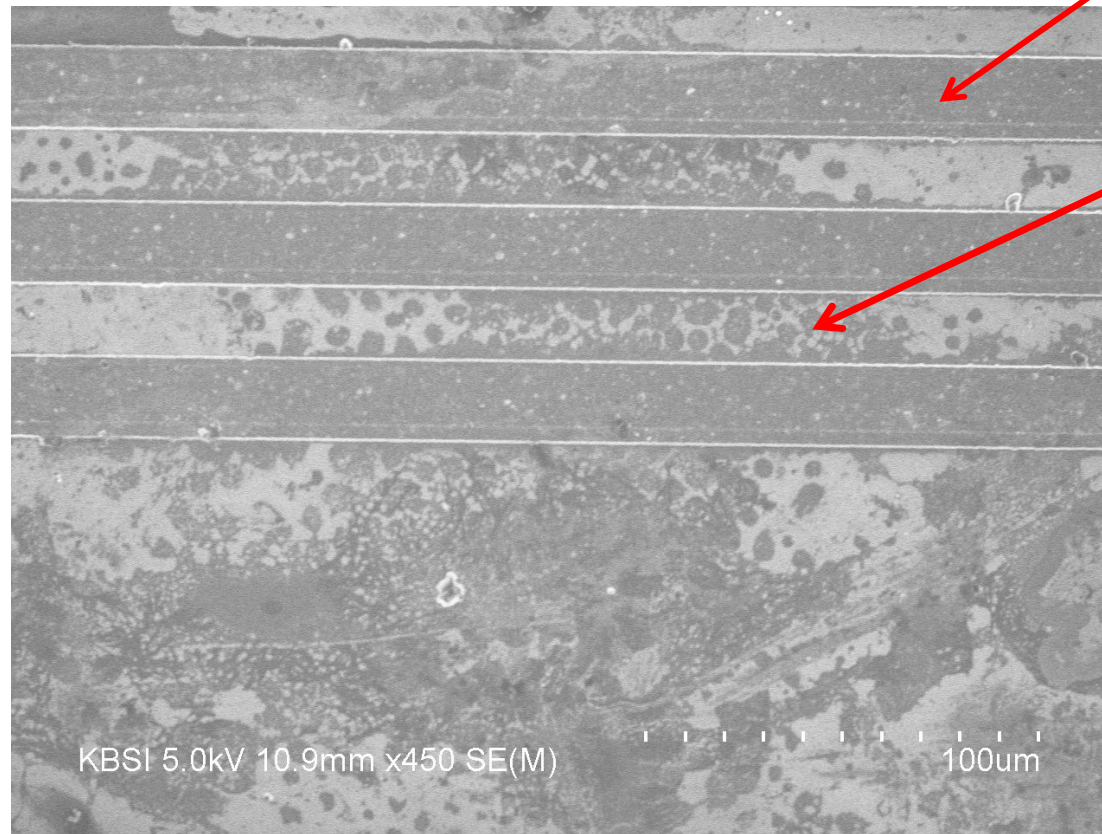
guard-ring electrode

silicon oxide

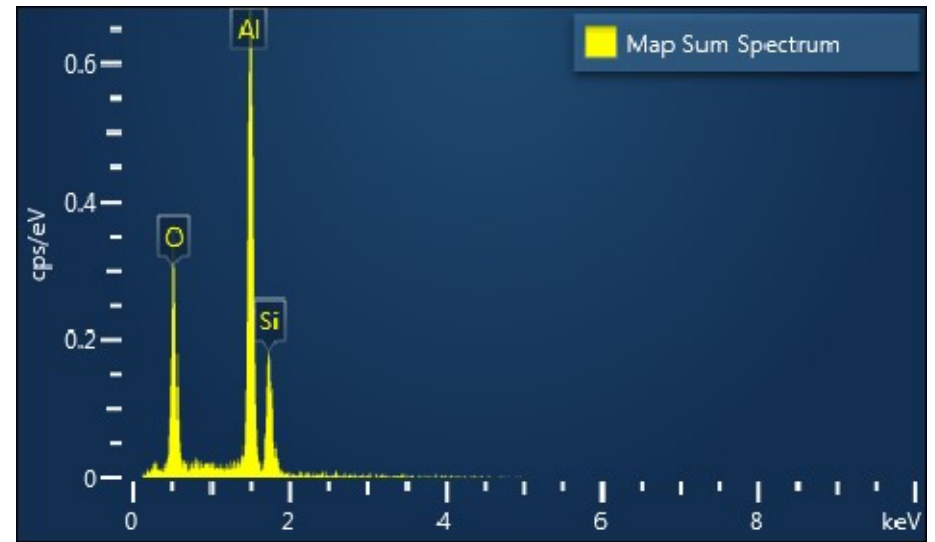
Electron Image 3

undamaged  
guard rings

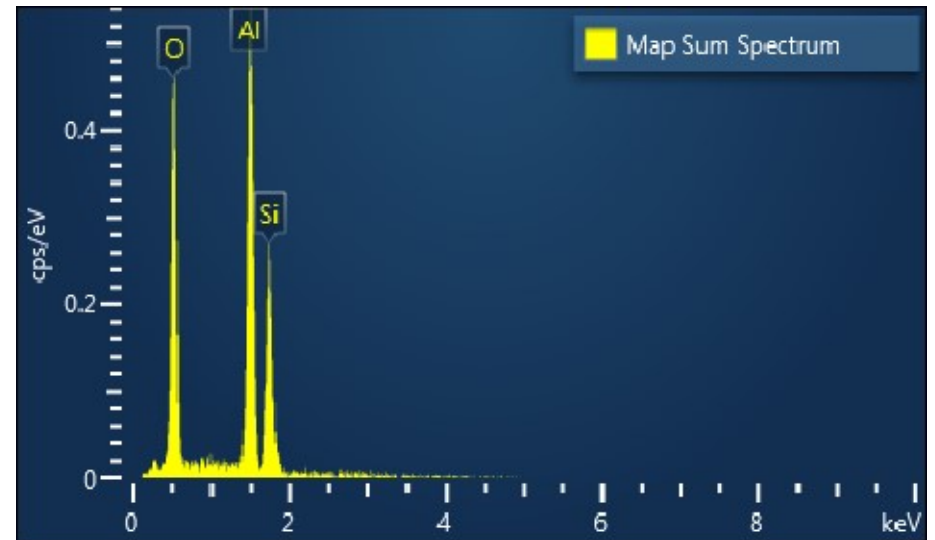
Electron Image 4

HV-induced  
damage on  
guard rings.
