This is a project log entry for [FPGA Computer/Eval board](#)

Defect list

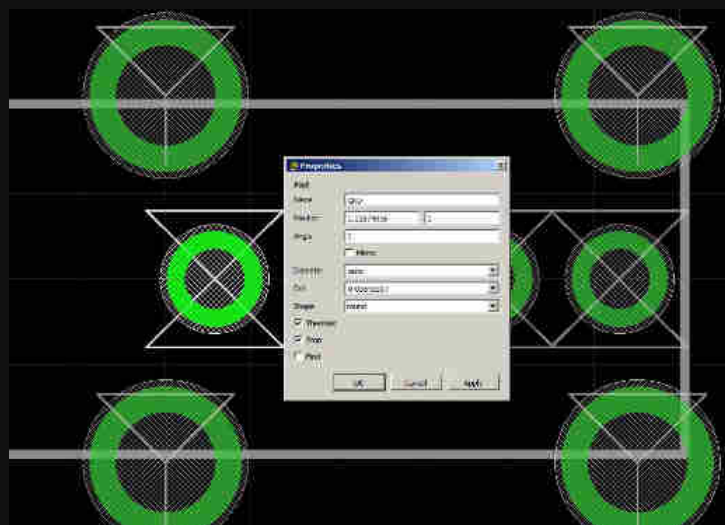
Foorprint:

Library: con-usb-2.lbr by Erik Christiansson; also con-usb-3.lbr by same author

Level: Serious, require localized copper change

Problem has not been resolved in con-usb-3.lbr at Cadsoft ftp.

Acon UAR80-4* datasheet clearly shown pin 1 location (USB Bus Power), but instead it is connected to ground. Seems like all the pin numbering is wrong, so all pins are affected.
