Significance of Defects Inside In-Service Aged Winding Insulations

Christof Sumereder and Tilman Weiers

Abstract—This study aims to gain insight into the consequences of local defects in stator winding insulation; therefore, optical (microscopic) inspections and voltage-endurance tests have been carried out on in-service aged generator bars. In this context, generator bars with mica-bitumen insulations and generator bars with mica-epoxy insulations were investigated. The mica-bitumen insulations had been in service for 43 years in a 12 kV hydro-generator. The generator bars with mica-epoxy insulation had been dismantled from two identically constructed 10.5-kV generators after 35 and 36 years of service. The time to breakdown values obtained from the voltage-endurance tests were evaluated using a Weibull distribution. Apart from the scale parameter, Weibull exponent of this distribution allowed for the identification of early failures. The voltage-endurance tests carried out on replacement bars for these generators did not yield any early failures; such failures, however, were detected on both types of the in-service aged insulations. In particular, these occurred at high levels

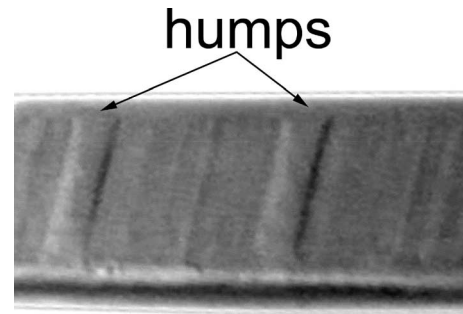
Along the slot sections, the insulations exhibited humps at cooling slots (Fig. 2) of the stator. As there were sites at which insulation had expanded into these cooling slots, the degradation of the insulation was expected to vary locally.

Fig. 2. Humps on the surface of mica-bitumen insulations at cooling slots of the stator.

The microscopic analysis of the groundwall insulation showed that the mica tapes had separated from each other during several decades of service. This delamination was very well visible outside the slot sections of the bars and below the humps shown in Fig. 2. This finding further contributed to the expectation for the residual voltage endurance to vary locally.

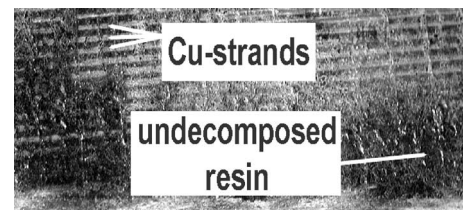
Fig. 4. Undecomposed resin on the surface of copper strands, which are delaminated from the mica-epoxy groundwall insulation.

Delaminations between copper strands and the groundwall insulation were also found in the generator bars with resin-rich mica-epoxy insulation systems. These delaminations were associated with resin decomposition zones that were caused by the partial discharge activity in these delaminations (Figs. 4 and 5). The appearance of the decomposed resin can be described as white or gray powder. In particular, the resin was, often, found to be totally decomposed at the edges.

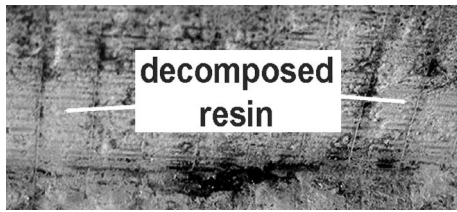
Fig. 5. Decomposed epoxy resin on the surface of copper strands.

exponent < 1) occurred only on the in-service aged bars, while none of the tested replacement bars failed early. The dissection of these bars with early failures revealed resin decomposition zones, as described earlier (Fig. 5). Bars that were tested at an elevated electric stress ($\approx 3 V_{pp}$) were, especially, likely to show early failures. So, the choice of the test level in voltage-endurance tests on in-service aged insulations is crucial for estimating the reliability of insulation.

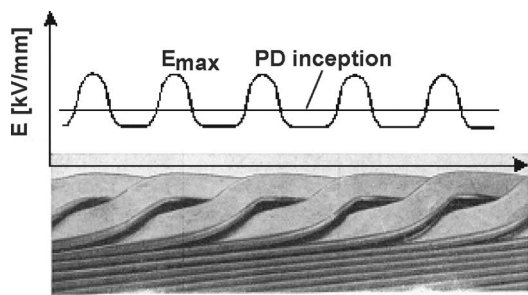
Fig. 7. Elevated electric field that leads to PD inception at Roebel transpositions.

Under the microscope, black colored spots could be observed all over the insulation. These spots (indicated in Fig. 6) are caused by the partial discharge activity at high electric field sites. Due to Roebel transposition of copper strands (Fig. 7), such high electric field sites occur at the edges of copper wires. The black colored spots closely followed the pattern of Roebel transposition.

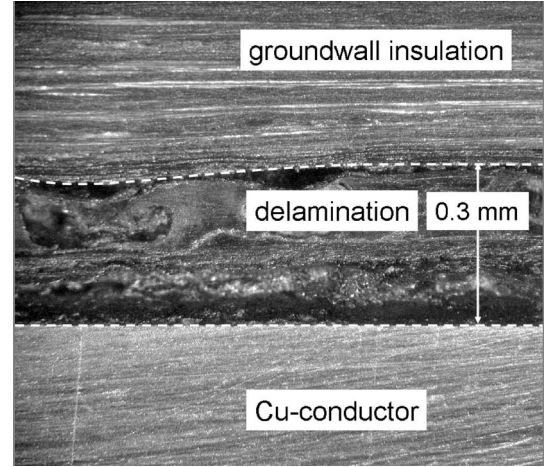
Fig. 11. Delamination found at an early failure site.

On the other side, time to breakdown values that were less than 1 min were found; these occurred when the electrodes were embedded within the humps (Fig. 2) or above a (large) delamination between copper strands and the groundwall insulation. Fig. 11 gives an example of a (large) delamination found at an early failure site. The delamination was found between a high-voltage electrode (Fig. 9) embedded outside the slot section of the tested bar and copper conductor. This confirms the assumption that the residual voltage endurance of mica-bitumen insulations is governed by local defects and that it varies locally.
