# BLADE INSPECTION REPORT

BT1 Wind Farm  
Turbine No.239262  
Local Turbine ID WTG18

On May 15, 2024, Bureau Veritas Vietnam conducted a comprehensive drone-based inspection of the rotor blade on turbine **No. 239262** at the BT1 Wind Farm.

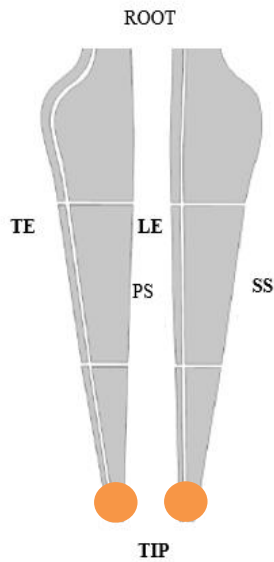
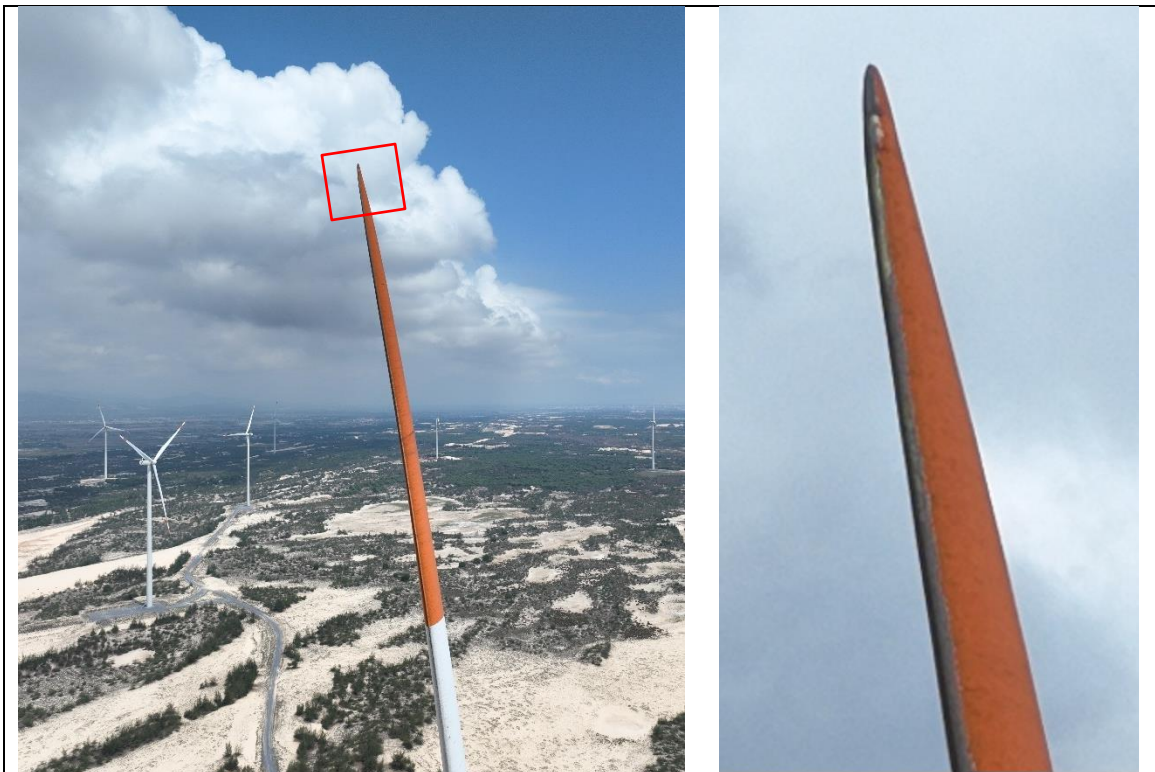
Damage 1 of 11 on blade 29101070WHYE255933

Leading Edge

73 m

Erosion

Tip Erosion

4

The blade tip is damaged due to erosion.

Repair required within a short time frame.

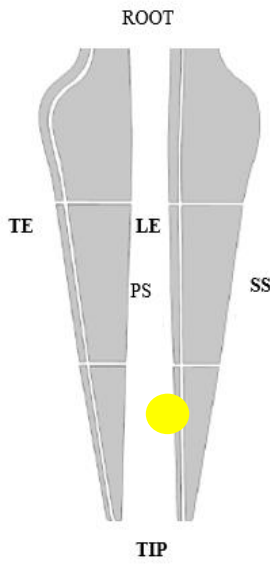
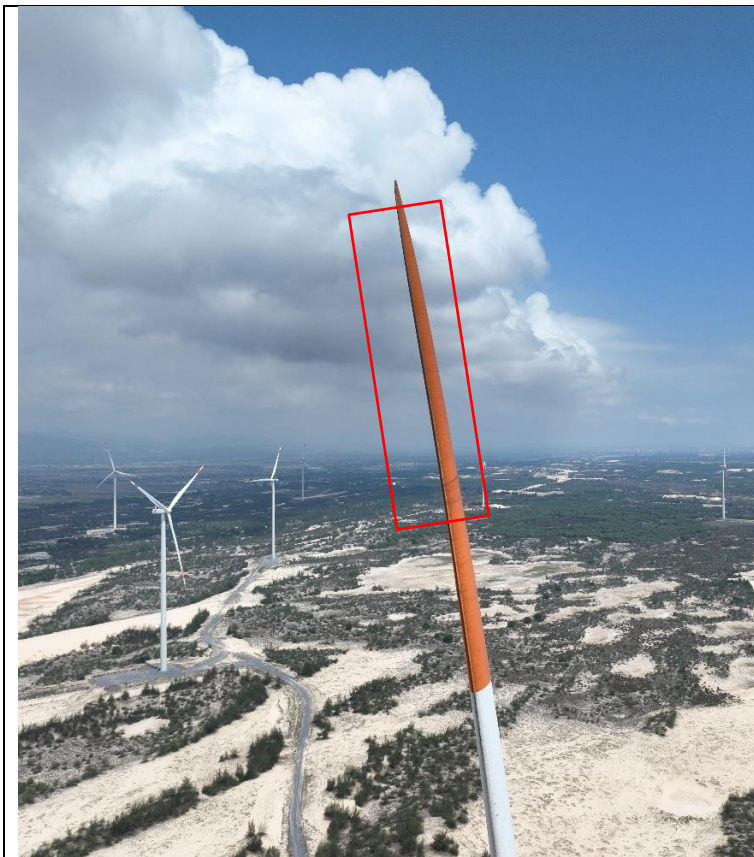
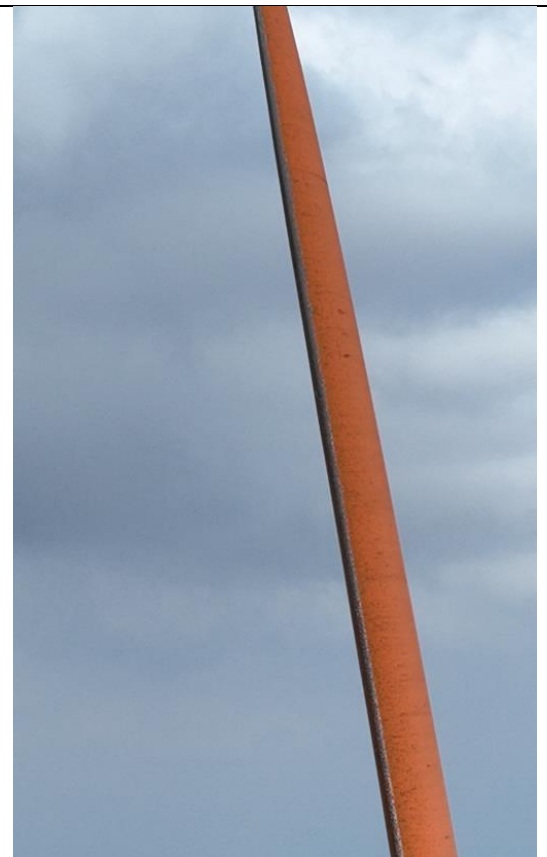
Damage 2 of 11 on blade 29101070WHYE255933

Leading Edge

66 m

Erosion

LE erosion

3

The leading edge (LE) side is damaged due to erosion.

Repair must be done within a time frame.

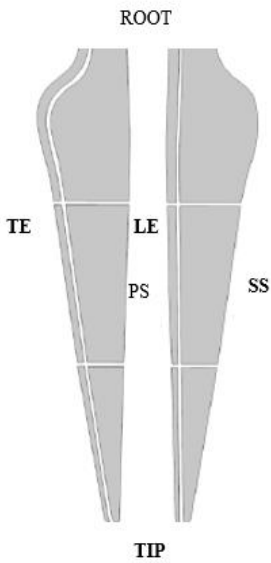
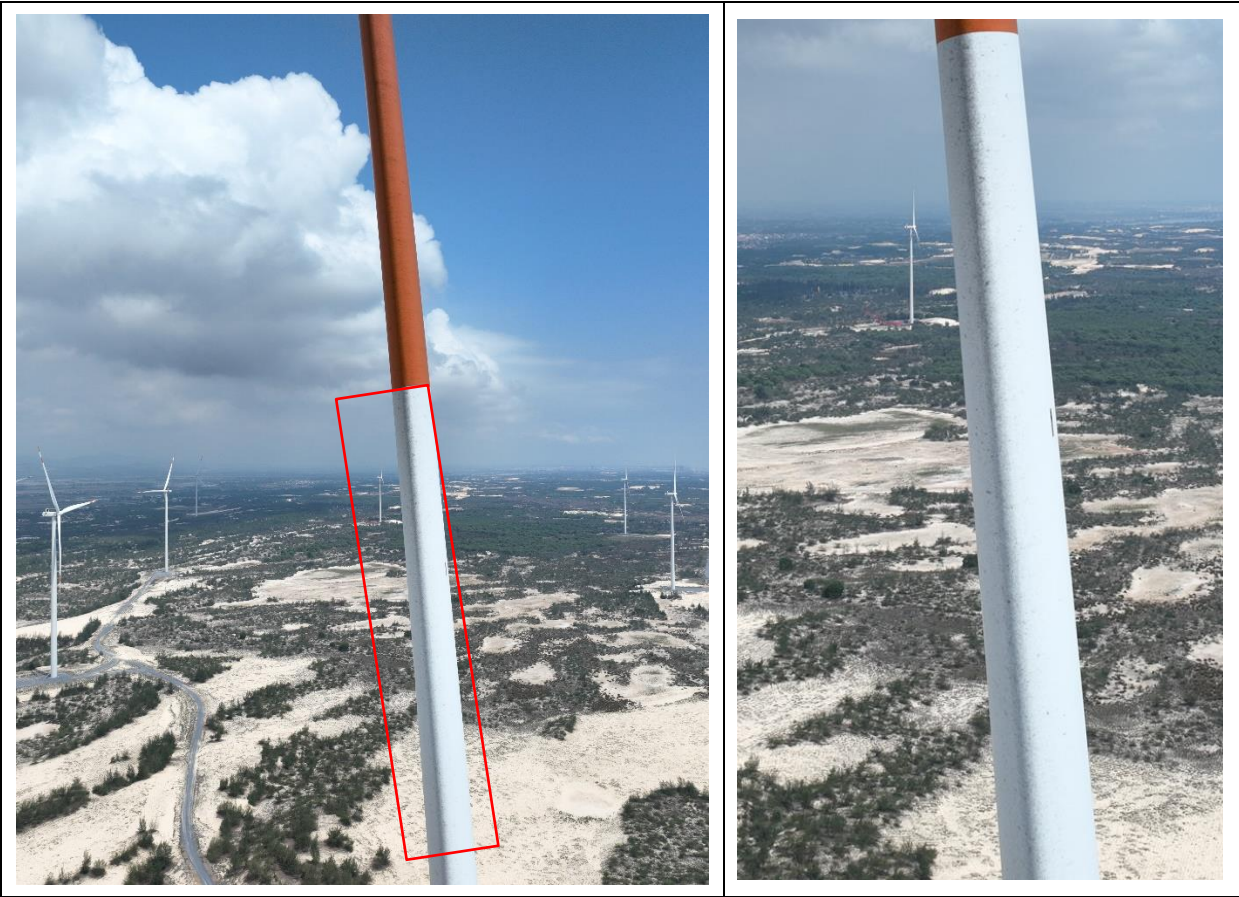
Damage 3 of 11 on blade 29101070WHYE255933

Leading Edge

65 m

Erosion

LE erosion

3

The leading edge (LE) side is damaged due to erosion.

Repair must be done within a time frame.

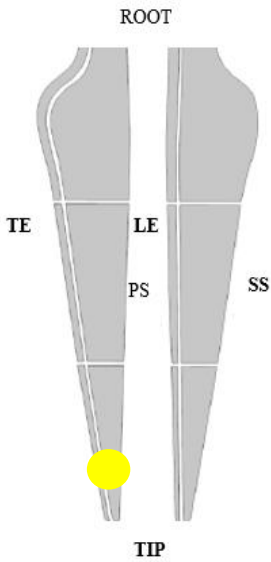
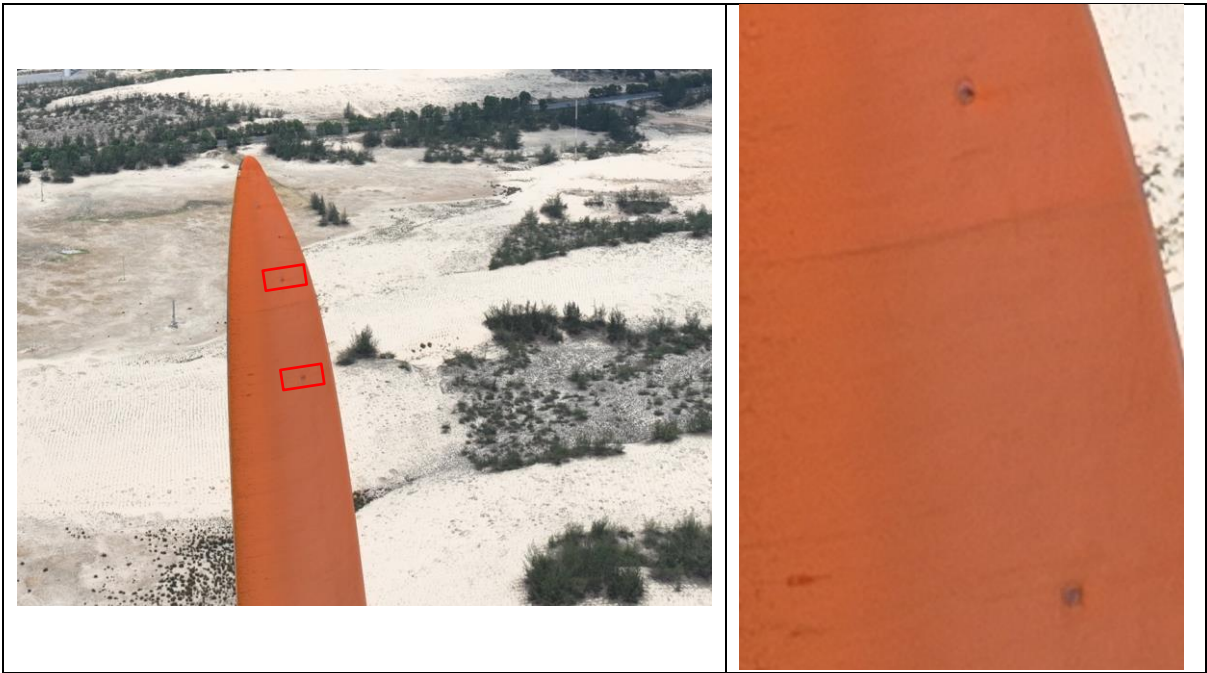
Damage 4 of 11 on blade 29101070WHYE255933

Pressure Side  
71 m  
Damage  
Lightning receptor damage

3  
Repair must be done within a time frame.  
Leak around lightning receptors on the PS side.

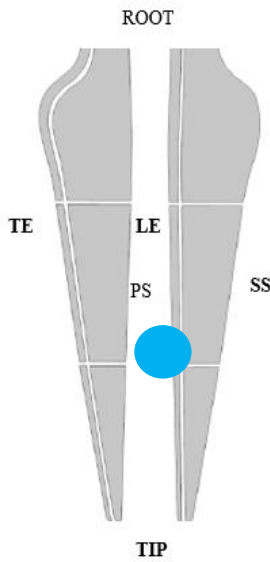
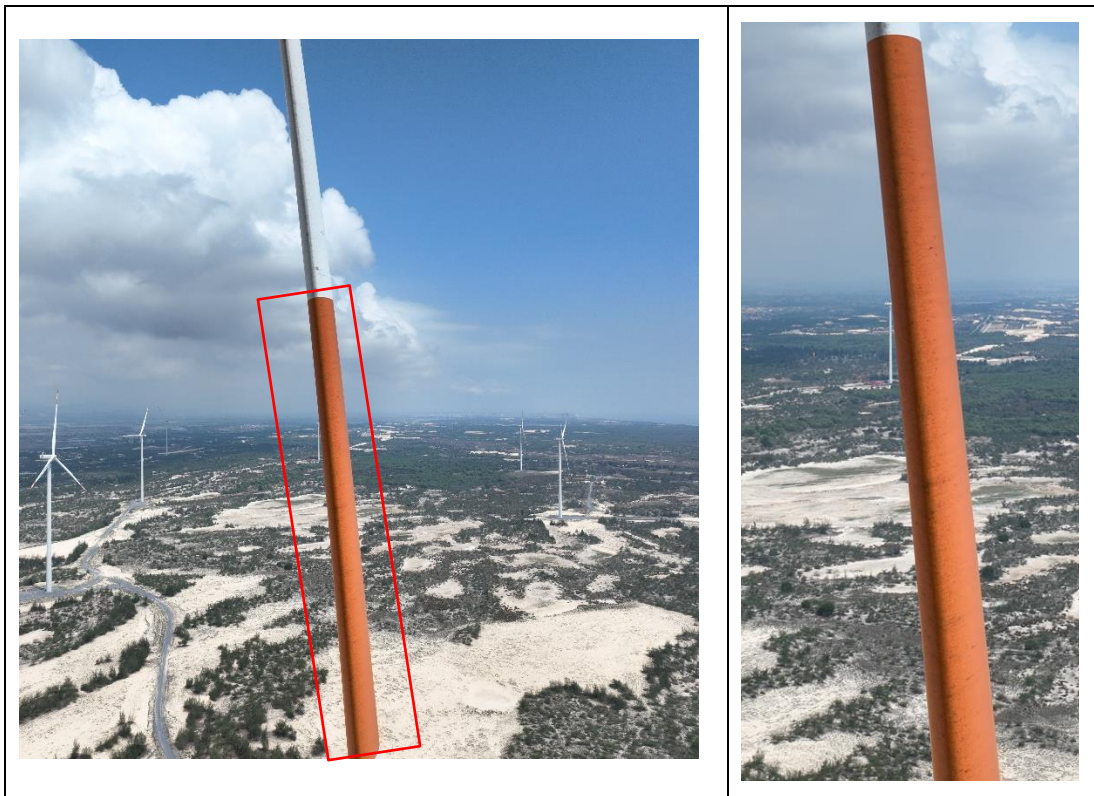
Damage 5 of 11 on blade 29101070WHYE255933

Leading Edge

57 m

Erosion

LE erosion

2

The leading edge (LE) side is damaged due to erosion.

Repair only if other damages are to be repaired.

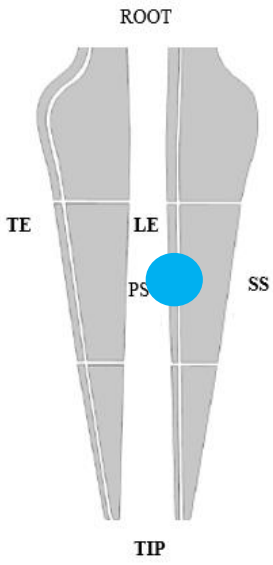
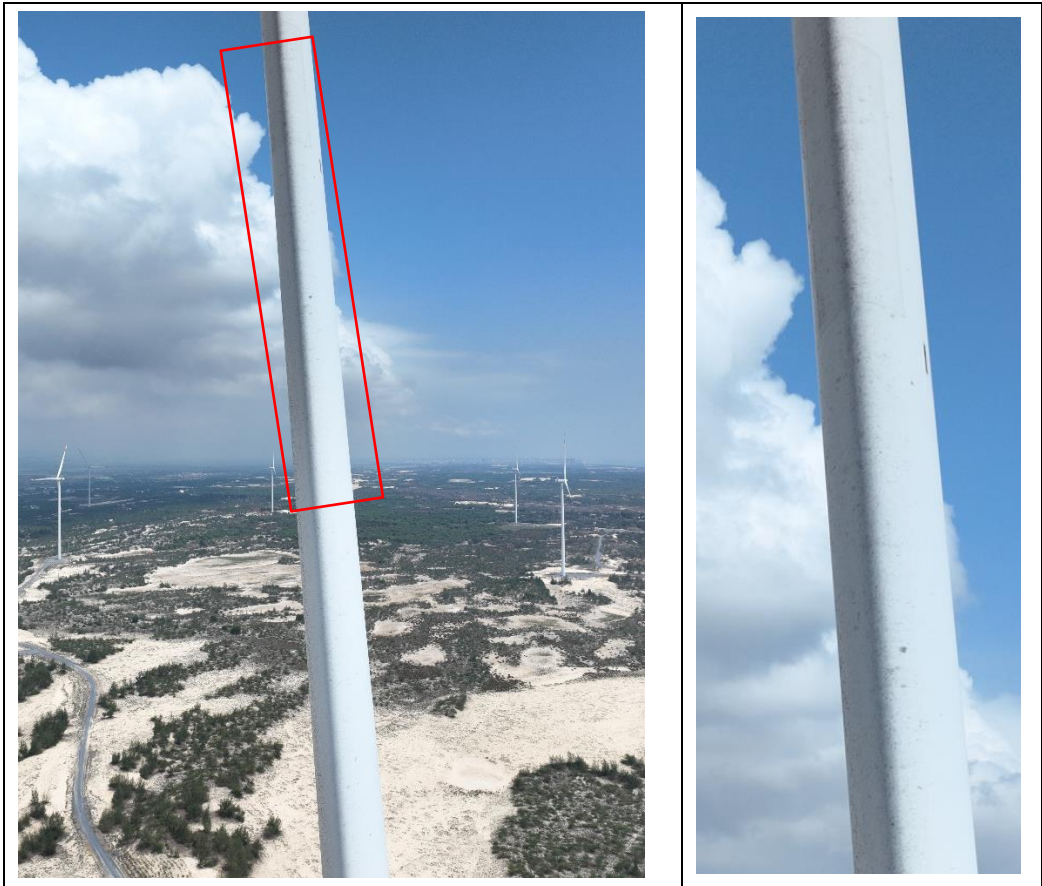
Damage 6 of 11 on blade 29101070WHYE255933

Blade Edge	Leading Edge
	Distance from Hub	49 m
	Damage Type	Erosion
	Damage Subtype	LE erosion
	Root Cause	
	Damage Severity	2
	Recommendation.	Repair only if other damages are to be repaired.
Comment	The leading edge (LE) side is damaged due to erosion.

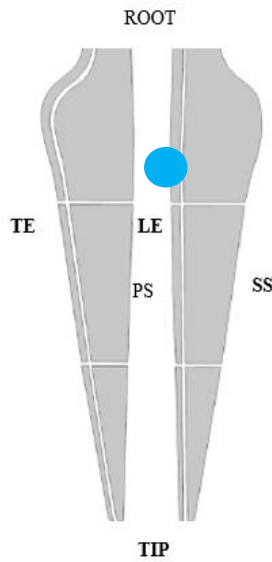
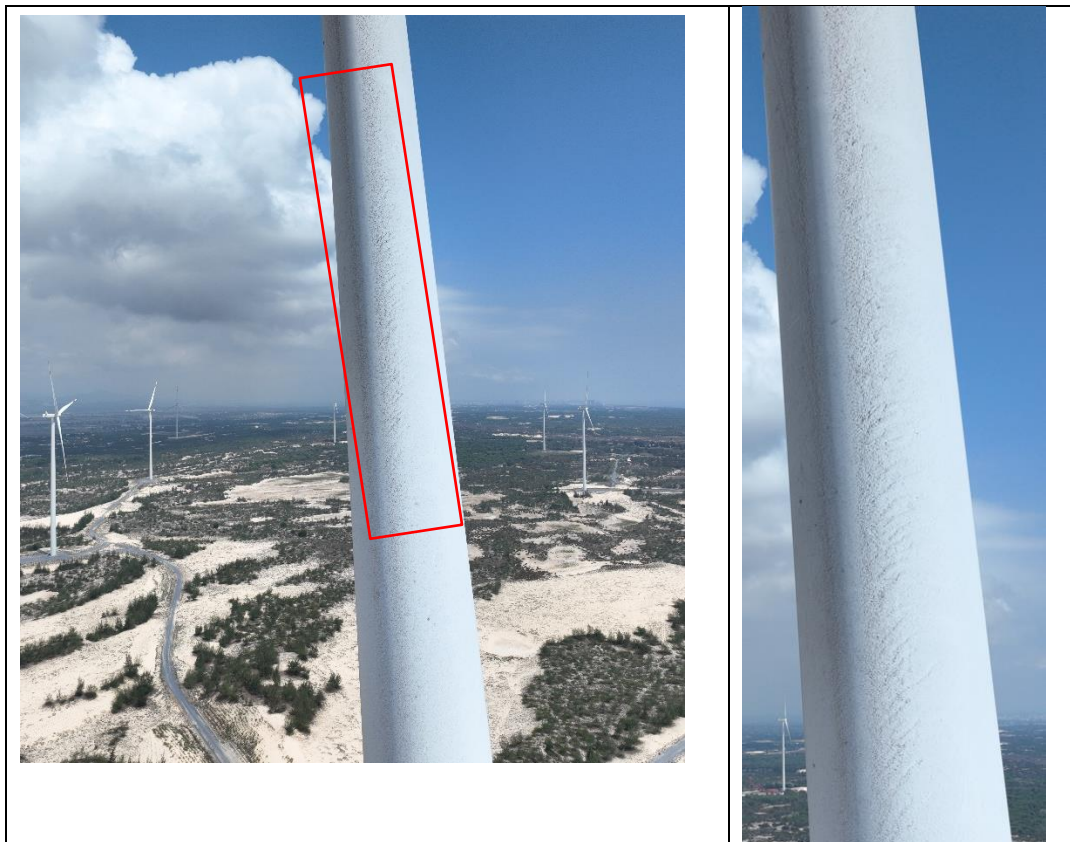
Damage 7 of 11 on blade 29101070WHYE255933

Leading Edge

26 m

Erosion

Coating damage

2

The leading edge (LE) side is damaged due to erosion.

Repair must be done within a time frame.

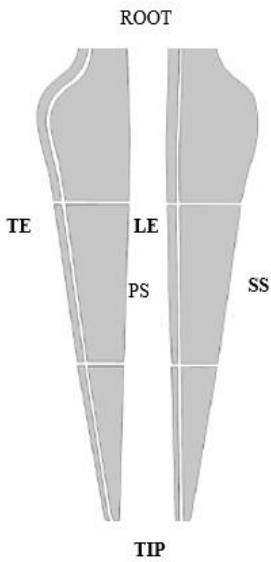
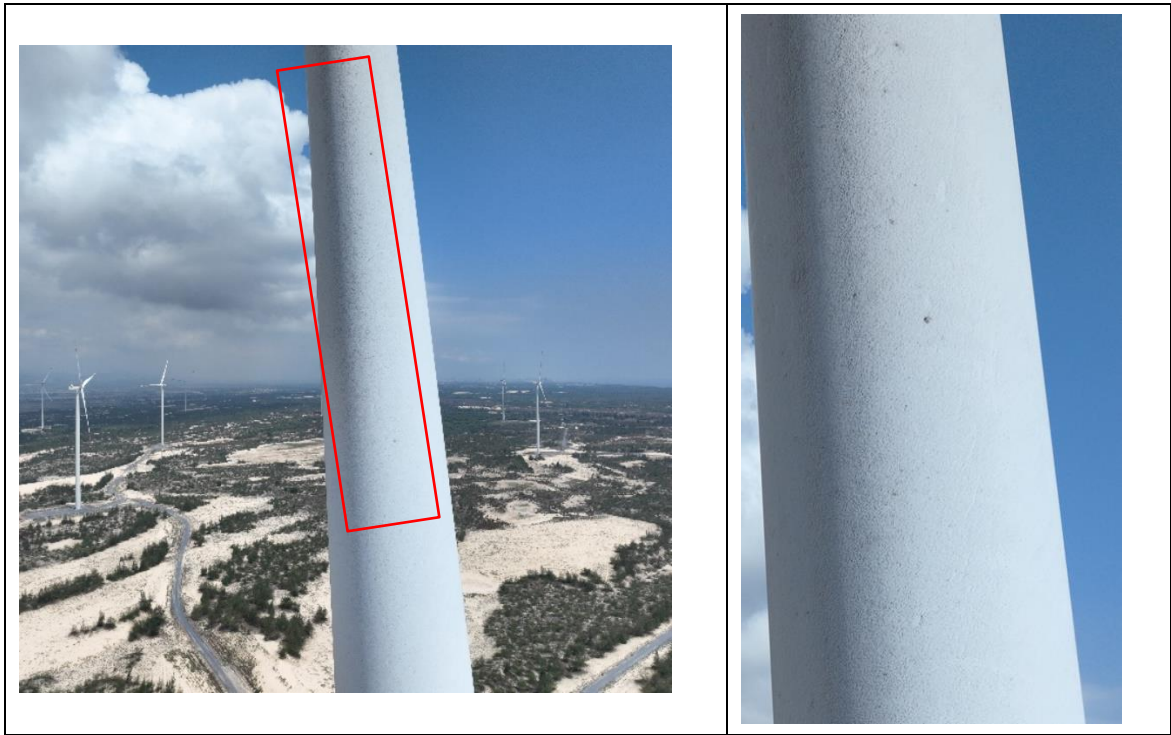
Damage 8 of 11 on blade 29101070WHYE255933

Leading Edge  
22 m  
Erosion  
Coating damage

2

No action. Monitor at next inspection  
The leading edge (LE) side is damaged due to minor erosion.

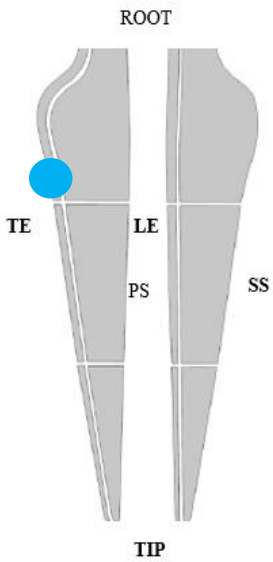
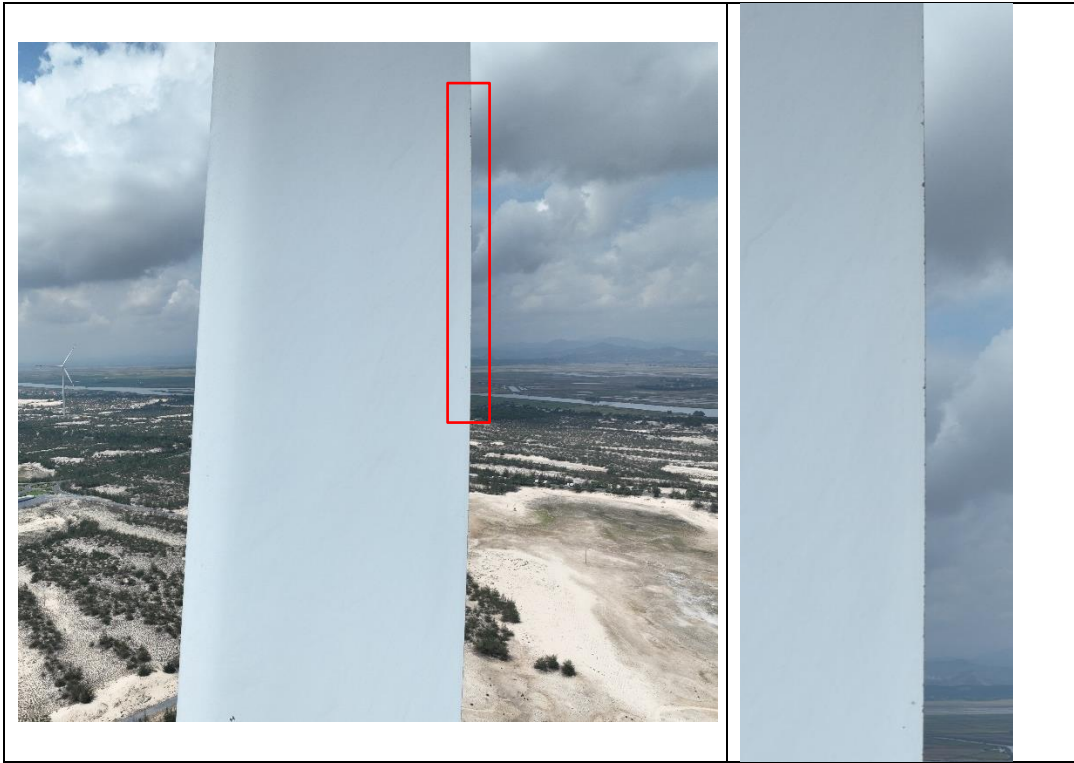
Damage 9 of 11 on blade 29101070WHYE255933

Blade Edge	Trailing Edge
	Distance from Hub	27 m
	Damage Type	Damage
	Damage Subtype	Chip
	Root Cause	
	Damage Severity	2
	Recommendation.	No action. Monitor at next inspection.
	Comment	Minor chips are occurring along the TE side.

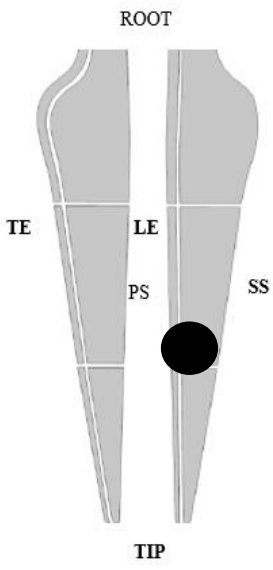
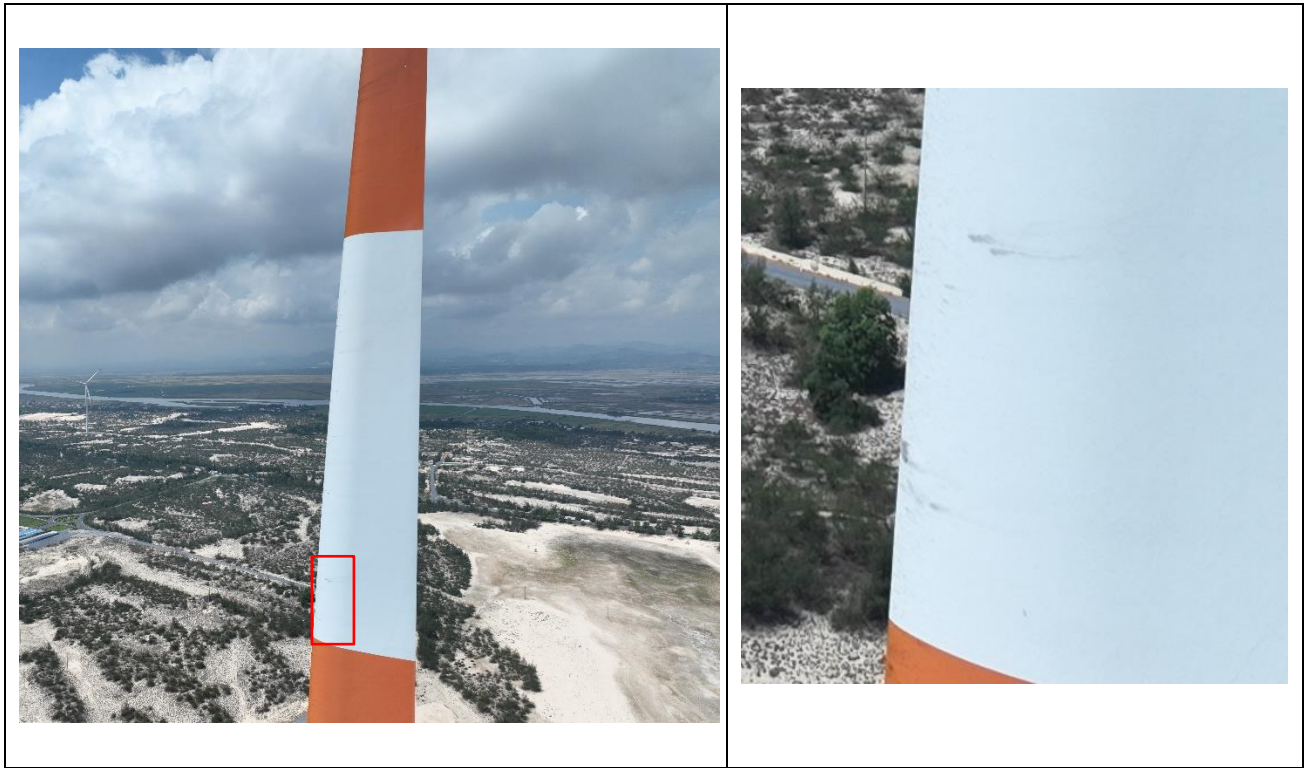
Damage 10 of 11 on blade 29101070WHYE255933

Blade Edge	Suction Side
	Distance from Hub	60 m
	Damage Type	Damage
	Damage Subtype	Contamination (Dirt/Grease/Oil)
	Root Cause	
	Damage Severity	1
	Recommendation.	No action.
	Comment	Contamination (Grease) on the suction side (SS)

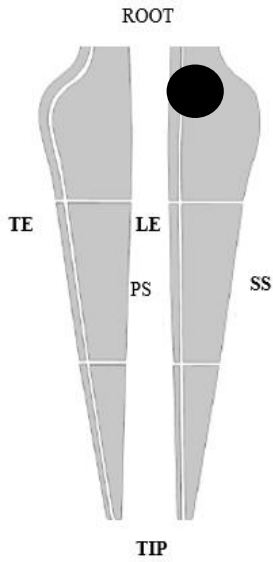
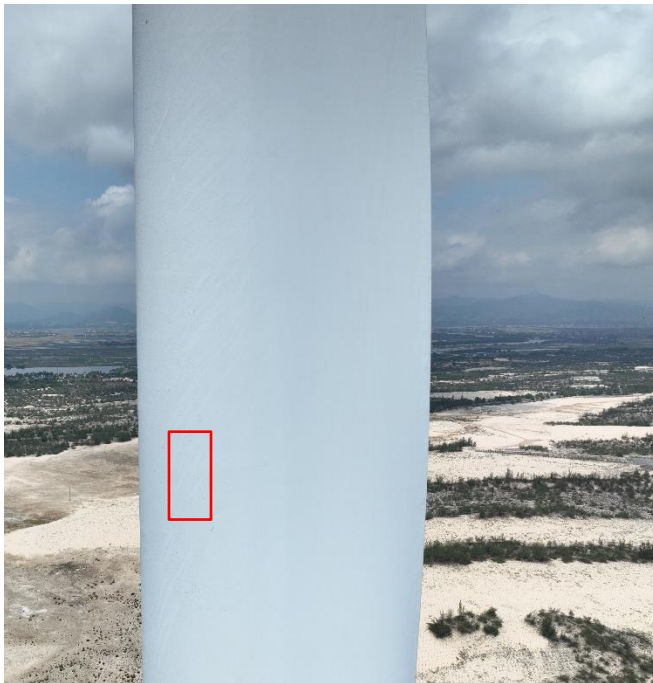
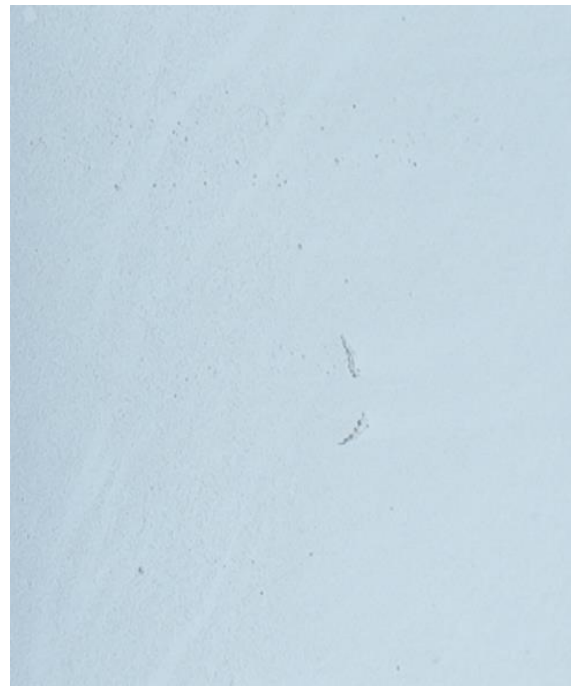
Images of Damage 11 of 11 on blade 29101070WHYE255933

Suction Side

10 m

Damage

Scratches

1

Minor scratches on the surface

No action.

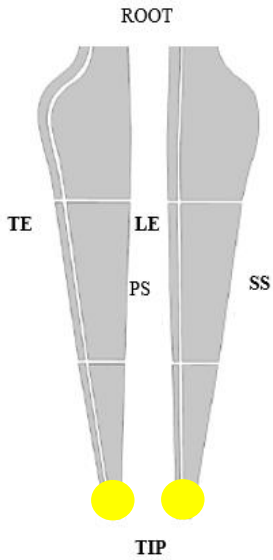
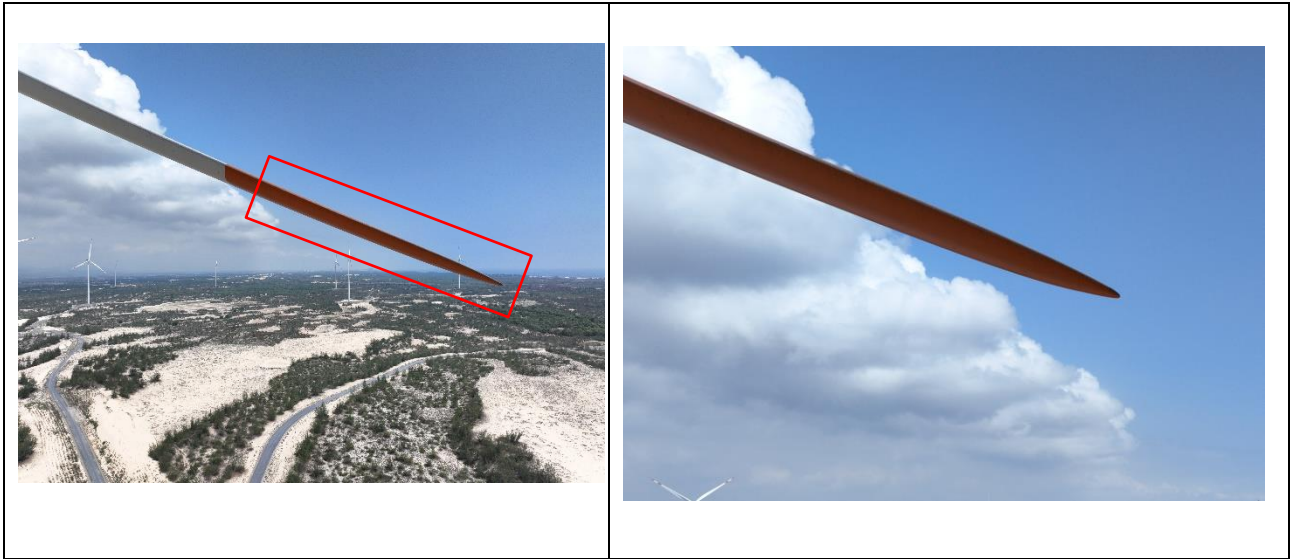
Damage 1 of 10 on blade 29101070WHYE255934

Blade Edge	Leading Edge
	Distance from Hub	73 m
	Damage Type	Erosion
	Damage Subtype	Tip section erosion.
	Root Cause	
	Damage Severity	3
	Recommendation.	Repair must be done within a time frame.
	Comment	Paint starting to wear off on the tip of the LE side.

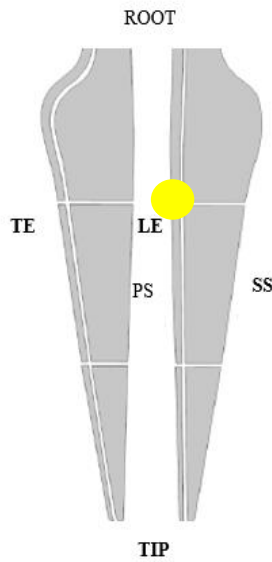
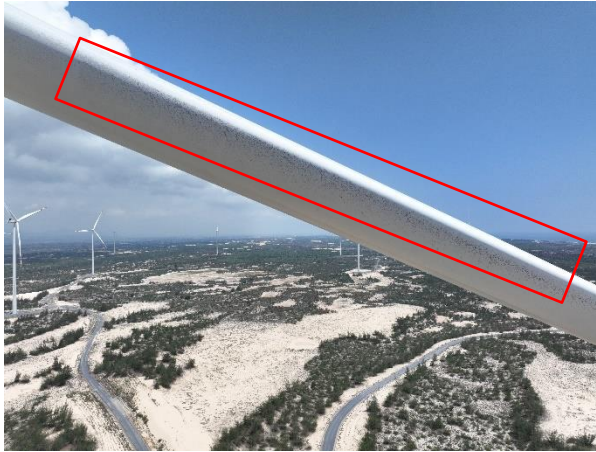
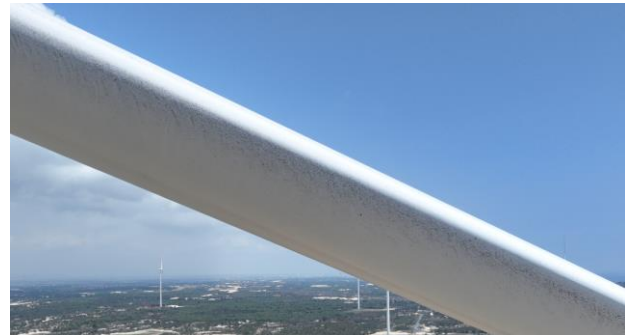
Damage 2 of 10 on blade 29101070WHYE255934

Leading Edge

34 m

Erosion

LE erosion

3

Erosion occurring on the leading edge (LE) of surfaces.

Repair must be done within a time frame.

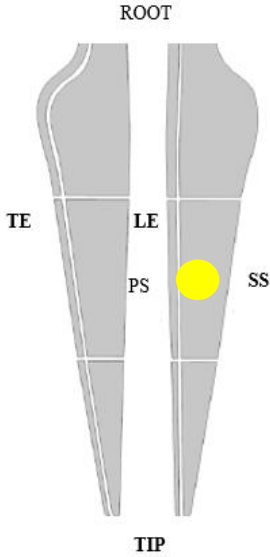
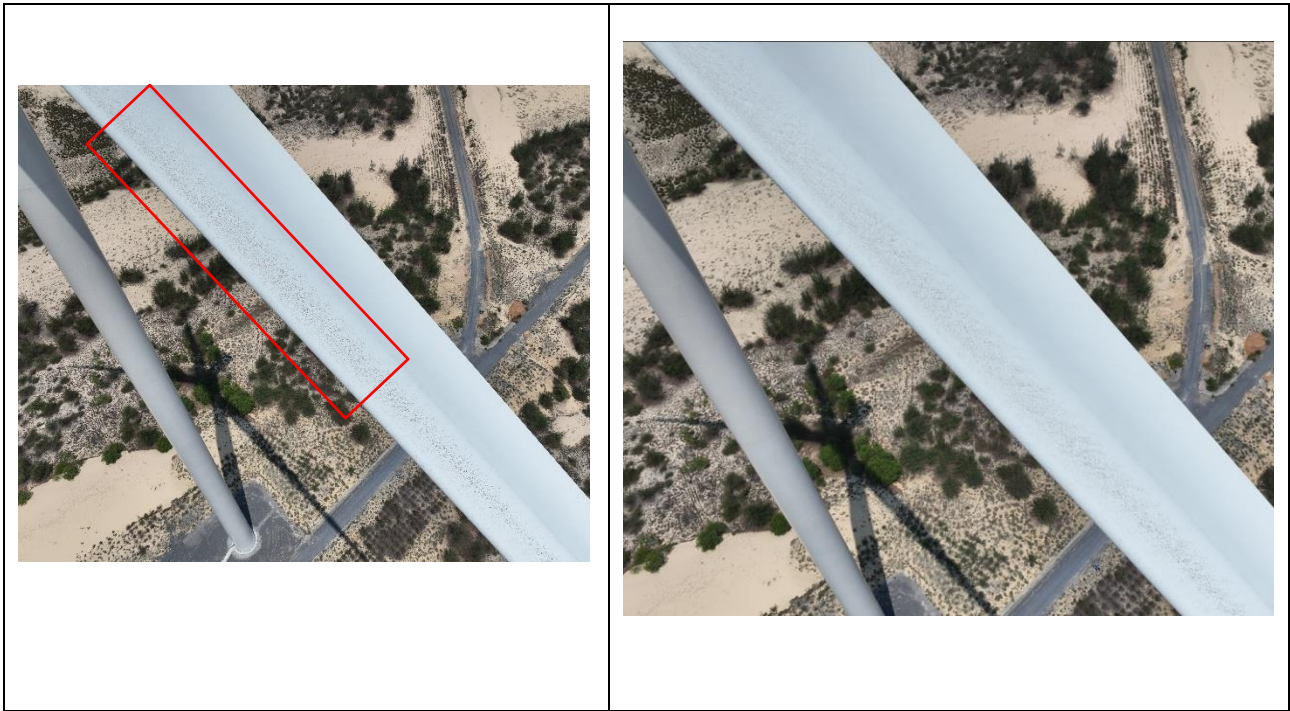
Damage 3 of 10 on blade 29101070WHYE255934

Blade Edge	Pressure Side
	Distance from Hub	49 m
	Damage Type	Erosion
	Damage Subtype	PS erosion
	Root Cause	
	Damage Severity	3
	Recommendation.	Repair must be done within a time frame.
	Comment	Erosion occurring on the PS side near the leading edge (LE) of surfaces.

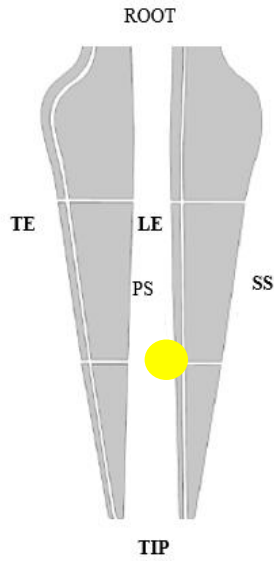
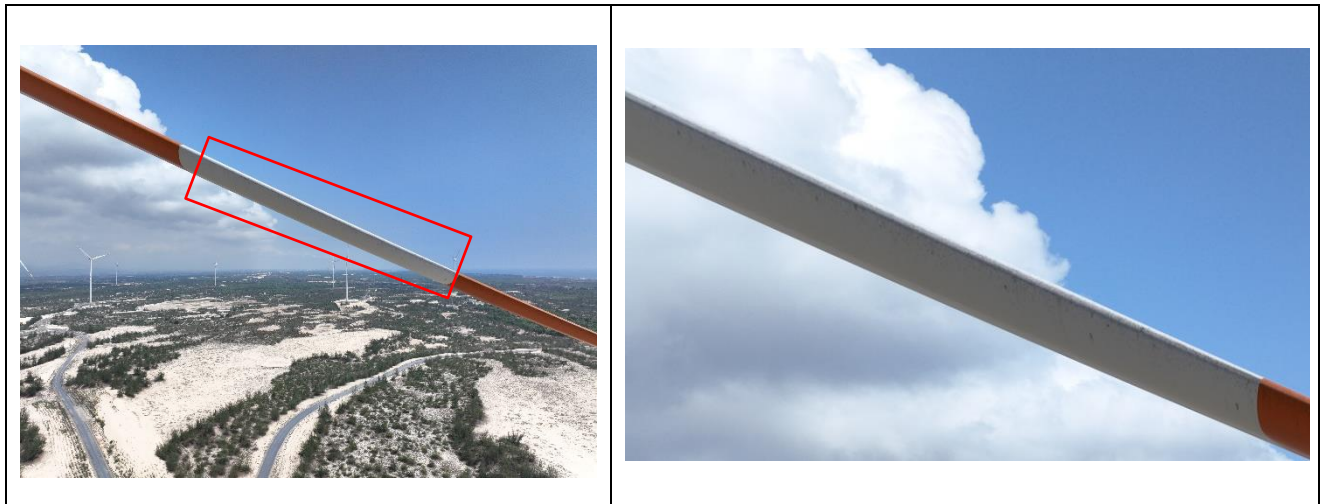
Damage 4 of 10 on blade 29101070WHYE255934

Suction Side

65 m

Erosion

SS erosion.

3

Erosion occurring on the leading edge (LE) of surfaces.

Repair must be done within a time frame.

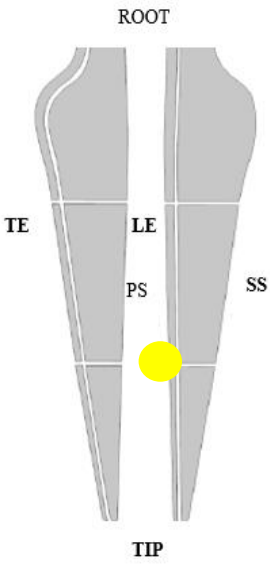
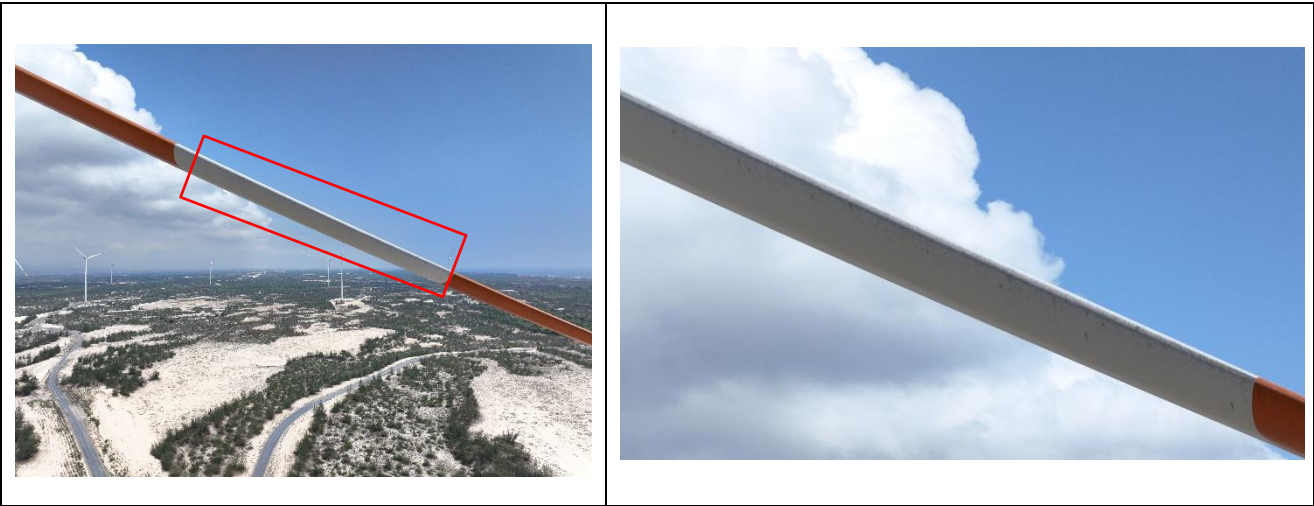
Damage 4 of 9 on blade 29101070WHYE255934

Blade Edge	Suction Side
	Distance from Hub	65 m
	Damage Type	Erosion
	Damage Subtype	SS erosion
	Root Cause	
	Damage Severity	3
	Recommendation.	Repair must be done within a time frame.
	Comment	Erosion occurring on the leading edge (LE) of surfaces.

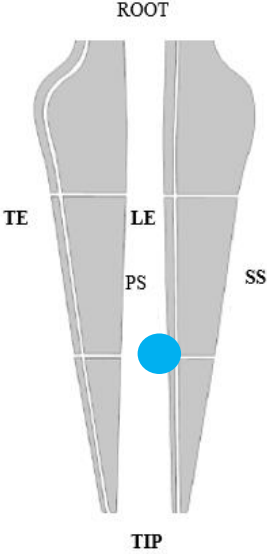
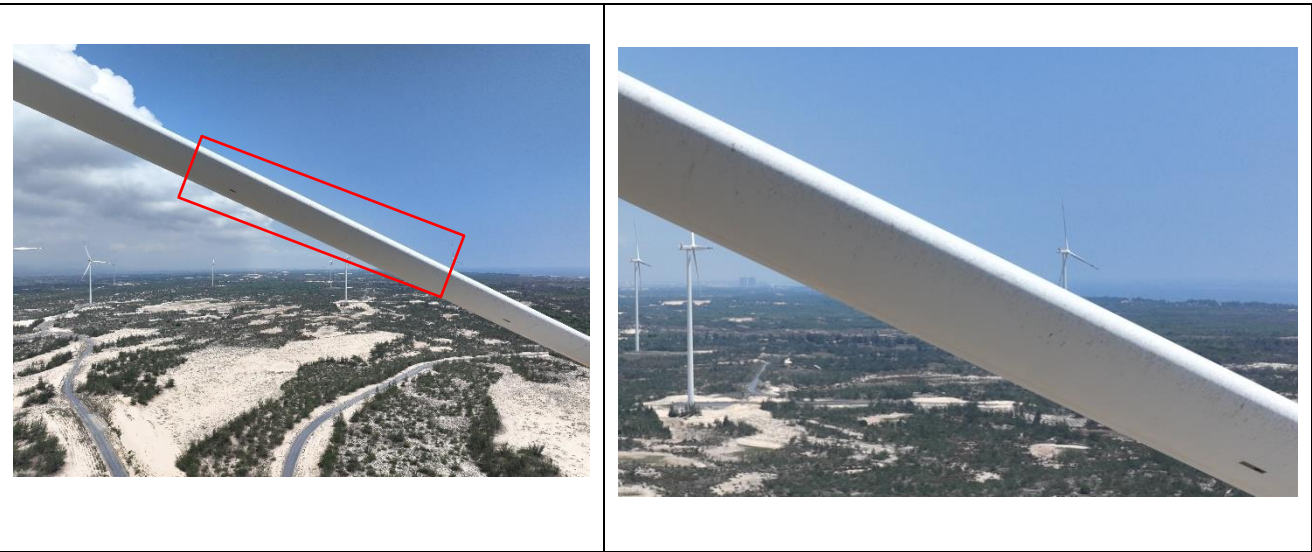
Damage 5 of 9 on blade 29101070WHYE255934

Blade Edge	Suction Side
	Distance from Hub	50 m
	Damage Type	Erosion.
	Damage Subtype	SS Erosion.
	Root Cause	
	Damage Severity	2
	Recommendation.	No action. Monitor at next inspection
Comment	Erosion occurring on the leading edge (LE) of surfaces.

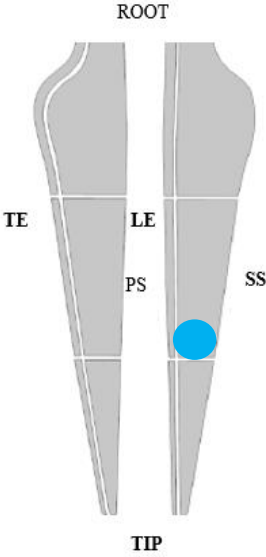
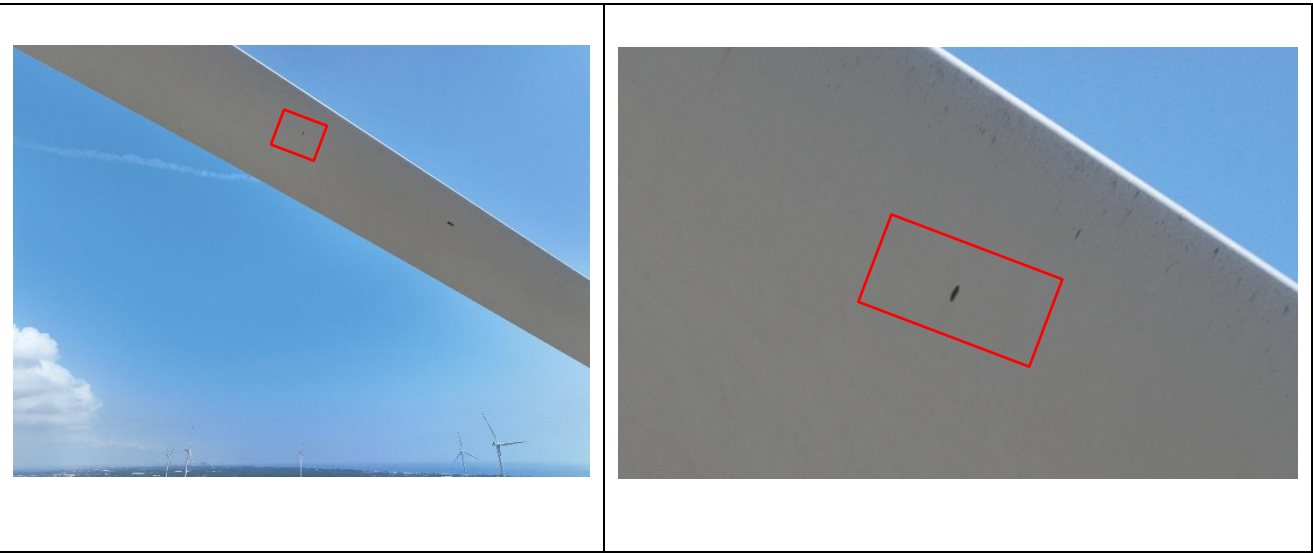
Damage 6 of 9 on blade 29101070WHYE255934

Blade Edge	
	Distance from Hub	53 m
	Damage Type	Coating damage
	Damage Subtype	Chip
	Root Cause	
	Damage Severity	2
	Recommendation.	Repair only if other damages are to be repaired.
	Comment	A minor chip on the SS surface

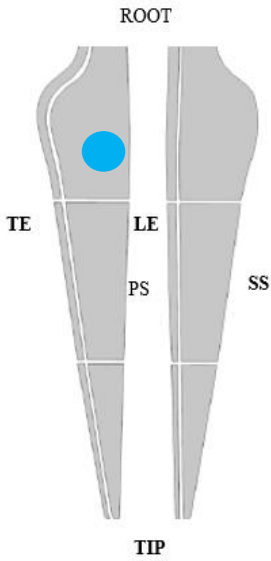
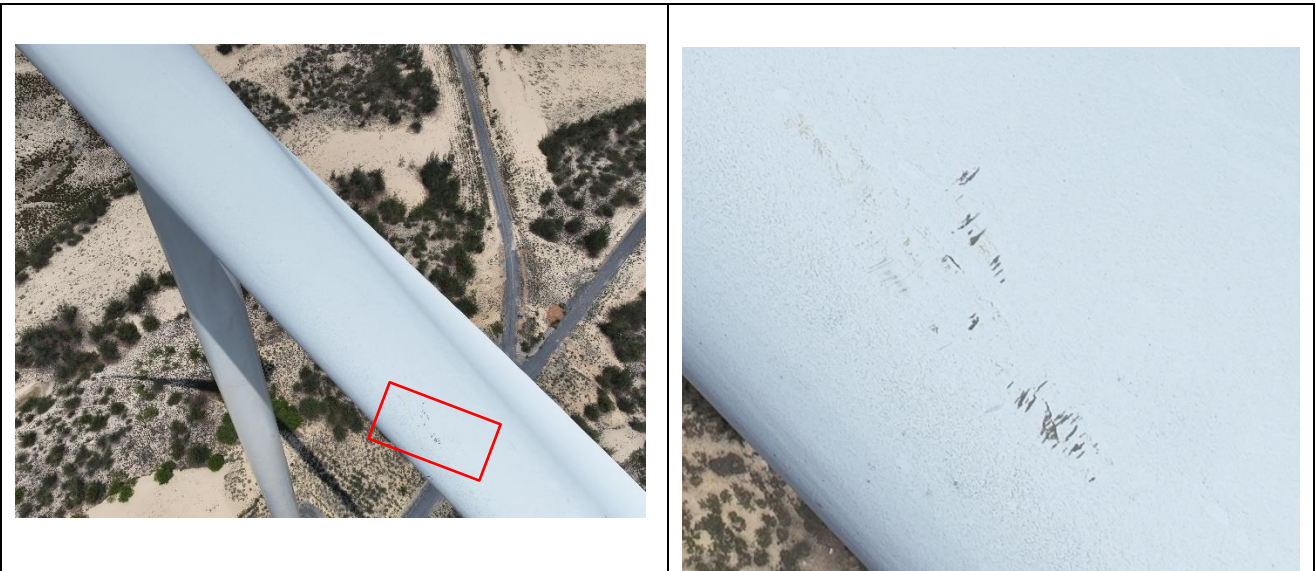
Damage 7 of 9 on blade 29101070WHYE255934

Pressure Side

21 m

Coating damage

Scratches.

2

Scratches on the pressure side surfaces.

Repair only if other damages are to be repaired.

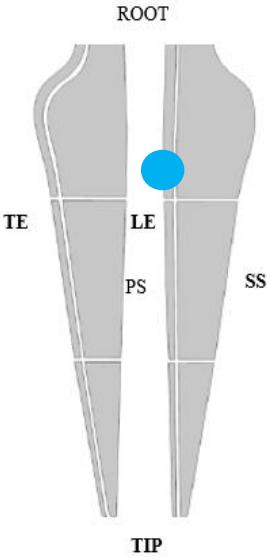
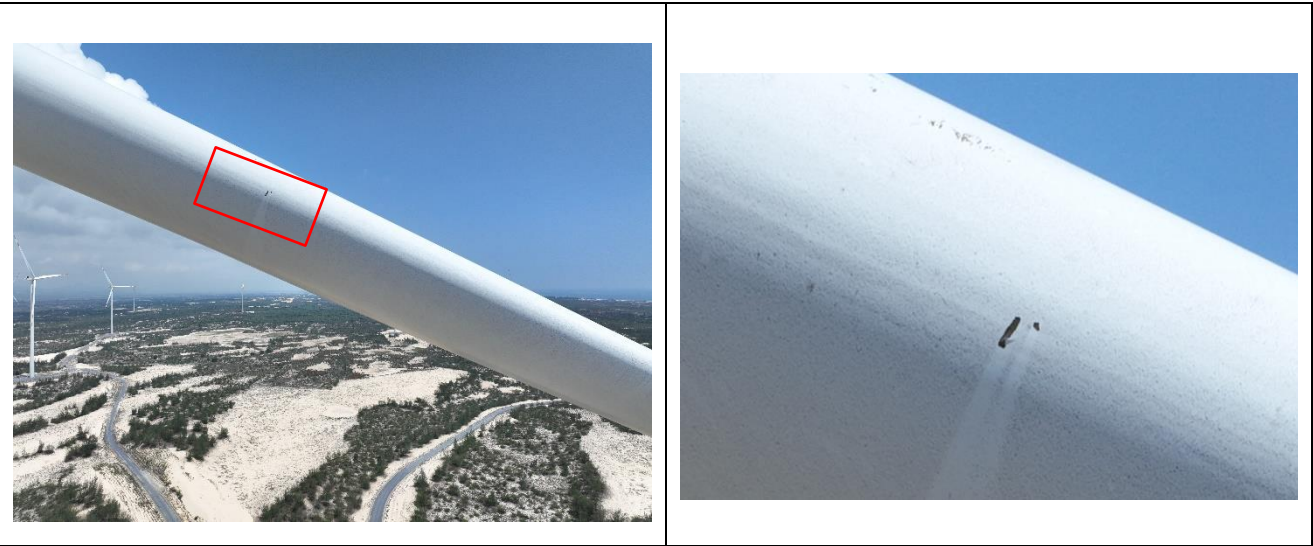
Damage 8 of 9 on blade 29101070WHYE255934

Blade Edge	Leading edge
	Distance from Hub	24 m
	Damage Type	Coating damage
	Damage Subtype	Chip
	Root Cause	
	Damage Severity	2
	Recommendation.	Repair only if other damages are to be repaired.
	Comment	Coating surface chipped on the LE side.

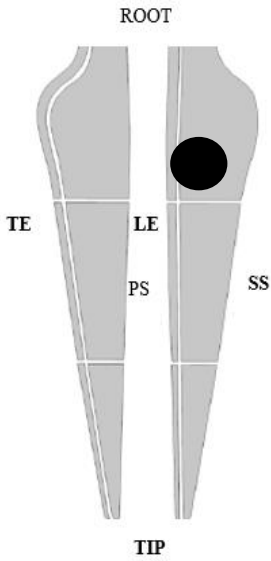
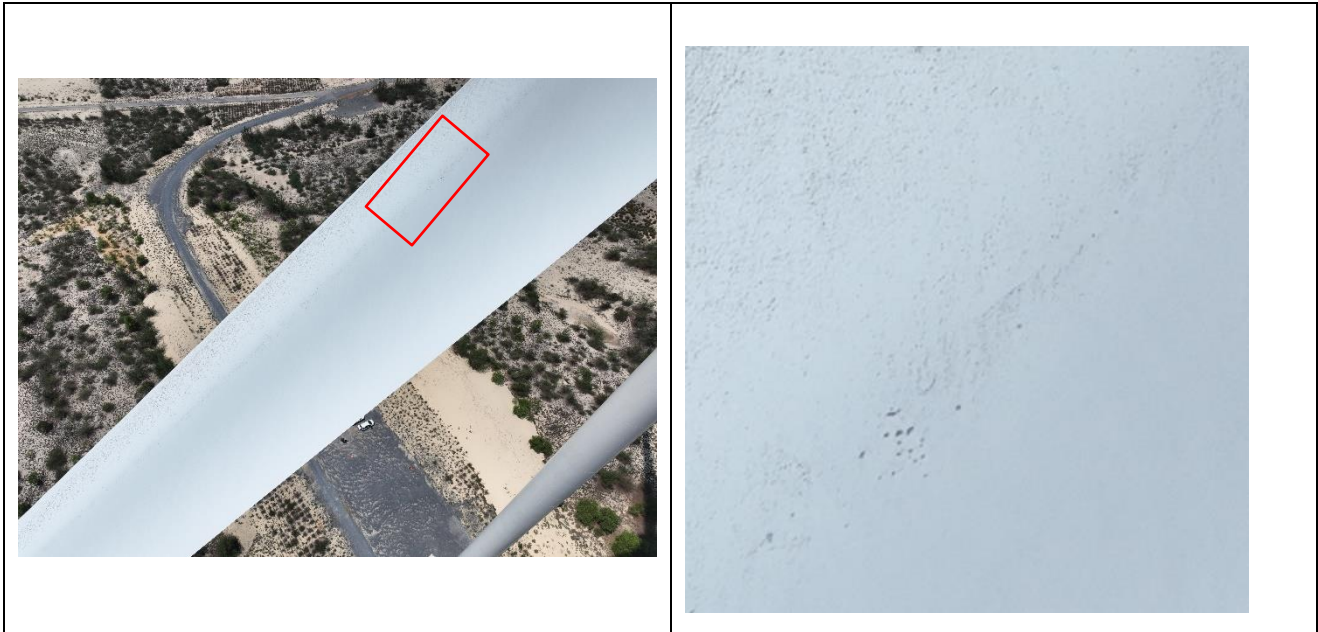
Damage 9 of 9 on blade 29101070WHYE255934

Suction Side
23 m
Erosion
SS Erosion.
1
No action. Minor erosion occurring on the Suction Side of surfaces.

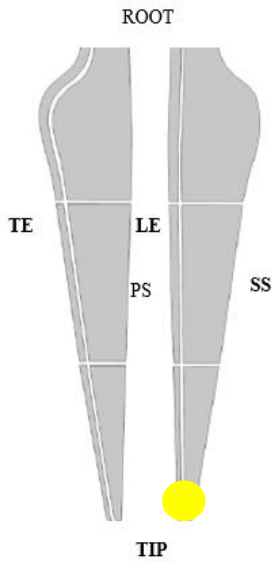
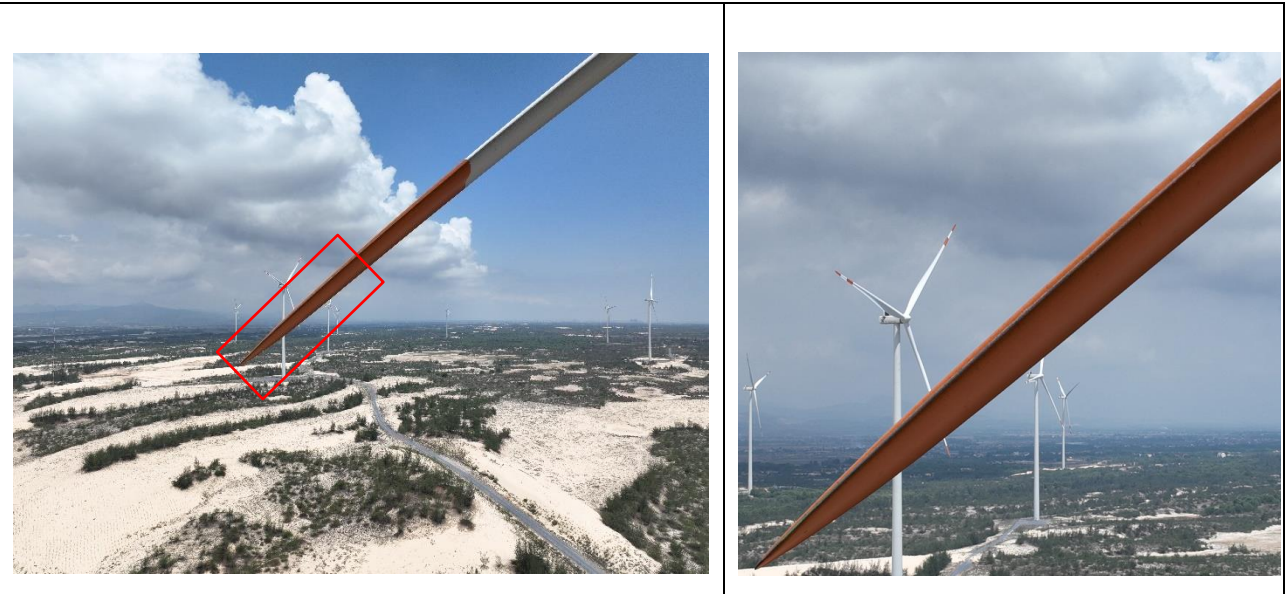
##### Damage 1 of 10 on blade 29101070WHYE255935

Leading Edge

73 m

Erosion

Tip section damage.

3

Erosion occurring on the LE surfaces at the Tip section.

Repair must be done within a time frame.
