# BLADE INSPECTION REPORT

BT1 Wind Farm  
Turbine No.239262  
Local Turbine ID WTG18

On May 15, 2024, Bureau Veritas Vietnam conducted a comprehensive drone-based inspection of the rotor blade on turbine **No. 239262** at the BT1 Wind Farm.

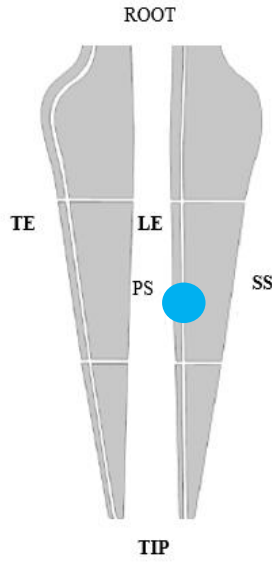
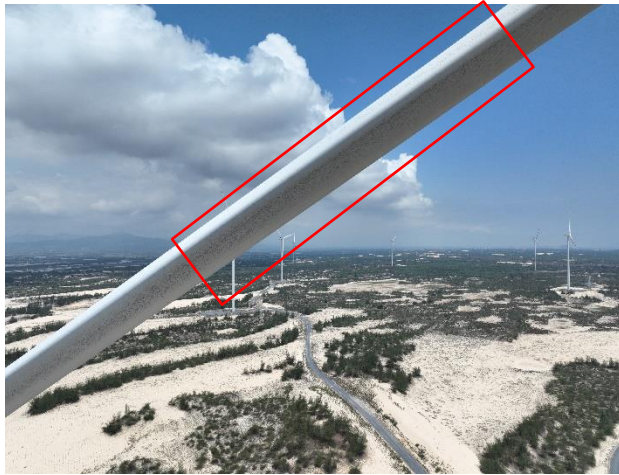
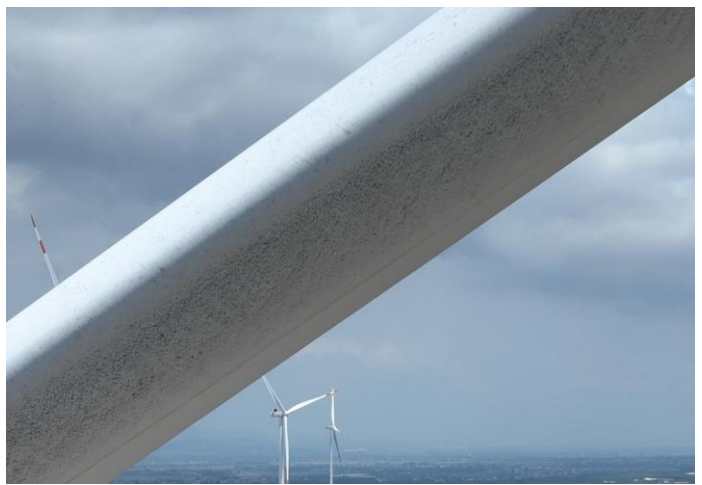
Damage 2 of 10 on blade 29101070WHYE255935

Leading Edge

41 m

Erosion

LE Erosion

2

Erosion occurring on the LE surfaces

Repair only if other damages are to be repaired.

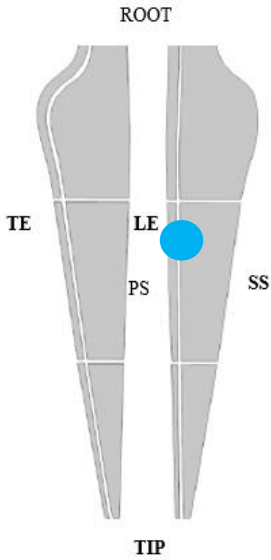
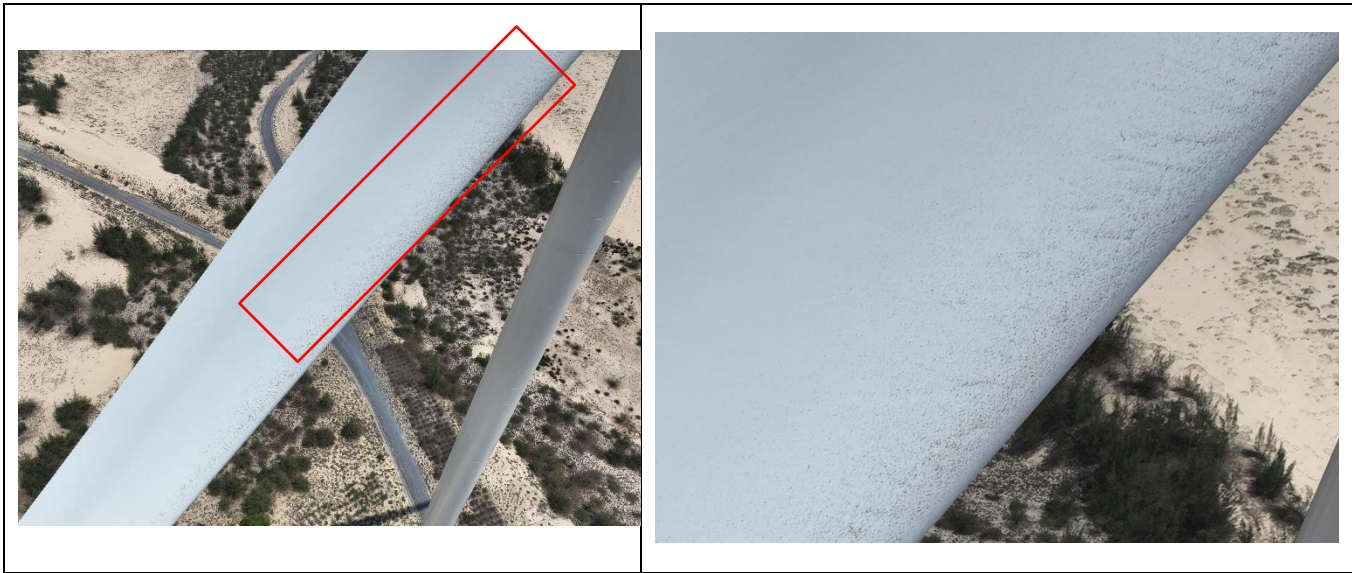
Damage 3 of 10 on blade 29101070WHYE255935

Leading Edge

30 m

Erosion

LE Erosion

2

Erosion occurring on the leading edge (LE) of surfaces.

Repair only if other damages are to be repaired.

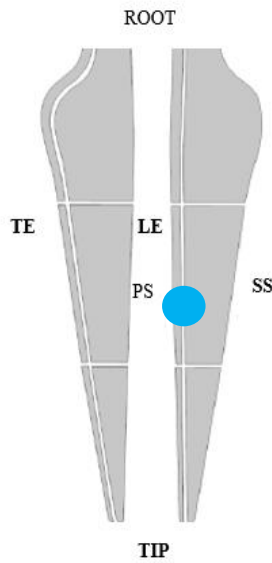
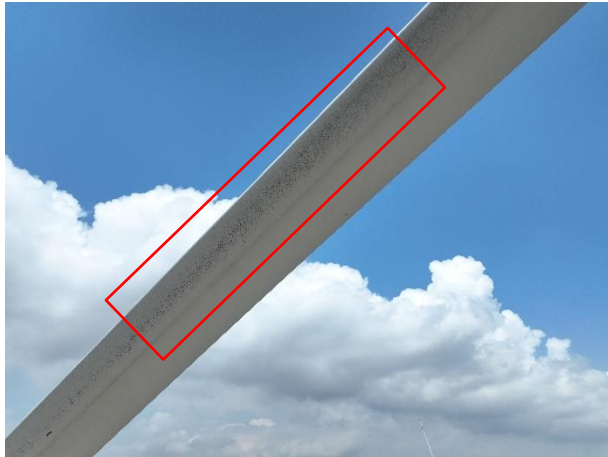
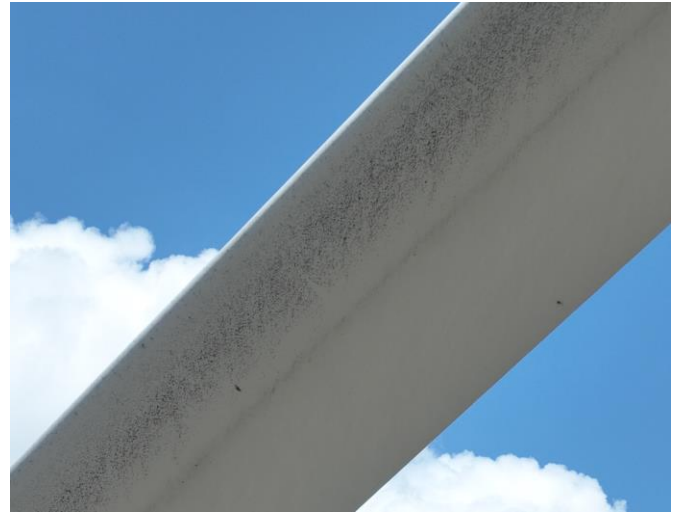
Damage 4 of 10 on blade 29101070WHYE255935

Pressure Side

41 m

Erosion

PS Erosion.

2

Erosion occurring on the PS side near the leading edge (LE) of surfaces.

Repair only if other damages are to be repaired.

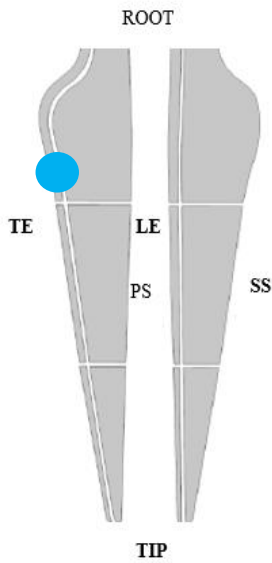
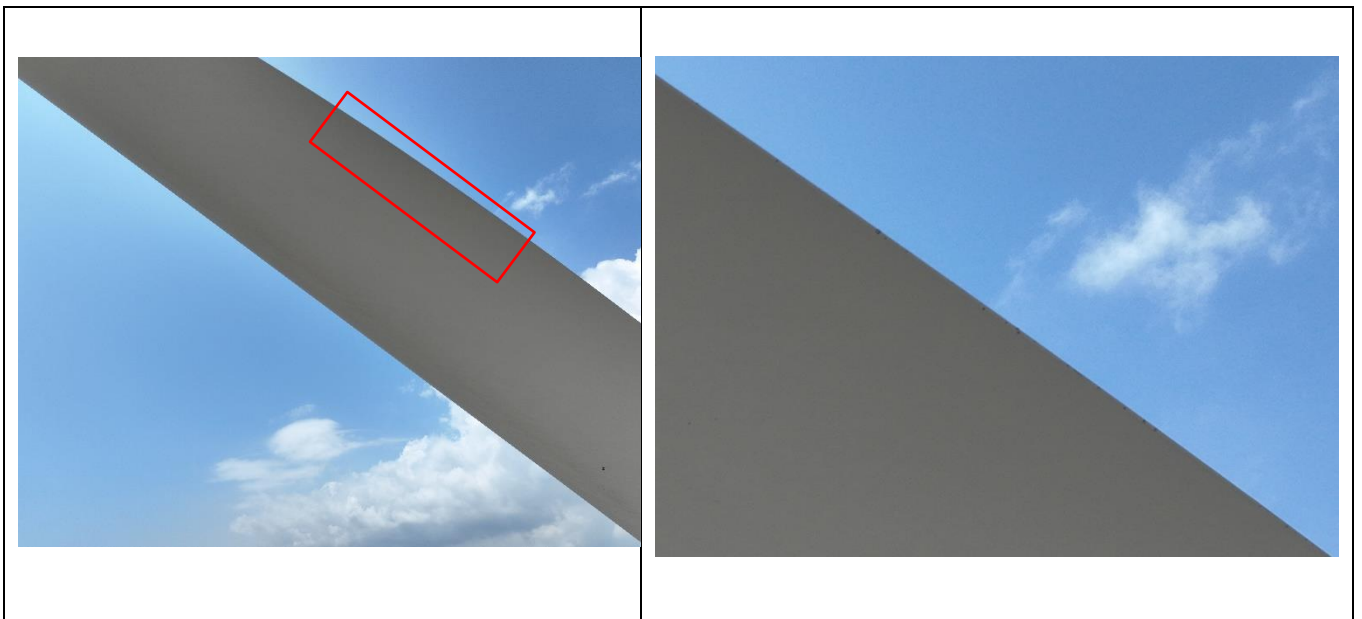
Damage 5 of 10 on blade 29101070WHYE255935

Trailing Edge

28 m

Coating damage

Chip

2

Minor chip occurring on the TE surfaces.

No action. Monitor at next inspection

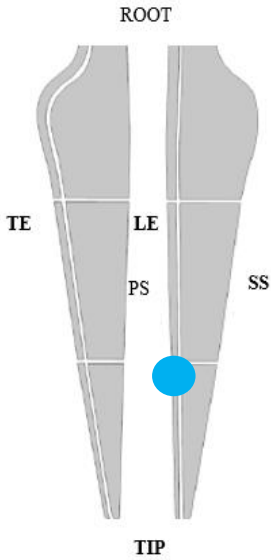
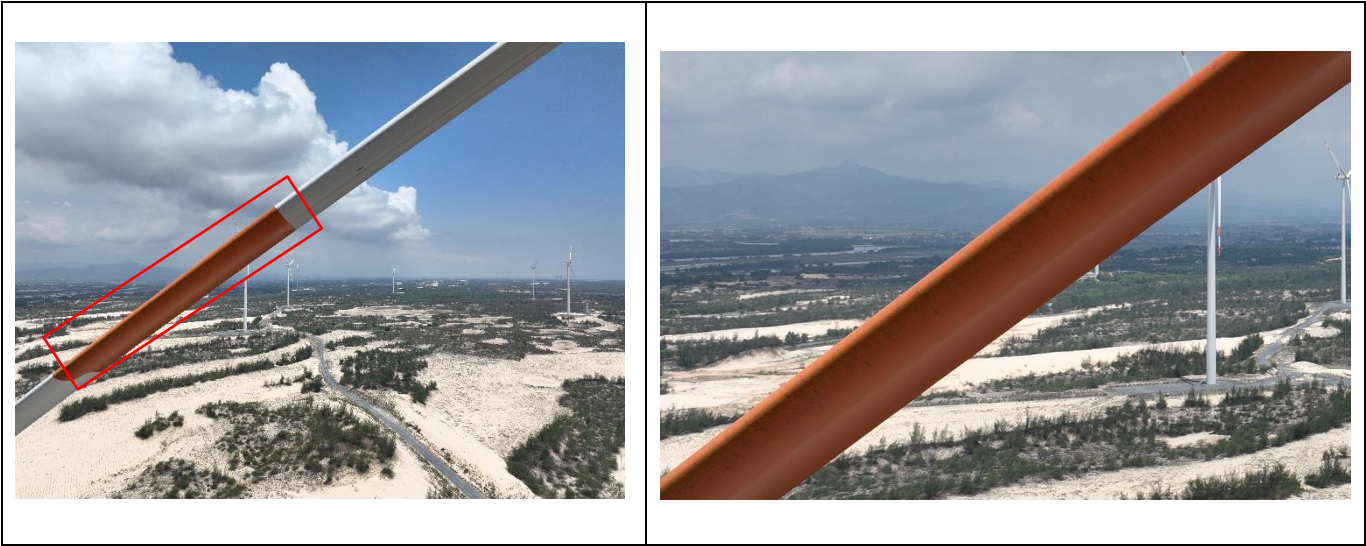
Damage 6 of 10 on blade 29101070WHYE255935

Leading Edge  
58 m  
Erosion  
LE Erosion

2

No action. Monitor at next inspection  
Minor erosion occurring on the leading edge (LE) of surfaces.

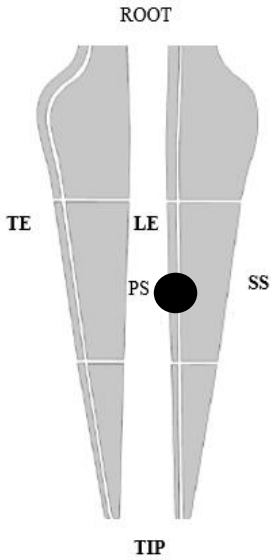
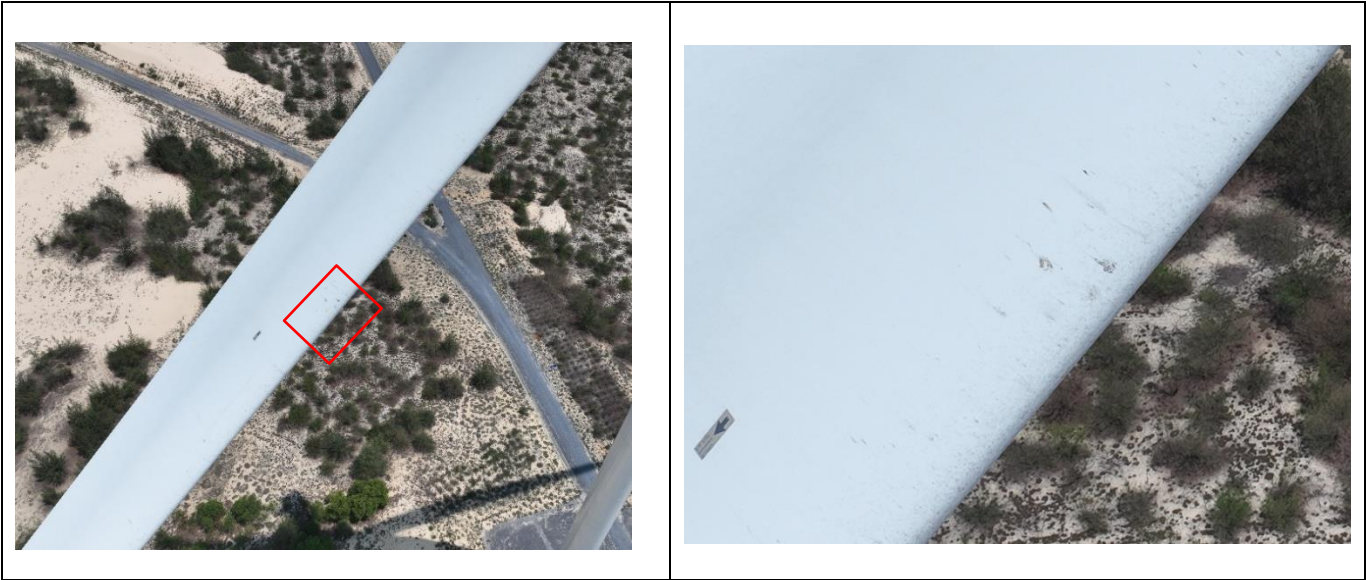
Damage 7 of 10 on blade 29101070WHYE255935

Leading Edge  
46 m  
Coating Damage  
Contamination (Dirt/grease/oil)

1

No action.  
Contamination (Dirt/grease) on the leading edge (LE) of surfaces.

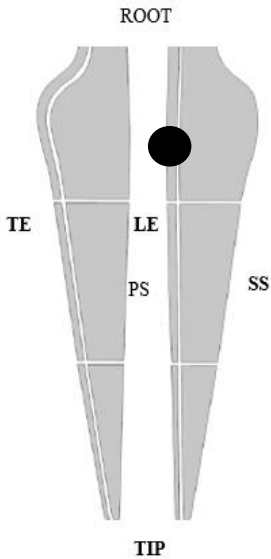
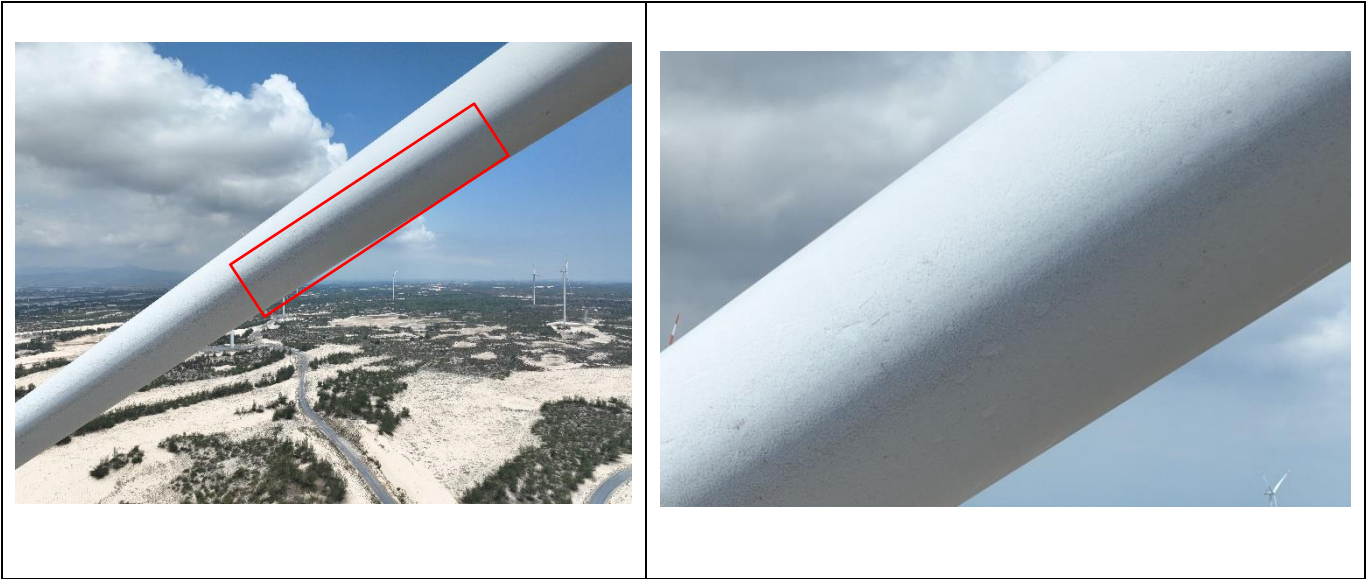
Damage 8 of 10 on blade 29101070WHYE255935

Leading Edge  
21 m  
Erosion  
LE Erosion

1

No action. Monitor at next inspection  
Minor erosion occurring on the leading edge (LE) of surfaces.

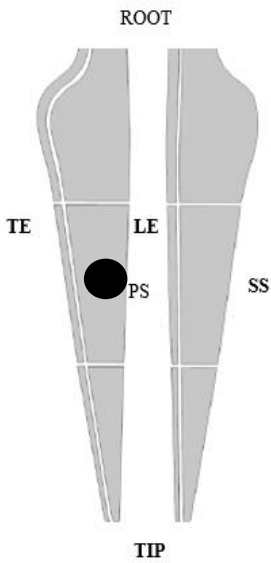
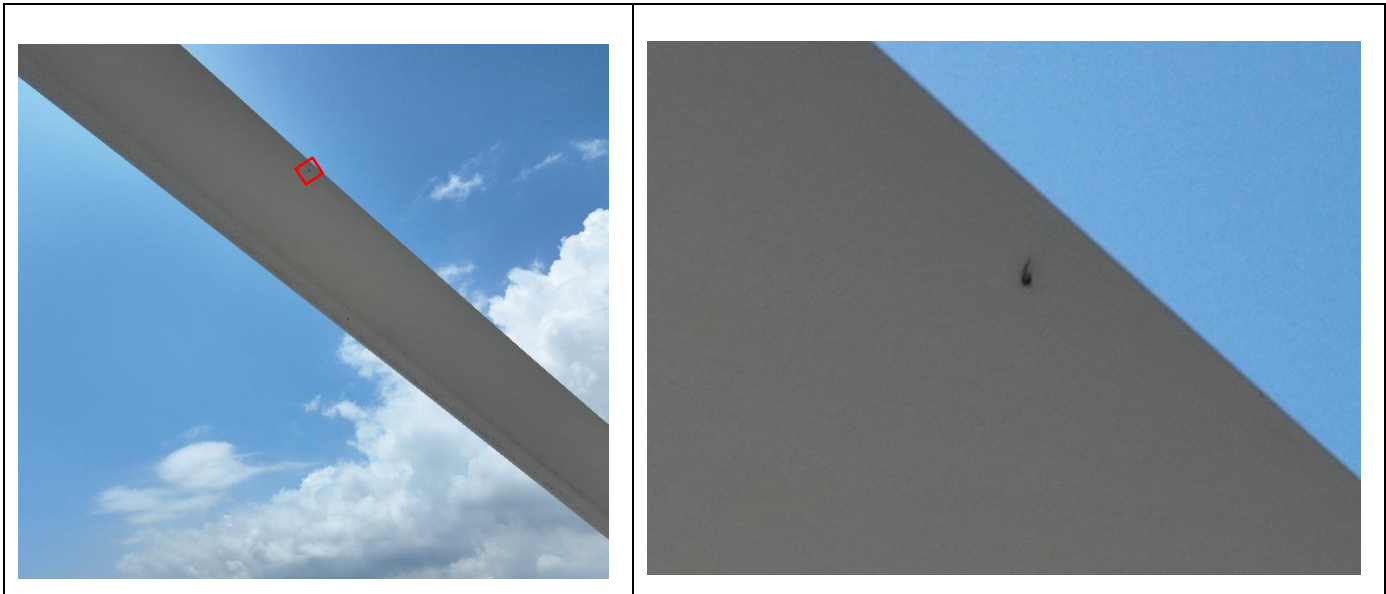
Damage 9 of 10 on blade 29101070WHYE255935

Pressure Side  
43 m  
Coating Damage  
Contamination (Dirt/grease/oil)

1

No action. Monitor at next inspection  
Contamination (Dirt/grease) on the PS of surfaces.

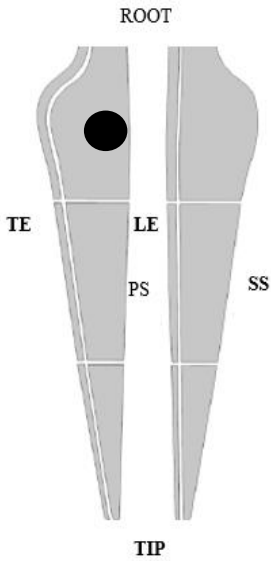
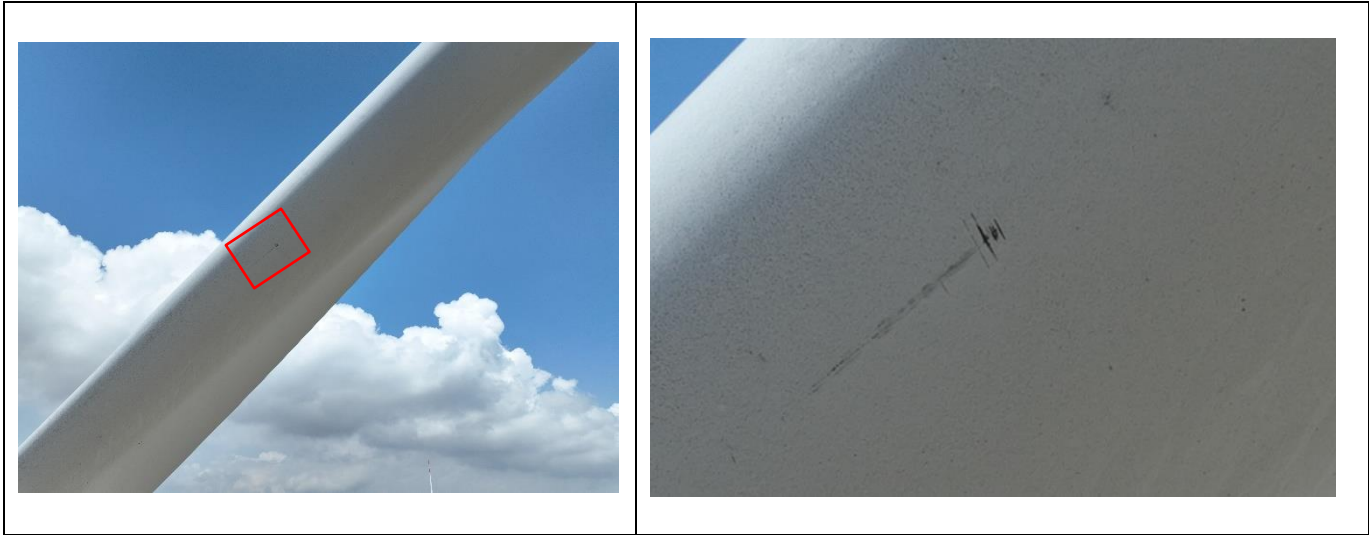
Damage 10 of 10 on blade 29101070WHYE255935

Pressure Side
16 m
Coating Damage
Scratches
1
No action. Monitor at next inspection
Minor scratches on the PS surfaces
