## EQUITY BACKUP CALL-OUT REPORT

5<sup>TH</sup> March 2025

Site: Equity Bank Kagio Branch

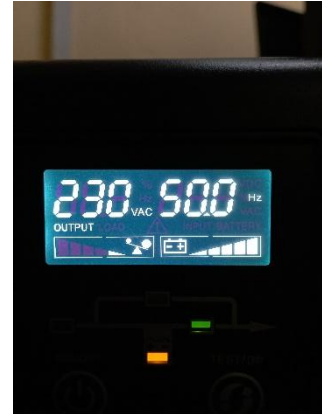
Figure 2: UPS on battery mode
