EQUITY BANK OTHAYA BRANCH
CALLOUT REPORT

11th January, 2025

Site: Equity Bank Othaya Branch
Region: Nyeri County
Contact: Dianah Maina

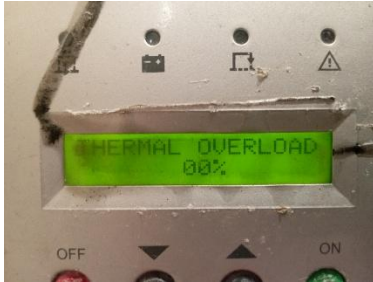
- a. On arrival, the UPS was on. The UPS had and an error of *Thermal Overload*.
- b. The UPS was turned off and disconnected but the server next to the backup system was still on. This indicated that there was a different source powering the clean power loads. The UPS was also indicating a load capacity of 0kVA on its screen.

UPS alarm

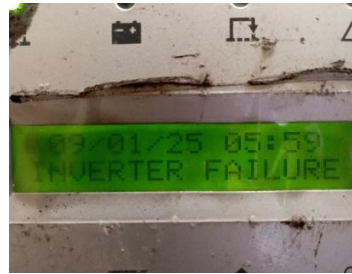
- c. On further troubleshooting of the UPS, the UPS had raised alarms of *Inverter failure and Bad connection*.
- d. The wiring of the UPS was traced and it was discovered a cable that was live had earlier on been connected the clean power consumer unit. This caused back feeding of power to output side of the UPS hence the *Bad connection* alarm. That specific cable was disconnected from the clean power consumer unit and insulated.

UPS alarm

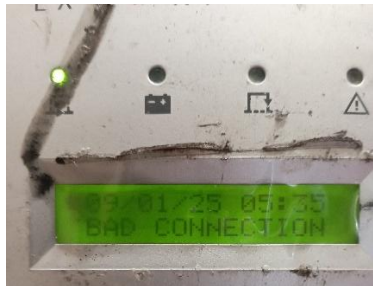
UPS alarm

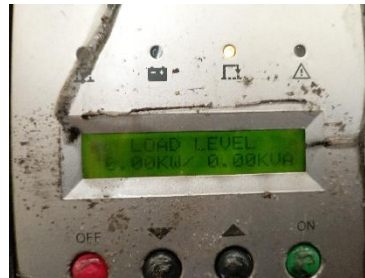
UPS on no load

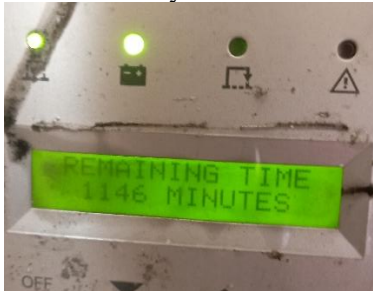
UPS on battery mode

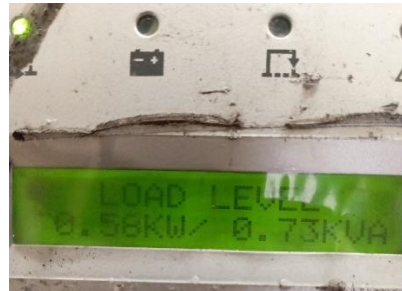
UPS on normal mode

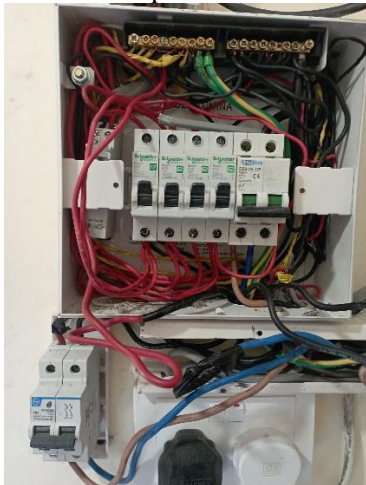
Initial clean power consumer unit wiring

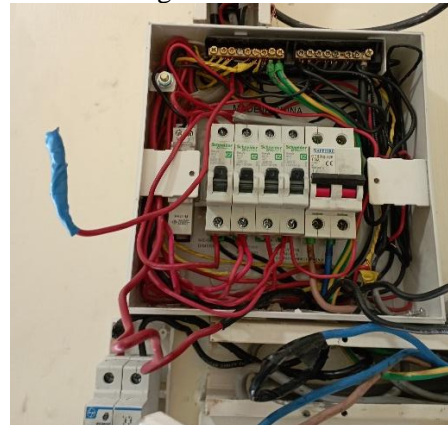
Clean power consumer unit wiring after disconnecting the live cable

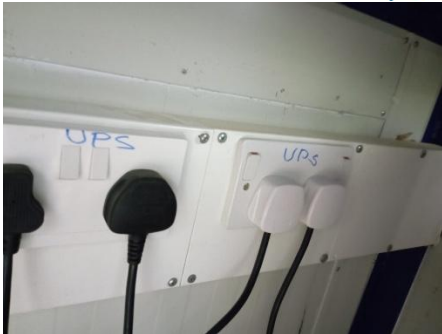
Workstation top plugs were replaced to non-standard type

Clean power consumer units were rewired to retain only clean power loads

- e. The UPS was then able to support the loads on clean power
- f. Some of the workstations and the servers insider the containers were not connected to clean power. The electrician responsible for that task was been notified of the pending connection of work stations and servers that haven't been connected to clean power and he did the clean power wiring that was required, as well as replacement of the top plugs for the workstations to non-standard top plugs.

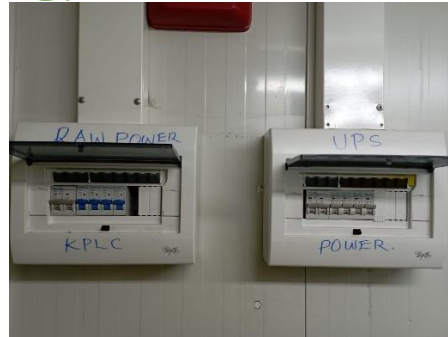
- g. Power loss simulation was conducted and the UPS was able to support the clean power loads which summed up to 1kW.

Total load level

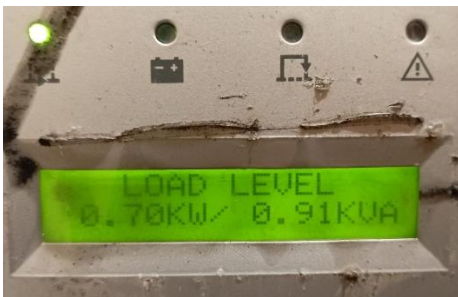
Remaining time on battery mode during power loss simulation
