## EQUITY BACKUP CALL-OUT REPORT

9<sup>th</sup> DECEMBER 2024

Site: Equity Bank Migori Branch

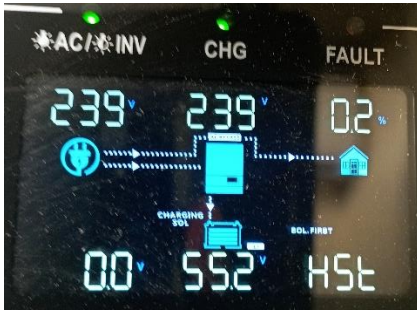
Figure 1: Host inverter on line mode

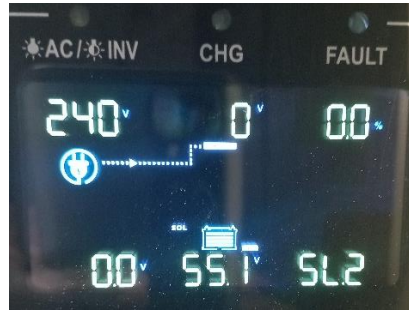
- On arrival, the backup system was ON with loads on KPLC.
- One inverter had no output supply to the loads.
- Checked the batteries, both are fully charged with voltages of 55V.
- Restarted the system by turning all inverters and batteries OFF and turning them ON. The system was back to normal operation mode.
- Set the b2ac to 95% and ac2b to 100%, to ensure the batteries are always full.
- Switched the ATS to inverter mode and the power backup system was able to support the loads during power loss simulation.

Figure 2: Slave 2 inverter having no output supply to the loads

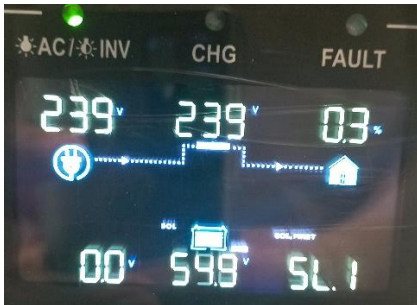
Figure 3: Slave 1 inverter on

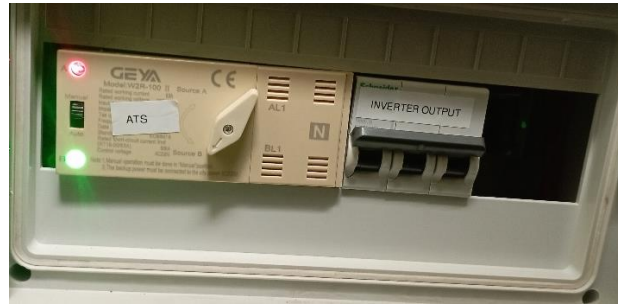
Figure 4: ATS on KPLC mode

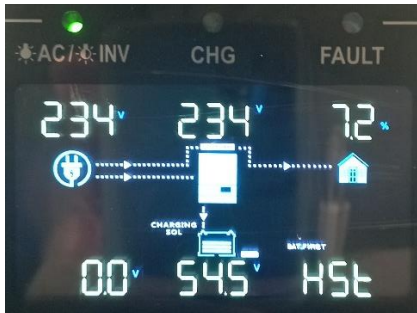
Figure 5: Host inverter on normal operation

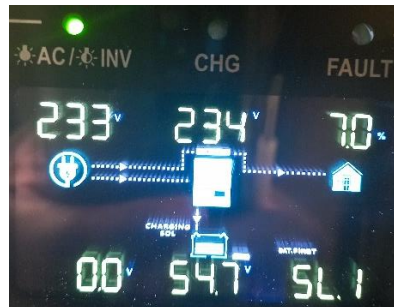
Figure 6: Slave 1 inverter on normal operation

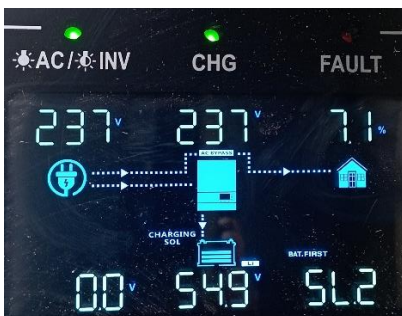
Figure 7: Slave 2 inverter on normal operation

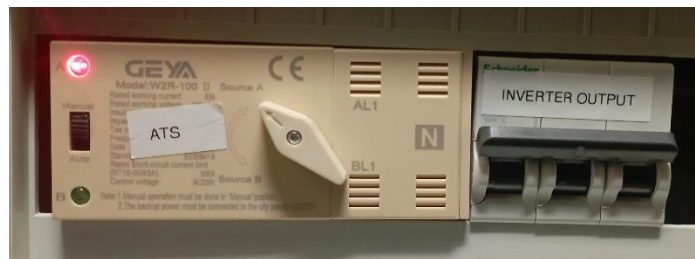
Figure 8: ATS on inverter mode

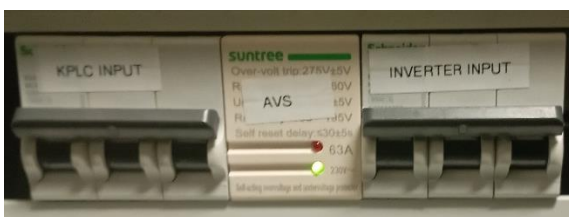
Figure 9: AVS in normal operation
