## EQUITY BACKUP CALL-OUT REPORT

4<sup>th</sup> JANUARY 2025

Site: Equity Bank Nairobi West Branch

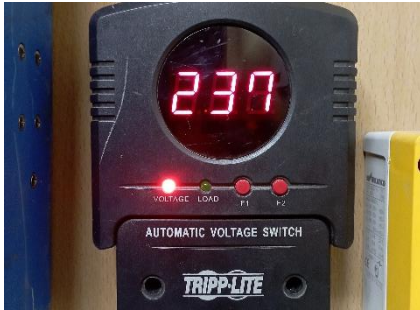
Figure 1: AVS on normal operation

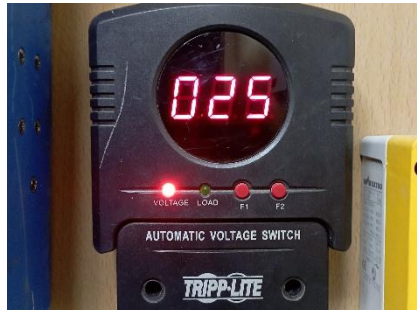
- On arrival, the backup system was ON with loads on inverter mode. The input of the backup system was KPLC
- The AVS was periodically cutting output supply, despite having constant input supply to the AVS.

- The values displayed on the screen of the AVS, were also inconsistent with actual meter readings.
- It was concluded that the AVS was faulty. The AVS was bypassed by directly connecting its input and output supply cables, as a temporary solution.

Figure 2: AVS having an output of 25v yet input supply is constant at 237v

The AVS is faulty. A temporary solution was to bypass it, as it awaits replacement.

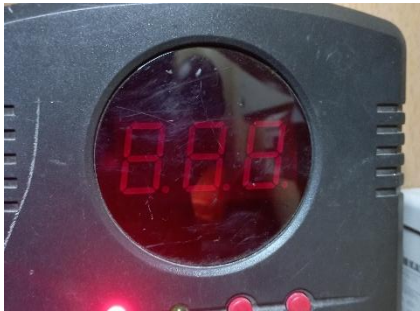
- The inverter and loads were disconnected from the output of the AVS, but the AVS was still periodically cutting output supply despite having no load.

- A blower was connected directly to the output of the AVS, to simulate load, but the blower also periodically switched between on and off states. This confirmed that the issue wasn't arising from the inverter side.

Figure 3: AVS having zero output despite having input supply

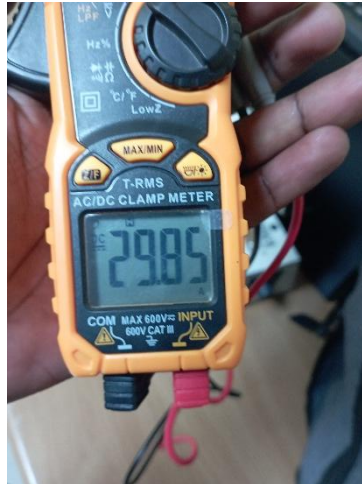
- The inverter was able to support the load using energy from the batteries, in instances when the AVS has no output.
- The batteries were checked and both were in good condition

Figure 4: 29A of current drawn from the batteries while discharging
