Report on the investigation of  
the fatal contact between the dive workboat

***Karin***

and a recreational diver  
in Scapa Flow, Orkney Islands, Scotland  
on 28 September 2023

REPORT NO 16/2025

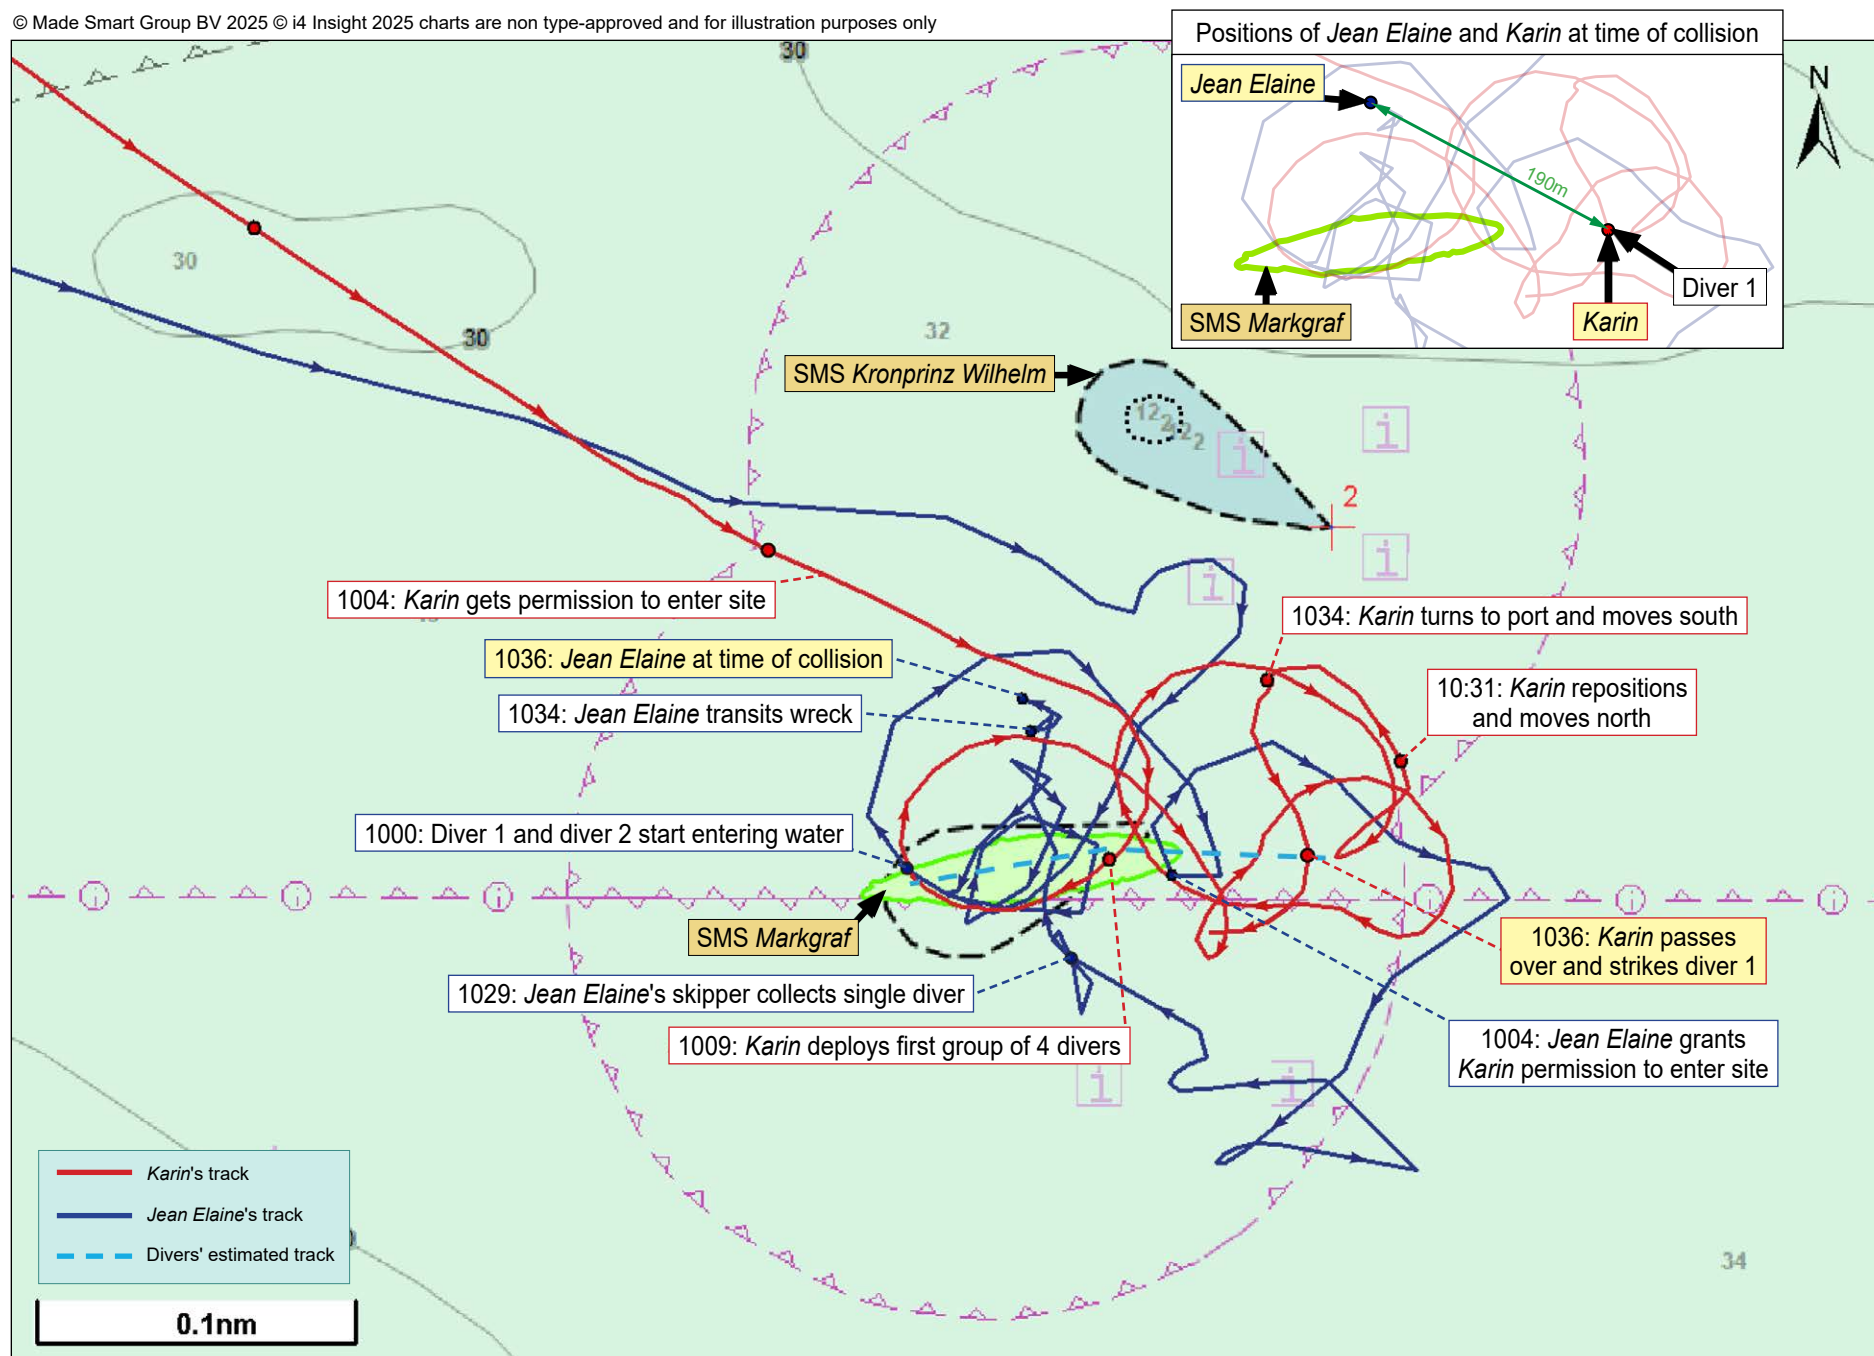
**Figure 3:** *Karin* and *Jean Elaine's* navigational history with estimated track for diver 1 and diver 2

At 1004, *Karin* arrived at the wreck site of *Markgraf*. When the vessel was about 200m from the shot lines (**Figure 3**), *Karin*'s skipper noticed *Jean Elaine* drifting approximately 50m to the east of the wreck location. *Karin*'s skipper called *Jean Elaine* on the very high frequency (VHF) radio and requested permission to enter the site and deploy divers. *Jean Elaine*'s skipper checked for signs of divers and/or bubbles at the shot lines and was satisfied that they were clear. *Jean Elaine*'s skipper granted access to enter and briefed *Karin*'s skipper that they had nine divers on the wreck.

At 1009, *Karin*'s skipper manoeuvred the vessel into position at the stern shot line and, assisted by the deckhand, deployed four of its divers (**Figure 3**). *Karin* then passed over *Jean Elaine*'s nine submerged divers as it crossed to the wreck's bow shot line, where a further four divers were deployed. Two passengers remained on board. *Karin*'s deckhand then went to the galley to prepare lunch for the divers' return. There were now 17 divers in the water, nine from *Jean Elaine* and eight from *Karin*.

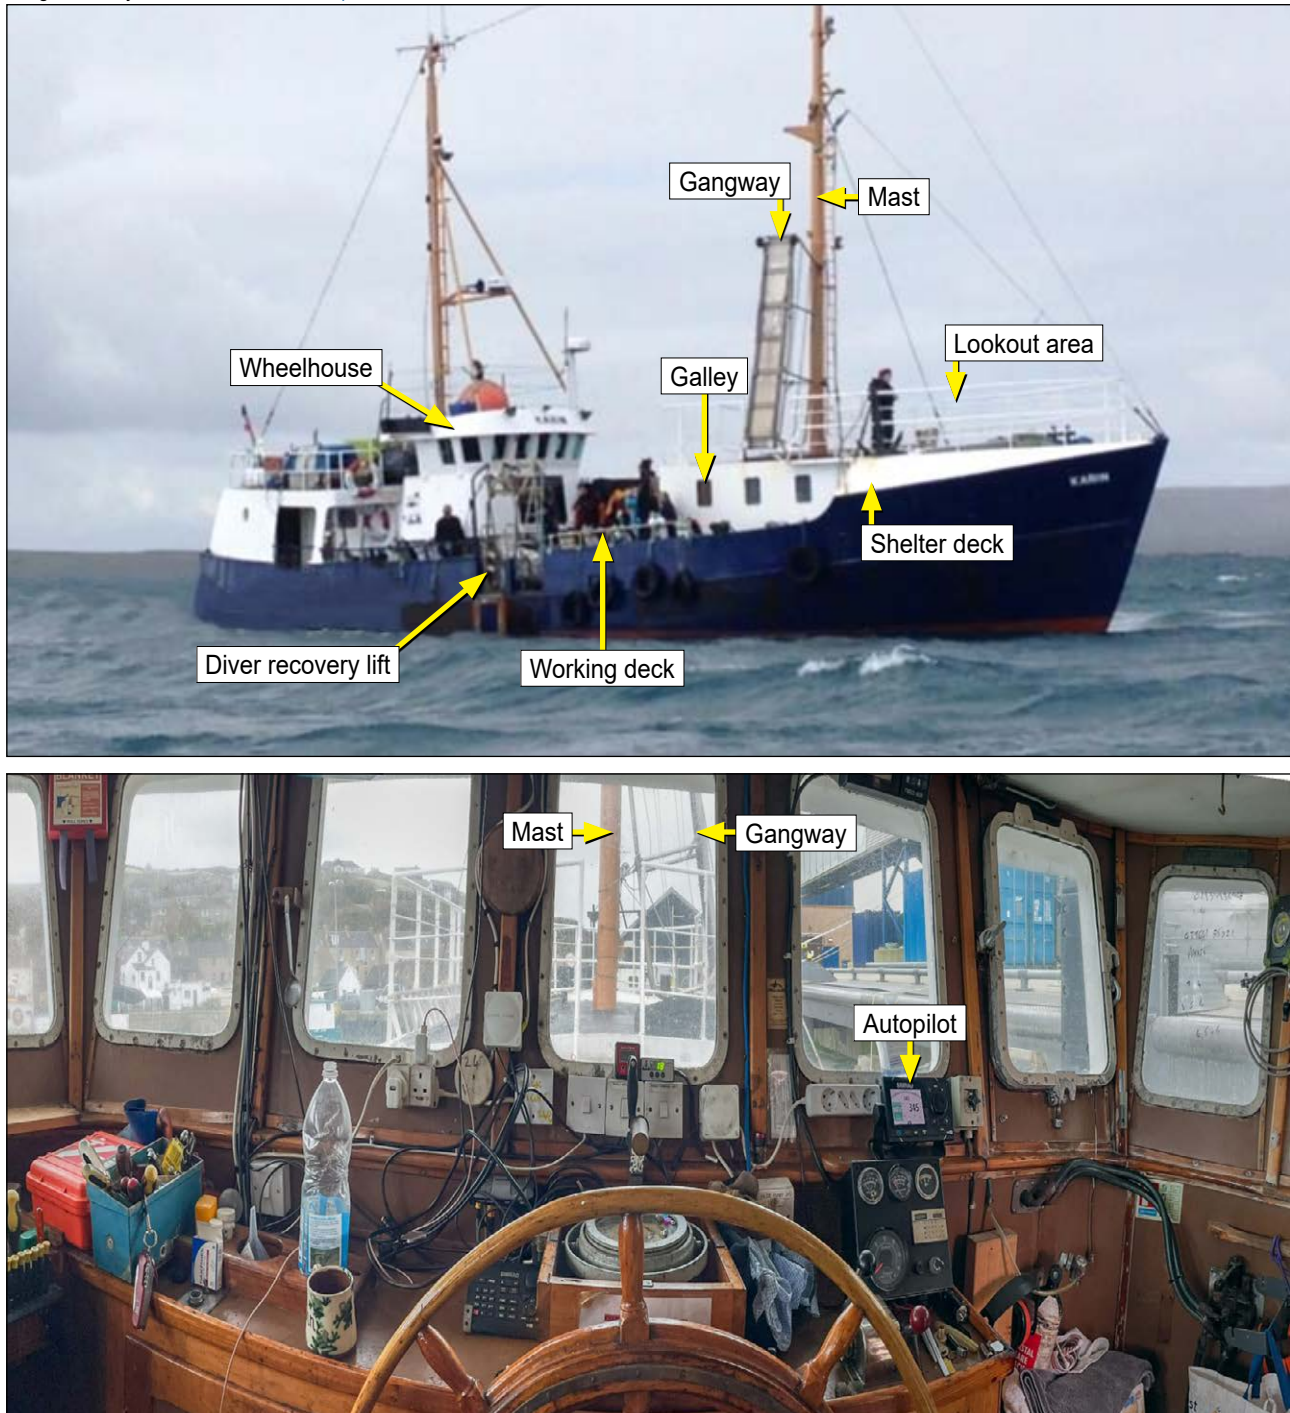
**Figure 5:** *Karin* deck arrangement and composite view of the wheelhouse [images are not from the day of the accident]

*Karin* was propelled by a single, keel-cooled diesel engine connected to a reduction gearbox that drove a four-blade, unguarded, fixed pitch propeller. The engine speed and propulsion direction were controlled by a dual lever cable throttle control unit. The steering was controlled by a single rudder, which was operated by either hand steering via the ship's wheel or the autopilot unit, which was mounted to the right of the wheelhouse central console (Figure 5).

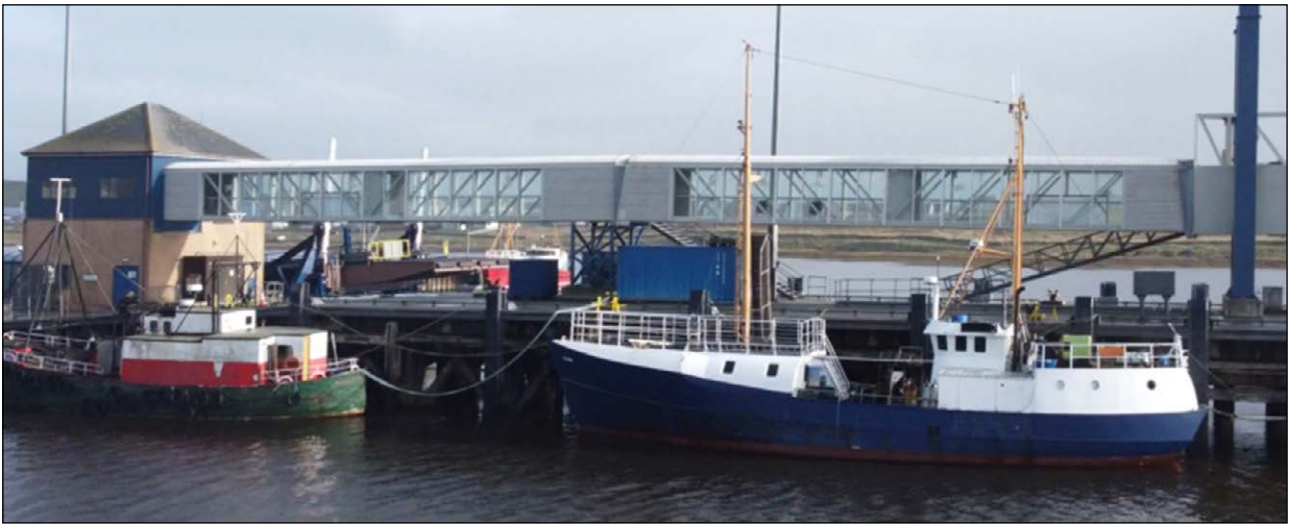
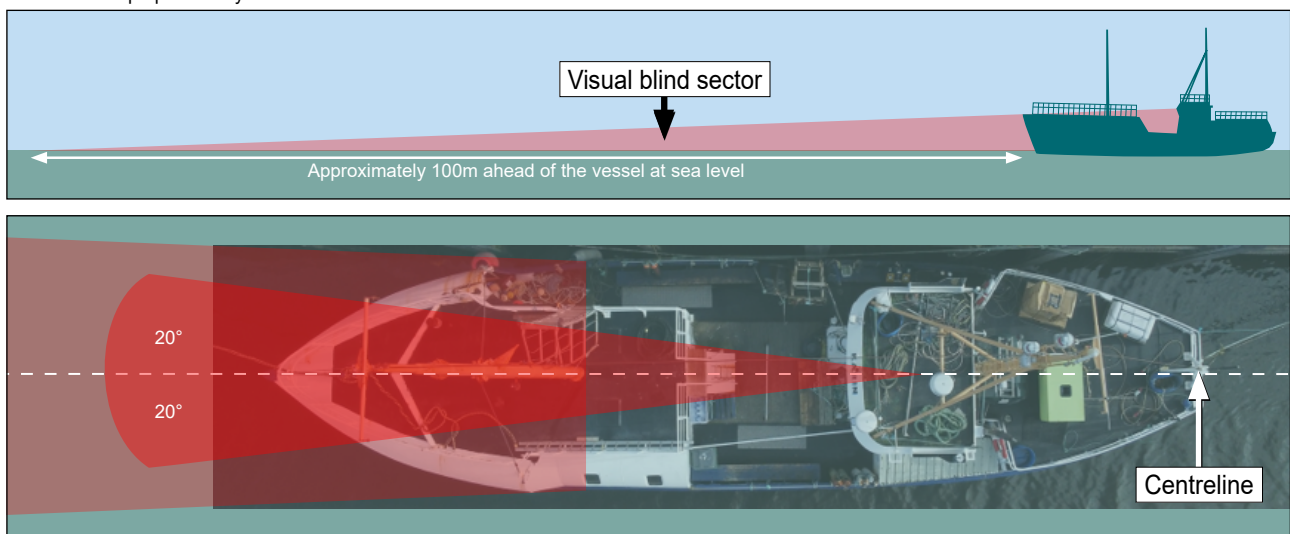
**Figure 6:** Representation of *Karin*'s visual blind sectors

The view from *Karin's* helm position was partially obscured by the 165mm stanchion supports between the five forward-facing windows, the shelter deck areas, the centreline-mounted forward mast and the vessel's gangway, which was stowed in a raised position. The height of the bow impeded forward visibility of the sea surface from the wheelhouse helm station by approximately 100m ahead of the vessel. This visual blind sector covered an area of 20° on each side of the centreline and a total area of 40° (**Figure 6**). *Karin's* skipper would post the deckhand to act as a lookout on top of the forward shelter deck area and relay observations verbally back to the helm when detecting divers in the water, especially when they were within the vessel's visual blind sector.

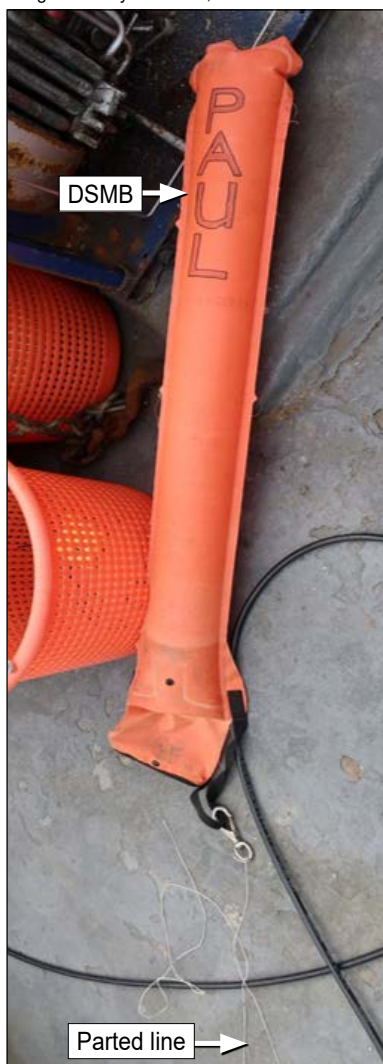
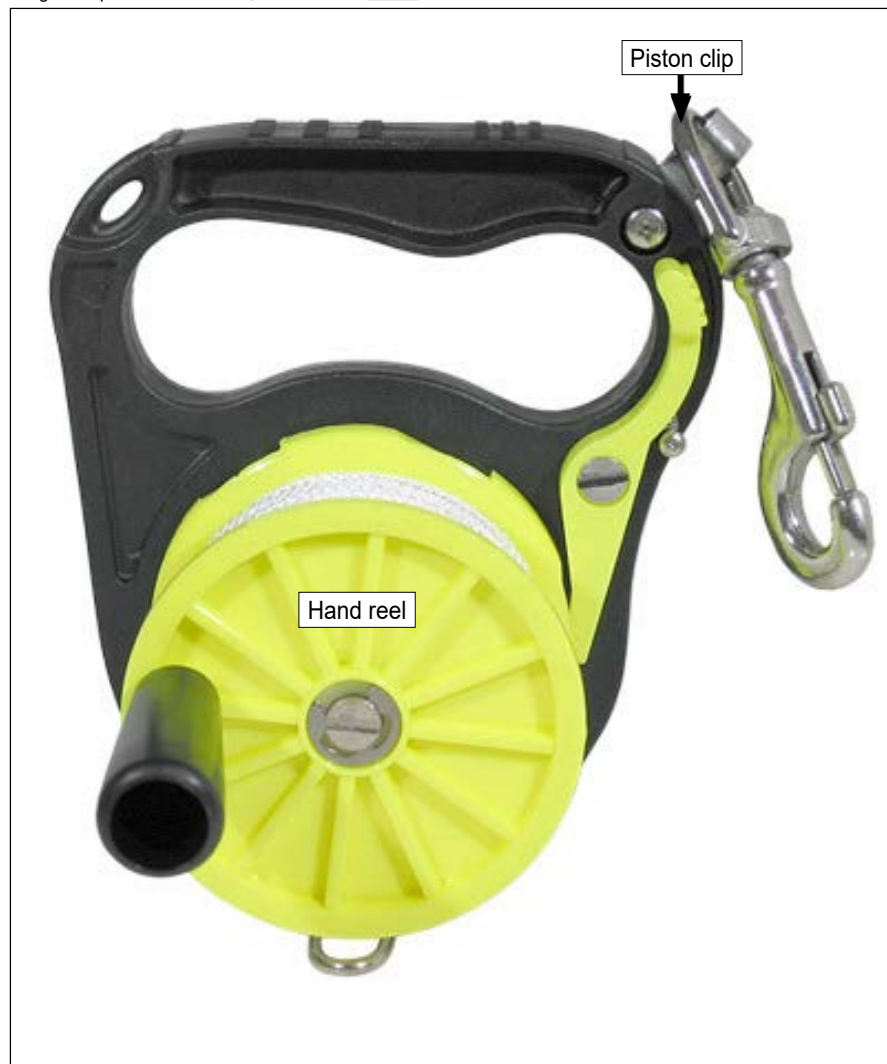
**Figure 2:** Diver 1's marked DSMB with its parted line and hand reel of a similar type to that used by diver 1

The diver and their dive buddy had ascended to their final scheduled decompression stop 3m below the surface. The divers were conducting a drift decompression away from the available shot line<sup>1</sup> but their presence was indicated by their delayed surface marker buoy (DSMB)<sup>2</sup>, the line of which was clipped to the casualty's dive vest (**Figure 2**). The DSMB was visible to the second dive boat waiting on the other side of the wreck site, but it was not sighted by *Karin*'s crew before *Karin* motored over it.

The crew of the second dive boat saw the DSMB disappear under *Karin*. Subsequently, one of the two divers failed to resurface. The coastguard was notified and an extensive 2-day air and sea search of the area was conducted, but without success.

- Divers using a DSMB should hold the line in their hand, as recommended by the British Sub-Aqua Club, rather than attach it to their person. In the event that the DSMB becomes snagged by a passing craft, the diver can then release the line to avoid entanglement and potentially being drawn to the surface or into contact with the craft.
