NARRATIVE REPORT

DWELLING / UNIT OWNER

Carrier:	Hartford Fire Insurance Company	Date of Loss:	10/10/2024
Insured:	GUY CARPENTER	Assigned:	10/10/2024
CID:	241216	Contacted:	10/10/2024
Claim Number:	560246	Inspected:	10/21/2024
Policy Number:	6500357167	Inspected With:	Guy and Cheryl Carpenter, Policyholders
Loss Address:	2808 SHANNON DR PUNTA GORDA FL 33950-2319	Mailing Address:	2808 SHANNON DR PUNTA GORDA FL 33950-2319
Coverage A:	\$ 217,000.00	Mortgage:	FIRST FLORIDA CREDIT UNION
Coverage B:	\$ 100,000.00	Verified with:	GUY CARPENTER, POLICYHOLDER
Policy Term:	7/6/2024 to 7/6/2025		
Risk:		Valuation:	
DOC:	1/1/1975	RCV Building:	\$223,576.21
FIRM:	9/19/1975	ACV Building:	\$205,255.27
Pre/Post:	Pre-FIRM	Qualification:	
Elevated:	Not Elevated	Type:	Single Family
Zone:	AE	Occupancy:	Owner occupied (Principal residence)
Foundation:	Concrete slab-on-grade	Insured to Value %:	96%
Basement:	No	Replacement Cost:	Yes
Ext. Finish:	Stucco

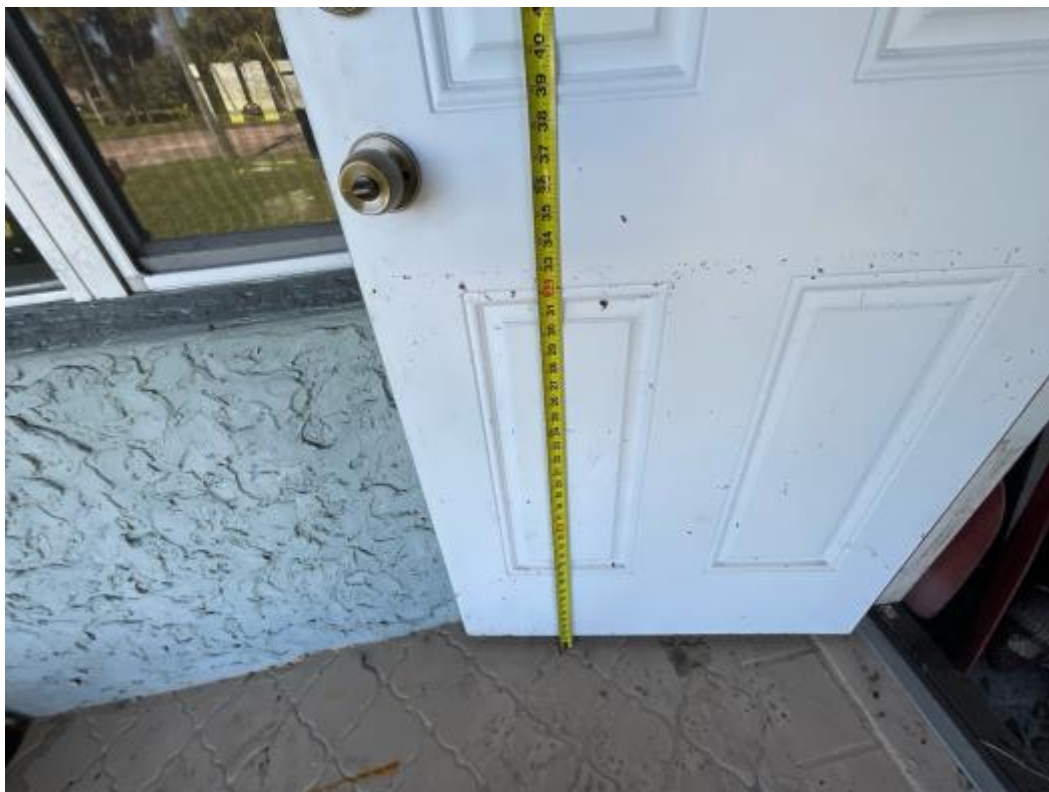
16-Exterior Waterline

Exterior Water Height:	32"
Interior Water Height:	25"

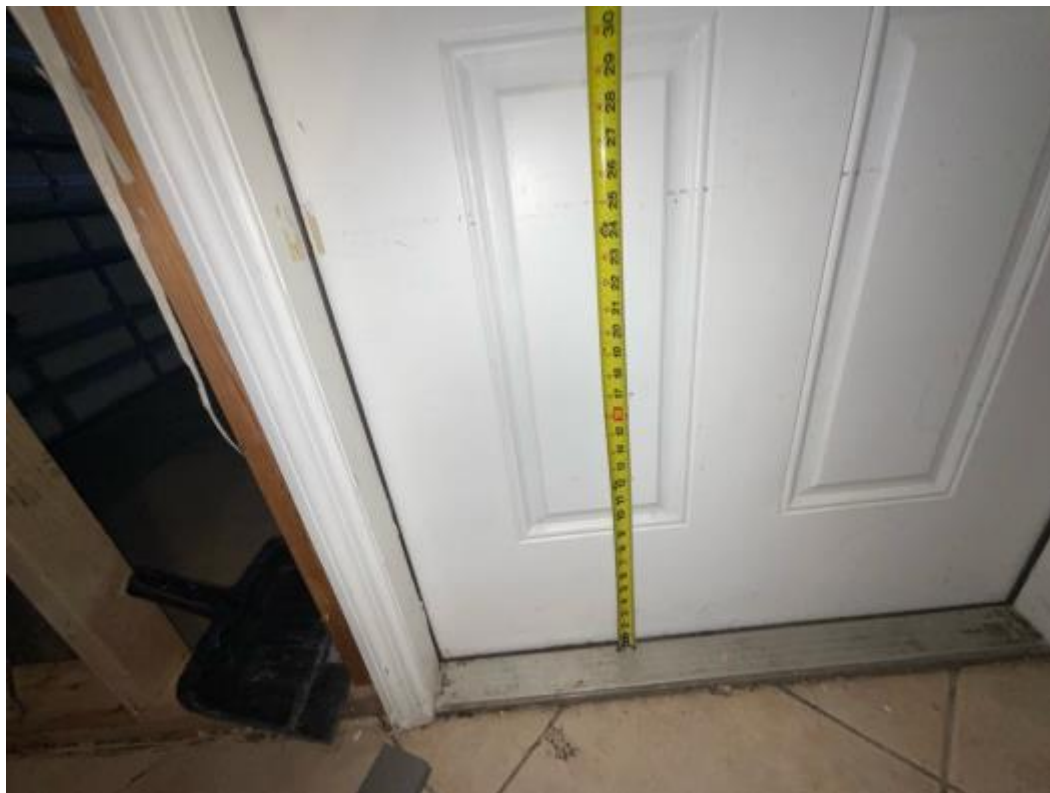
150-Interior Water Line

Interior water line 25"

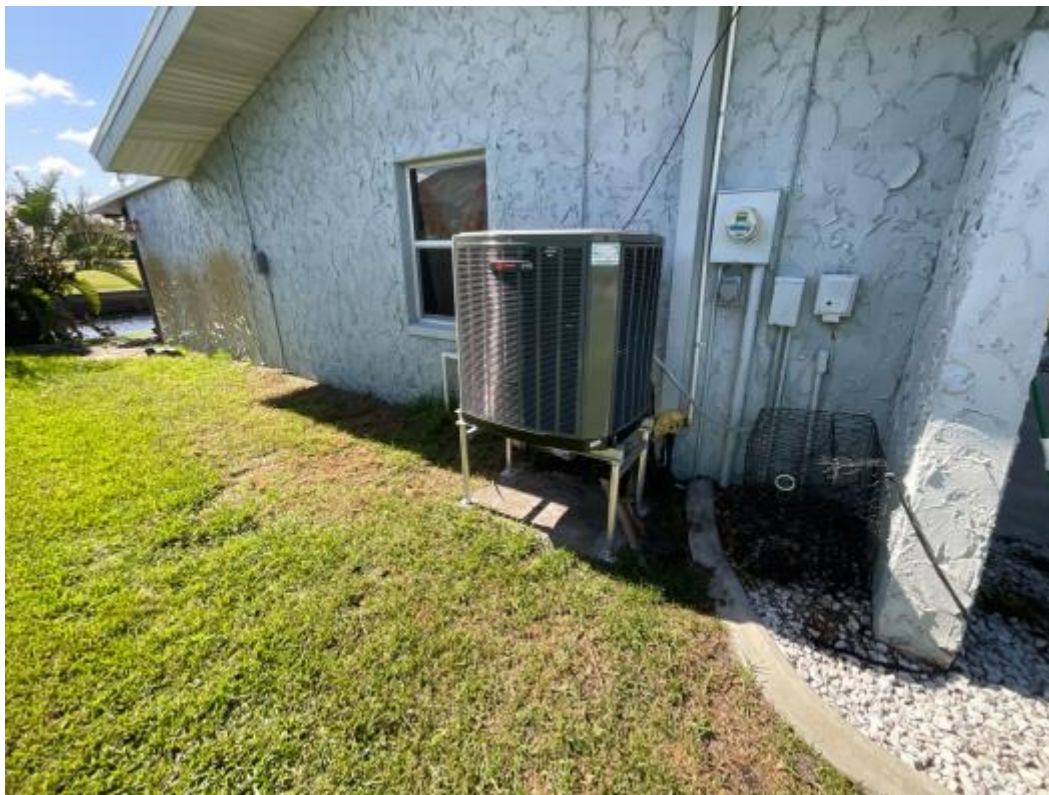
4-A/C Condenser Unit

Policyholder replaced condenser unit after Milton and had the unit raised.

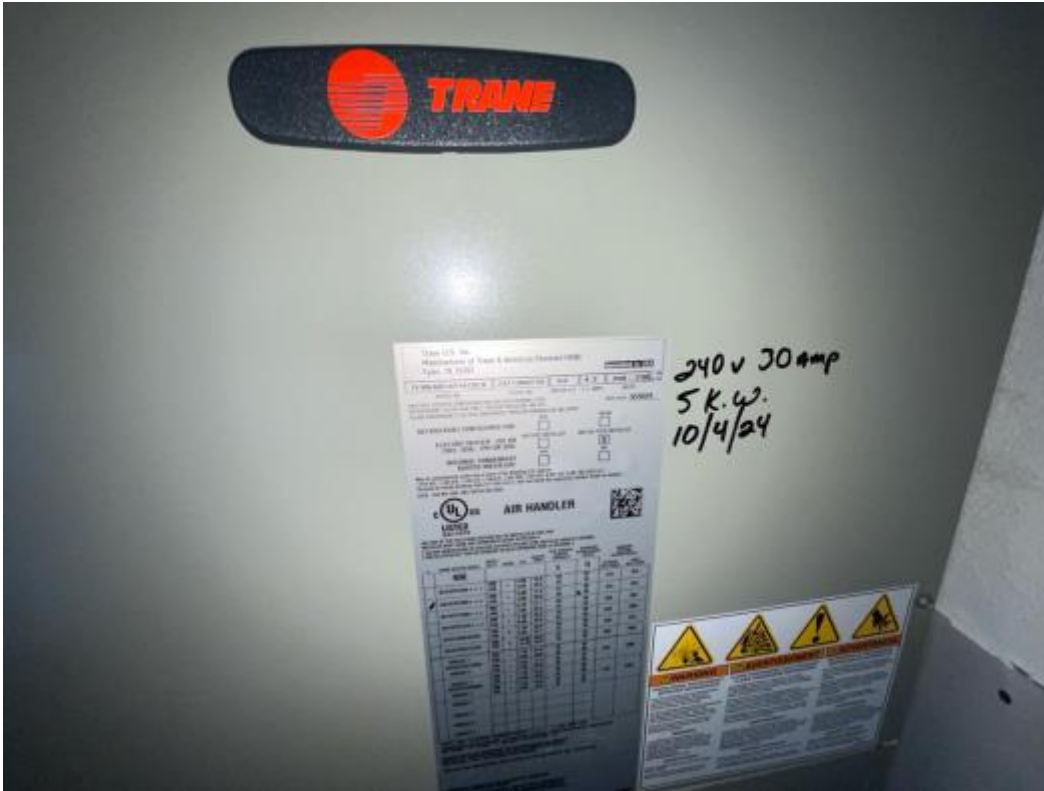
33-AC Air handle

Policyholder replaced the air handle unit after Milton .

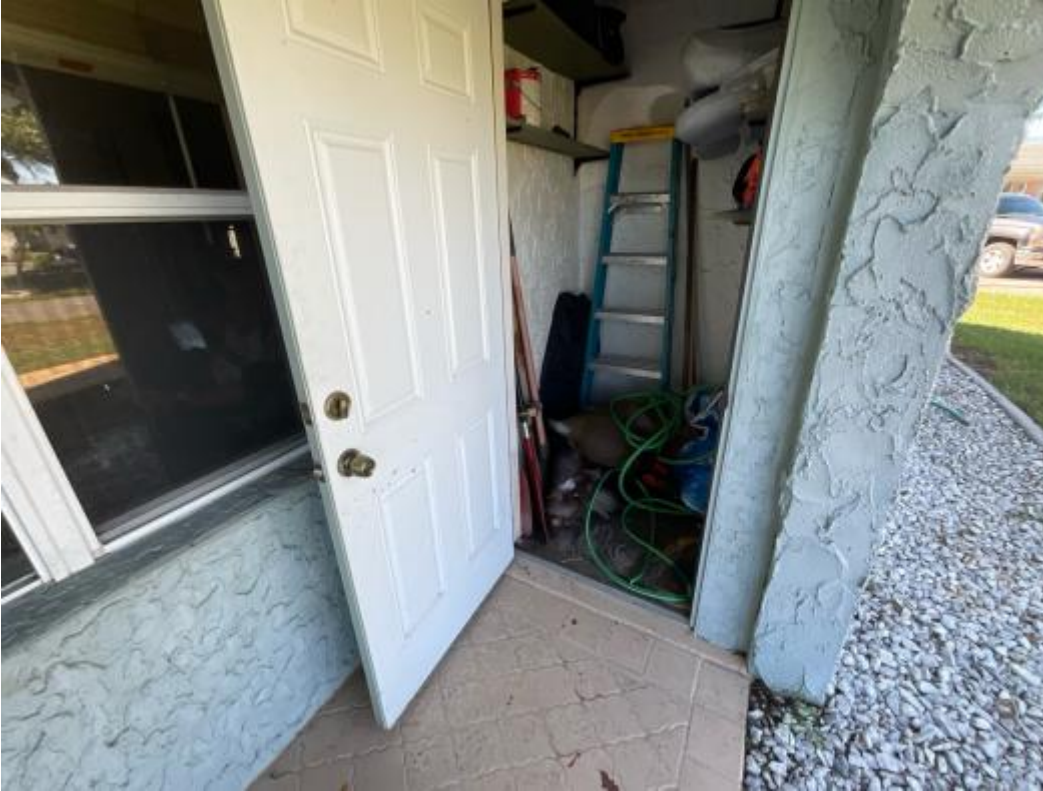
12-Ground Level Storage Room

Please note mud residue remaining on the interior of the storage room.

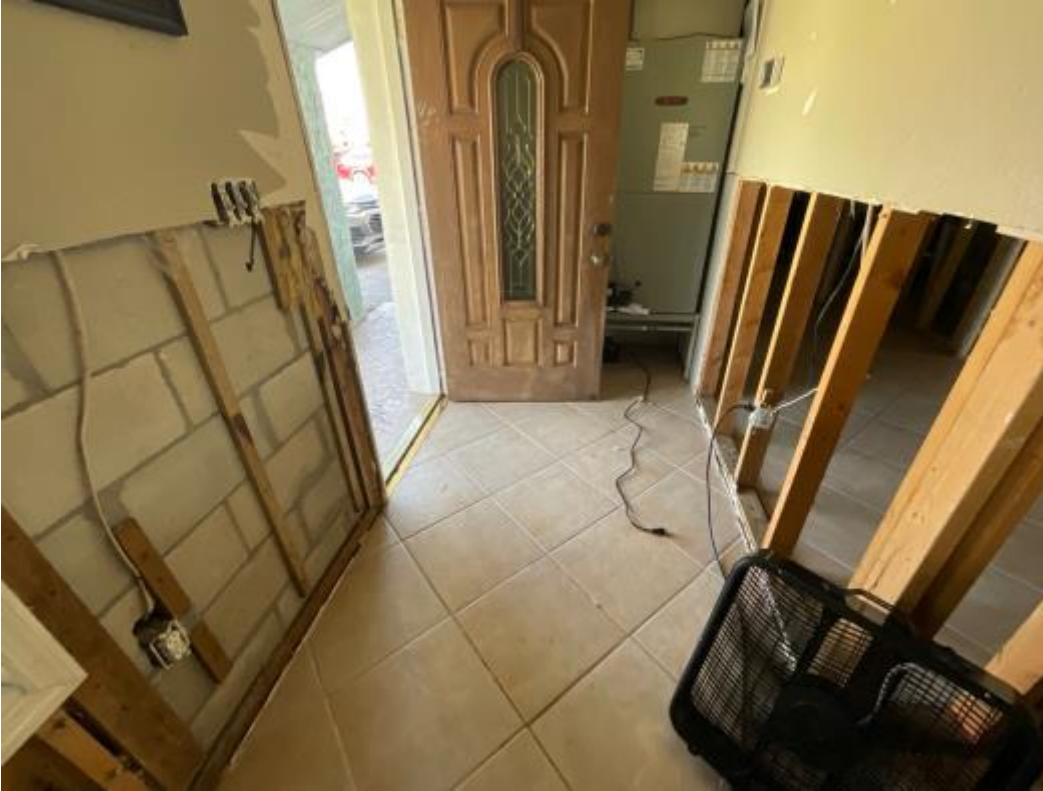
22-Entrance Into Dwelling

The air handler was replaced after Helene. A portion of it was submerged in water during flood event. Front door is swollen and not closing properly.

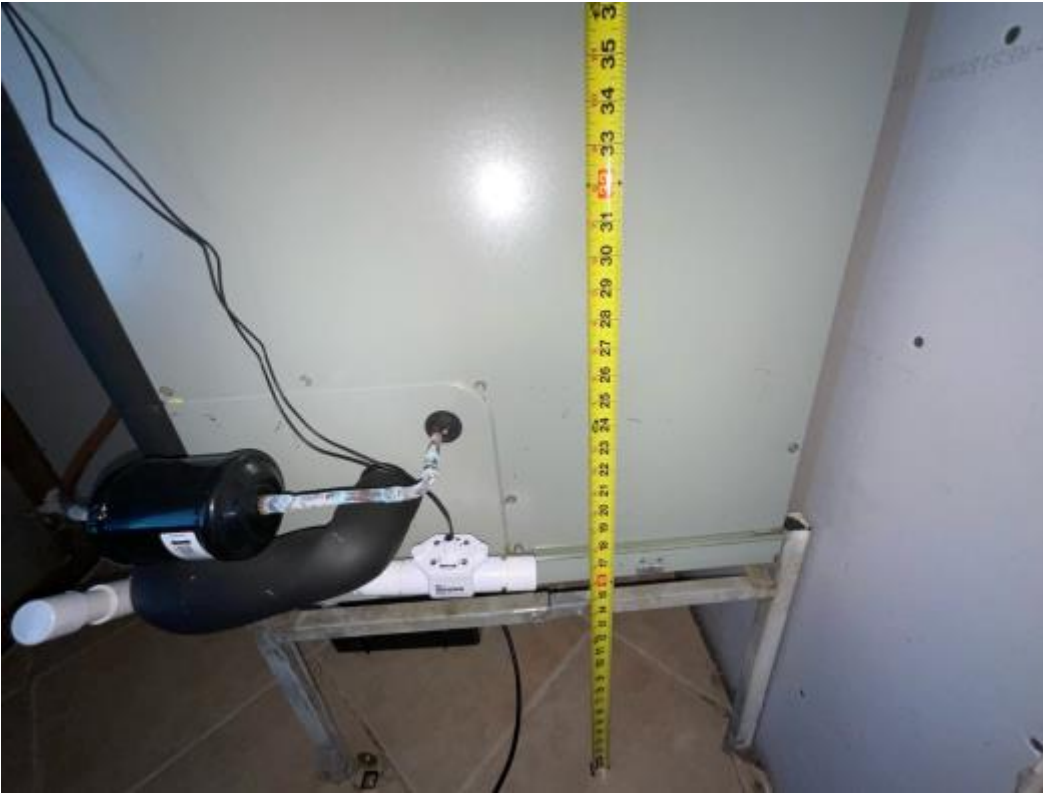
35-Air Handler

Tape measure shows interior waterline of 22 inches.
Portion of newly installed air handler was submerged in floodwater.

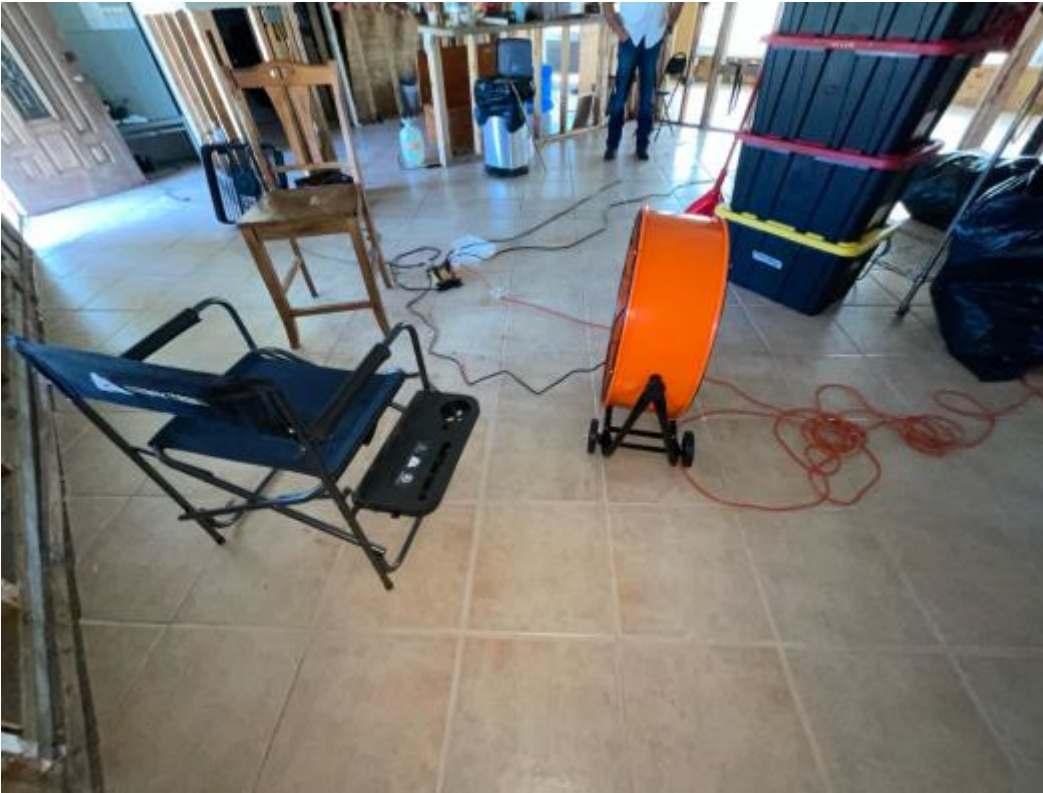
41-Living Room

Adjuster has uploaded video showing the Movement in the tile flooring which indicates separation between the slab and the tiles.

- Clean tile flooring with orbital scrubber and seal grout with 2 coats per industry standards.

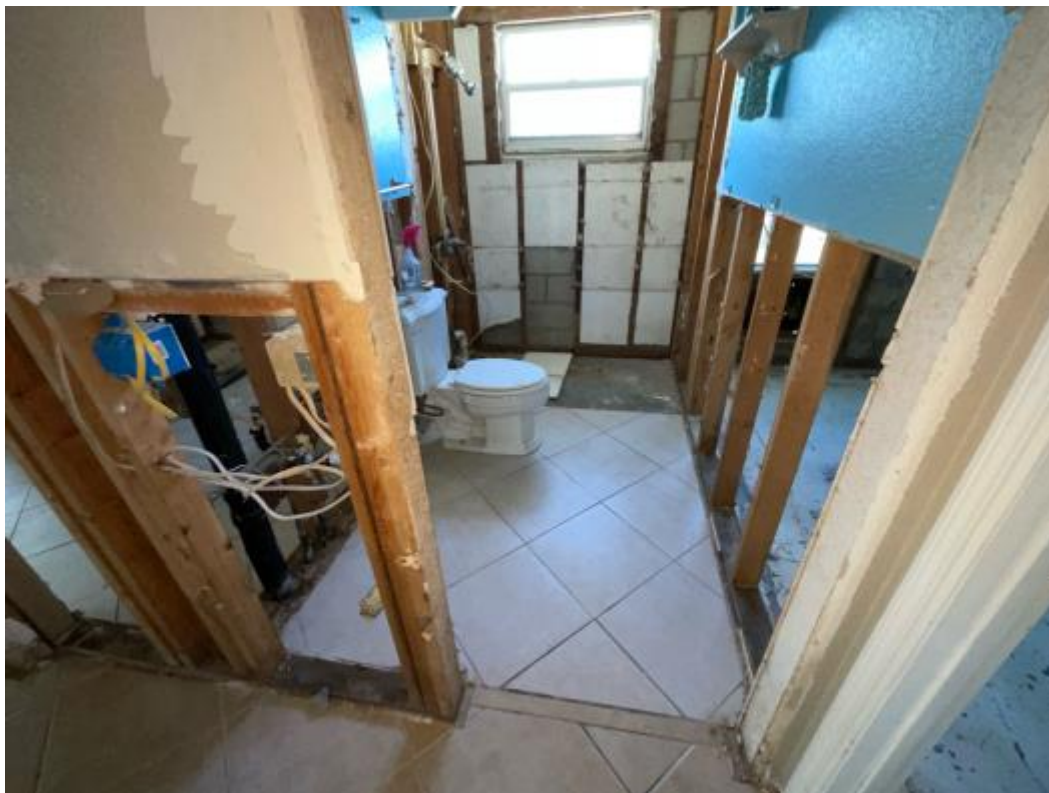
54-Hallway Bathroom

Jetted tub in hallway bathroom had to be removed to dry out the wall behind it.

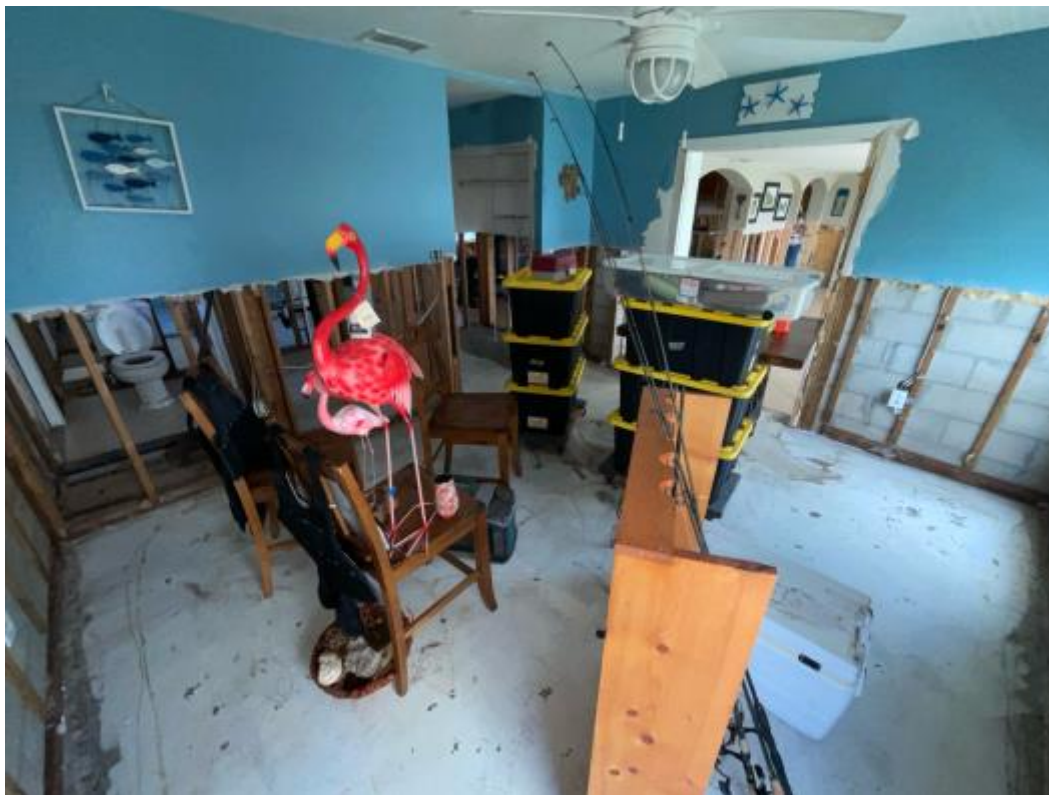
82-Dining Room

Overview of room
Interior waterline 22 inches
Four foot gut in this room.
