Unnamed tributary		co-0812-r-001	Sedimentation Risk Index 40																																																																		
<u>Common:</u> 7.6mi NW of Florala <u>Drainage:</u> North Creek <u>GPS:</u> 31.090967, -86.406400 <u>Land owner:</u> J.N & A.B. Heisler Heirs		<u>County:</u> Covington <u>State:</u> Alabama <u>PLSS (T-R-S):</u> 2N-16E-36 <u>Parcel No.:</u> 6 <u>Road Name:</u> Laird Rd

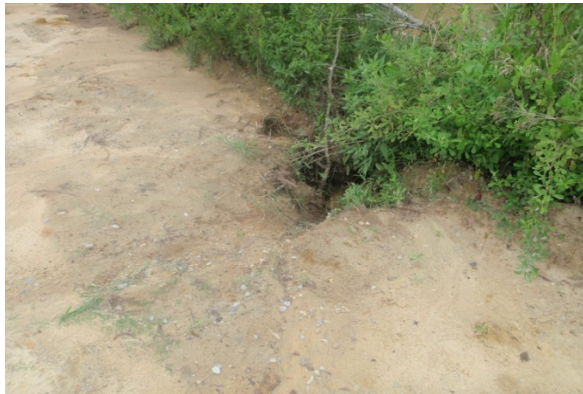
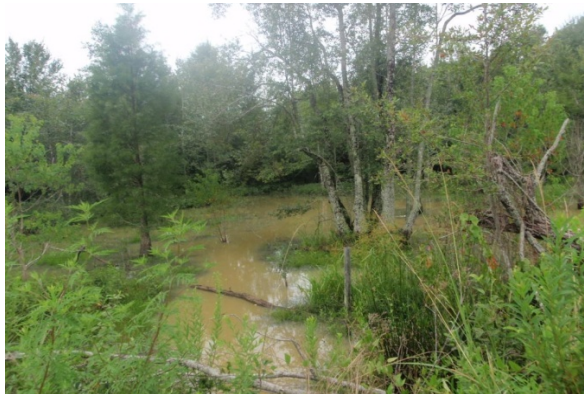
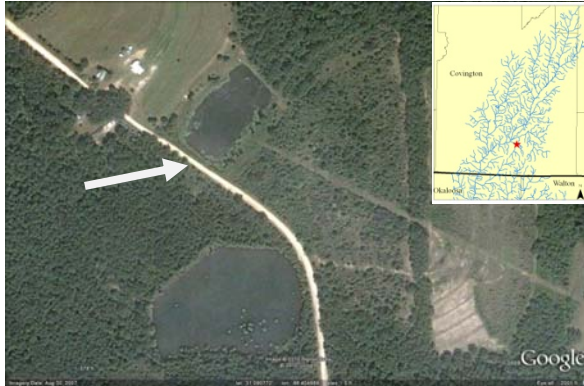
Notes: DS road erosion leading into wetland. Rock placed in US channel. Looks like there should be a culvert
