Unnamed tributary		co-0831-r-002	Sedimentation Risk Index 44																																																																		
<u>Common:</u> 8.5mi N of Florala <u>Drainage:</u> Beaver Creek <i>GPS:</i> 31.128261, -86.309600 <u>Land owner:</u> Rayonier Forest Resources LP		<u>County:</u> Covington <u>PLSS (T-R-S):</u> 2N-17E-24 <u>Parcel No.:</u> 1 <u>Road Name:</u> Johnson's Quarters	<u>State:</u> Alabama

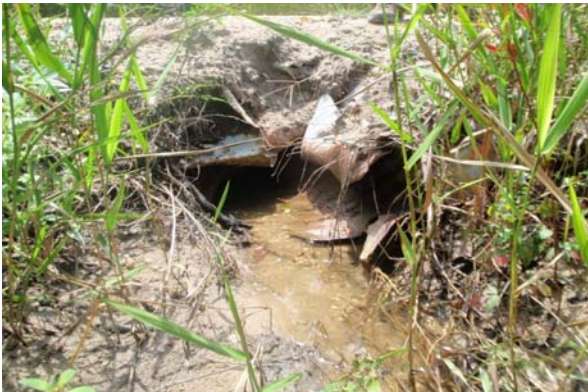
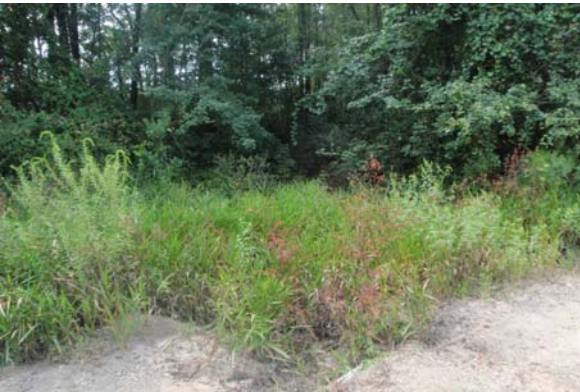
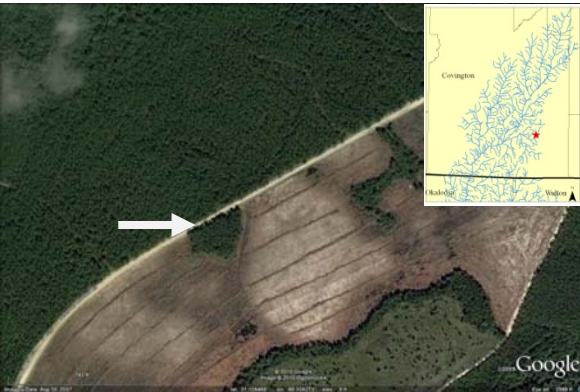
Notes: Culvert crushed
