Unnamed tributary		ok-0407-r-001	Sedimentation Risk Index 48
<u>Common:</u> 8.3mi SW of Crestview <u>Drainage:</u> Turkey Gobbler Creek <u>GPS:</u> 30.646942, -86.616639 <u>Land owner:</u> US Government- Eglin AFB		<u>County:</u> Okaloosa <u>State:</u> Florida <u>PLSS(T-R-S):</u> 2N-24-19 <u>Parcel No.:</u> 1 <u>Road Name:</u> RR 215 Eglin AFB

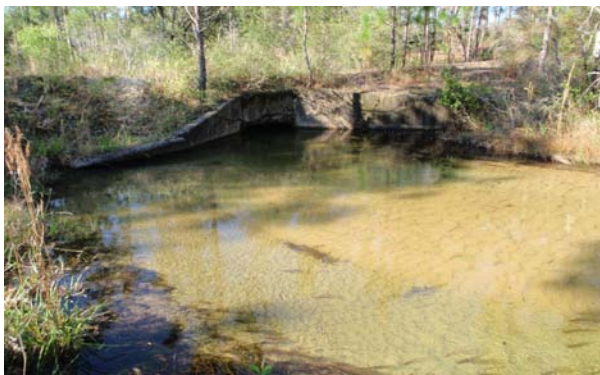
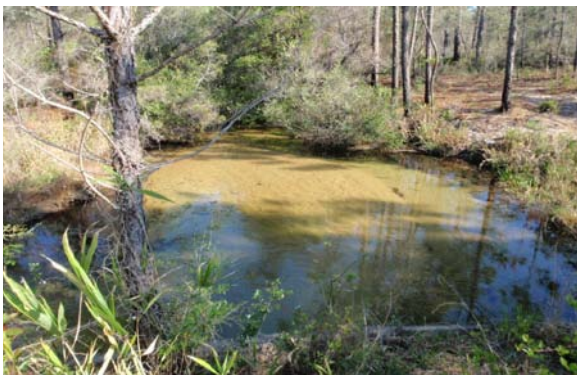
Crossing Structure- US		US	
Risk Factor	Ranking	Score	
US Channel Morph	C	5	
DS Channel Morph	C	5	
DS Bank Alteration	MINOR/PARTIAL	3	
Upstream Skew Angle	<5°	5	
Crossing fill condition	Good/Vegetated	5	
Inlet/Outlet Condition	No Impairment	5	
Road Approach Material	All Aggregate	5	
Potential Eroded Volume Mean	<21 y ³	5	
Approach Slope Mean	>4%	1	
Soil K Factor	<0.20	5	
Upstream Rt Outlet	Concrete	0	
Upstream Lt Outlet	Concrete	0	
Upstream Rt Ditch	Concrete	0	
Upstream Lt Ditch	Concrete	0	
Downstream Rt Outlet	Vegetated	1	
Downstream Lt Outlet	Concrete	0	
Downstream Rt Ditch	Bare soil	0

Downstream Lt Ditch	Concrete	0	
Outlet Total	Partially Improved Outlet System	3	
Ditches Total	Unimproved Drainage System	1	
SRI Total	Low Risk	48	
Additional Site Features <u>Crossing Type and Quantity:</u> Culvert, 1 <u>Crossing Materials:</u> Reinforced Concrete <u>Soil Types:</u> 12,13,25 <u>Rt Approach Prism Fill:</u> 0.25in <u>Lt Approach Prism Fill:</u> 0.25in

Notes: Both approaches paved hilltop to hilltop
