Unnamed tributary		co-0731-r-006	Sedimentation Risk Index <b>36</b>																																																																		
<u>Common:</u> 3.9mi NW of Florala <u>Drainage:</u> Horsehead Creek <u>GPS:</u> 30.997012, -86.499121 <u>Land owner:</u> Rayonier Forest Resources LP		<u>County:</u> Covington <u>State:</u> Alabama <u>PLSS (T-R-S):</u> 1N-17E-19/30 <u>Parcel No.:</u> 1 <u>Road Name:</u> Union Church Rd

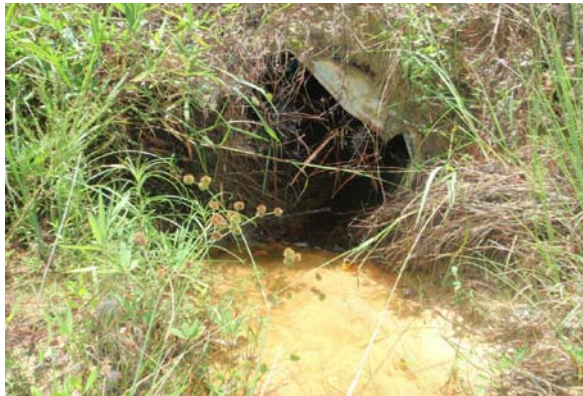
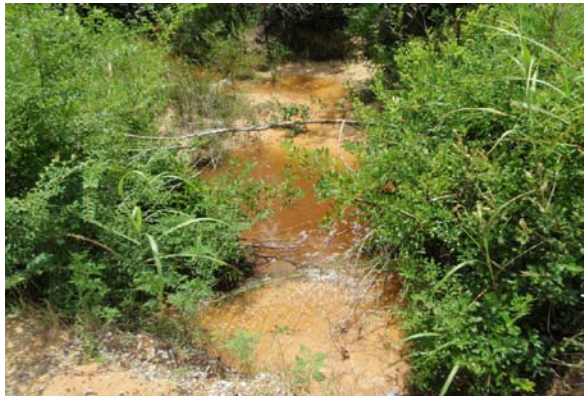
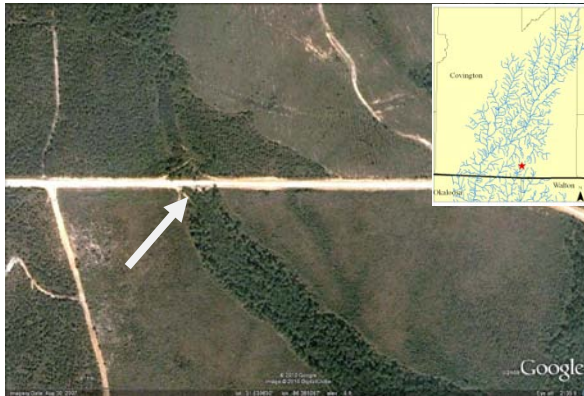
Crossing Structure: US		DS																																																																			
<table border="1"> <thead> <tr> <th>Risk Factor</th> <th>Ranking</th> <th>Score</th> </tr> </thead> <tbody> <tr><td>US Channel Morph</td><td>E</td><td>5</td></tr> <tr><td>DS Channel Morph</td><td>E</td><td>5</td></tr> <tr><td>DS Bank Alteration</td><td>HIGH</td><td>1</td></tr> <tr><td>Upstream Skew Angle</td><td>&lt;5°</td><td>5</td></tr> <tr><td>Crossing fill condition</td><td>Poor/Bare soil</td><td>1</td></tr> <tr><td>Inlet/Outlet Condition</td><td>Sed Islands/Scouring</td><td>3</td></tr> <tr><td>Road Approach Material</td><td>All Sand/Clay</td><td>3</td></tr> <tr><td>Potential Eroded Volume Mean</td><td>&gt;40 y<sup>3</sup></td><td>1</td></tr> <tr><td>Approach Slope Mean</td><td>2.1-4%</td><td>3</td></tr> <tr><td>Soil K Factor</td><td>&lt;0.20</td><td>5</td></tr> <tr><td>Upstream Rt Outlet</td><td>Vegetated</td><td>1</td></tr> <tr><td>Upstream Lt Outlet</td><td>Vegetated</td><td>1</td></tr> <tr><td>Upstream Rt Ditch</td><td>Bare soil</td><td>0</td></tr> <tr><td>Upstream Lt Ditch</td><td>Bare soil</td><td>0</td></tr> <tr><td>Downstream Rt Outlet</td><td>Bare soil</td><td>0</td></tr> <tr><td>Downstream Lt Outlet</td><td>Bare soil</td><td>0</td></tr> <tr><td>Downstream Rt Ditch</td><td>Bare soil</td><td>0</td></tr> <tr><td>Downstream Lt Ditch</td><td>Bare soil</td><td>0</td></tr> <tr><td>Outlet Total</td><td>Partially Improved Outlet System</td><td>3</td></tr> <tr><td>Ditches Total</td><td>Unimproved Drainage System</td><td>1</td></tr> <tr><td><b>SRI Total</b></td><td><b>High Risk</b></td><td><b>36</b></td></tr> </tbody> </table>		Risk Factor	Ranking	Score	US Channel Morph	E	5	DS Channel Morph	E	5	DS Bank Alteration	HIGH	1	Upstream Skew Angle	<5°	5	Crossing fill condition	Poor/Bare soil	1	Inlet/Outlet Condition	Sed Islands/Scouring	3	Road Approach Material	All Sand/Clay	3	Potential Eroded Volume Mean	>40 y <sup>3</sup>	1	Approach Slope Mean	2.1-4%	3	Soil K Factor	<0.20	5	Upstream Rt Outlet	Vegetated	1	Upstream Lt Outlet	Vegetated	1	Upstream Rt Ditch	Bare soil	0	Upstream Lt Ditch	Bare soil	0	Downstream Rt Outlet	Bare soil	0	Downstream Lt Outlet	Bare soil	0	Downstream Rt Ditch	Bare soil	0	Downstream Lt Ditch	Bare soil	0	Outlet Total	Partially Improved Outlet System	3	Ditches Total	Unimproved Drainage System	1	<b>SRI Total</b>	<b>High Risk</b>	<b>36</b>

Notes: Undersized culvert.
