Yellow River			ok-0416-001		Severity Score 4
<u>Common:</u> 6.2mi SW of Crestview <u>Drainage:</u> Blackwater Bay <u>GPS:</u> 30.703051848, -86.65072881 <u>Land owner:</u> NFWFMD			<u>County:</u> Okaloosa <u>State:</u> Florida <u>PLSS(T-R-S):</u> 2N-24W-4 <u>Parcel No.:</u> 1

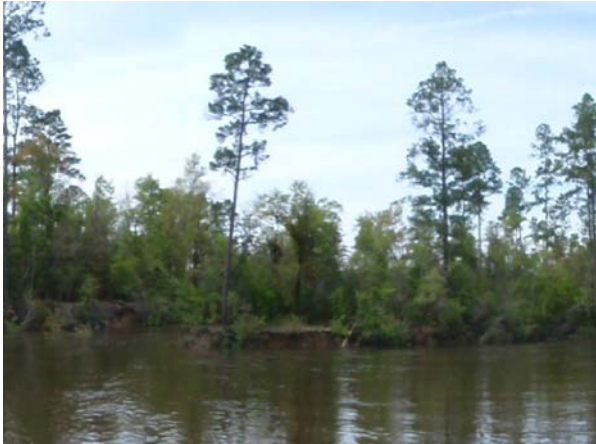
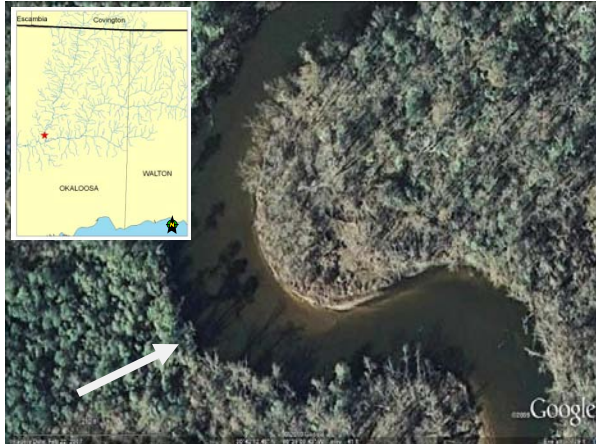
RB					
Risk Factor	Ranking	Score	Feature	Within Range	Descriptive Field
Channel Stability	Fair	1.5	303(d)	Yes	COLIFORMS, TURBIDITY, MERCURY
Channel Alteration	None	0	Wetland Species	Yes	1-3 FOCAL SPECIES IN UPLAND AREAS
Bank Erosion	Mass Wasting	1.5	Rare and Imperiled	Yes	ALABAMA SHAD, ALLIGATOR GAR, BLUENOSE SHINER, GULF STURGEON, SPECKLED CHUB, IRONCOLOR SHINER, SPOTTED BULLHEAD, SPECKLED DARTER
BEHI	High	1	Land Use/Cover	Yes	N/A / STREAMS AND WATERWAYS
Local NPSP	No Evidence	0	Candidate Mussels	No	N/A
Shoring Structures	Not Present	0	Sturgeon C.H.	Yes	N/A
Pipe Discharge	Not Present	0	Additional Site Features

Notes: Data collected during flood stage- receding.

Private/primitive road 0.08mi west of the documented site, with a path leading to the river's edge

Since this occurs on an outside bend, it is likely that the erosion is mostly natural, with some contribution from the nearby path.
