Yellow River		co-0807-004	Severity Score 1.75																																																																																
<u>Common:</u> 7.5mi SE of Libertyville <u>Drainage:</u> Blackwater Bay <u>GPS:</u> 31.141633378, -86.408140513 <u>Land owner:</u> RB: USA/ LB: James & Patricia Caton		<u>County:</u> Covington <u>State:</u> Alabama <u>PLSS:</u> 2N-16E-13 <u>Parcel No.:</u> 2/3

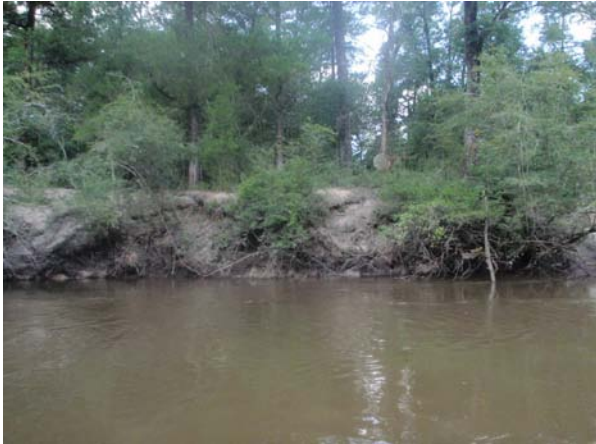
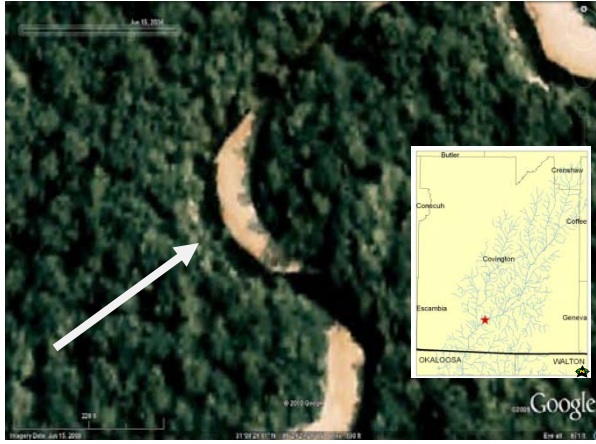
RB																																																																																			
<table border="1"> <thead> <tr> <th>Risk Factor</th> <th>Ranking</th> <th>Score</th> </tr> </thead> <tbody> <tr><td>Channel Stability</td><td>Good</td><td>0.5</td></tr> <tr><td>Channel Alteration</td><td>None</td><td>0</td></tr> <tr><td>Bank Erosion</td><td>Historic</td><td>0.5</td></tr> <tr><td>BEHI</td><td>Moderate</td><td>0.5</td></tr> <tr><td>Local NPSP</td><td>No Evidence</td><td>0</td></tr> <tr><td>Shoring Structures</td><td>Not Present</td><td>0</td></tr> <tr><td>Pipe Discharge</td><td>Not Present</td><td>0</td></tr> <tr><td>Water Odors</td><td>Not Present</td><td>0</td></tr> <tr><td>Fish Passage Barrier</td><td>Not Present</td><td>0</td></tr> <tr><td>RB: Riparian Buffer</td><td>100+ ft</td><td>0</td></tr> <tr><td>LB: Riparian Buffer</td><td>100+ ft</td><td>0</td></tr> <tr><td>RB: Floodplain Access</td><td>Partial</td><td>0.25</td></tr> <tr><td>LB: Floodplain Access</td><td>Full</td><td>0</td></tr> <tr><td><b>River Threat Index:</b></td><td></td><td><b>1.75</b></td></tr> </tbody> </table>	Risk Factor	Ranking	Score	Channel Stability	Good	0.5	Channel Alteration	None	0	Bank Erosion	Historic	0.5	BEHI	Moderate	0.5	Local NPSP	No Evidence	0	Shoring Structures	Not Present	0	Pipe Discharge	Not Present	0	Water Odors	Not Present	0	Fish Passage Barrier	Not Present	0	RB: Riparian Buffer	100+ ft	0	LB: Riparian Buffer	100+ ft	0	RB: Floodplain Access	Partial	0.25	LB: Floodplain Access	Full	0	<b>River Threat Index:</b>		<b>1.75</b>	<table border="1"> <thead> <tr> <th>Feature</th> <th>Within Range</th> <th>Descriptive Field</th> </tr> </thead> <tbody> <tr><td>303(d)</td><td>No</td><td>N/A</td></tr> <tr><td>Wetland Species</td><td>No</td><td>N/A</td></tr> <tr><td>Rare and Imperiled</td><td>No</td><td>N/A</td></tr> <tr><td>Land Use/Cover</td><td>Yes</td><td>N/A/ UPLAND LONGLEAF PINE WOODLAND - OPEN UNDERSTORY MODI</td></tr> <tr><td>Candidate Mussels</td><td>No</td><td>N/A</td></tr> <tr><td>Sturgeon C.H.</td><td>No</td><td>N/A</td></tr> <tr> <td colspan="2"><b>Additional Site Features</b></td> <td></td> </tr> <tr> <td colspan="2"><u>Stream Channel Woody Material:</u></td> <td>Moderate</td> </tr> <tr> <td colspan="2"><u>Impoundments:</u></td> <td>None</td> </tr> <tr> <td colspan="2"><u>Substrate Composition:</u></td> <td>Medium Sand</td> </tr> <tr> <td colspan="2"><u>Bank Material:</u></td> <td>Sand</td> </tr> </tbody> </table>		Feature	Within Range	Descriptive Field	303(d)	No	N/A	Wetland Species	No	N/A	Rare and Imperiled	No	N/A	Land Use/Cover	Yes	N/A/ UPLAND LONGLEAF PINE WOODLAND - OPEN UNDERSTORY MODI	Candidate Mussels	No	N/A	Sturgeon C.H.	No	N/A	<b>Additional Site Features</b>			<u>Stream Channel Woody Material:</u>		Moderate	<u>Impoundments:</u>		None	<u>Substrate Composition:</u>		Medium Sand	<u>Bank Material:</u>		Sand
