Unnamed tributary		co-0810-r-021	Sedimentation Risk Index 40																																																																		
<u>Common:</u> 12.6mi SW of Andalusia <u>Drainage:</u> Persimmon Creek <u>GPS:</u> 31.139772, -86.567758 <u>Land owner:</u> USA-Conecuh Nat. Forest		<u>County:</u> Covington <u>State:</u> Alabama <u>PLSS (T-R-S):</u> 2N-15E-17 <u>Parcel No.:</u> 4 <u>Road Name:</u> Hog Foot Rd

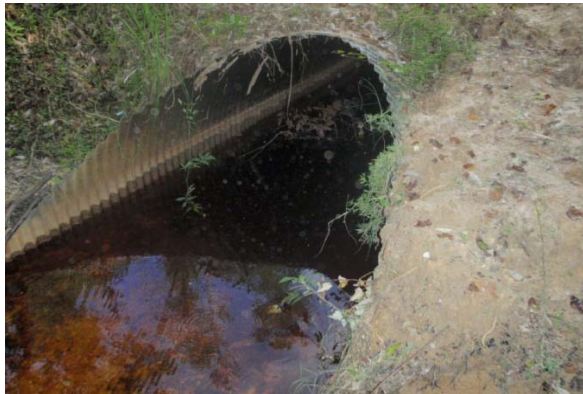
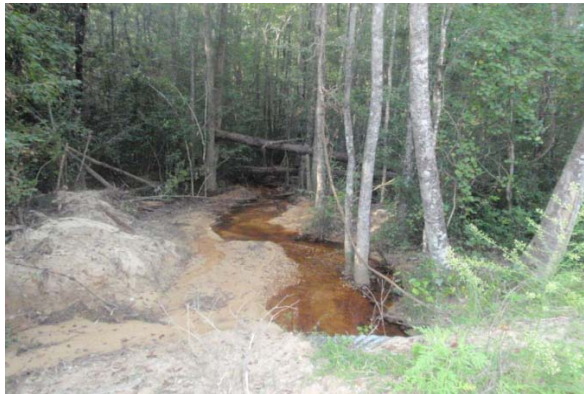
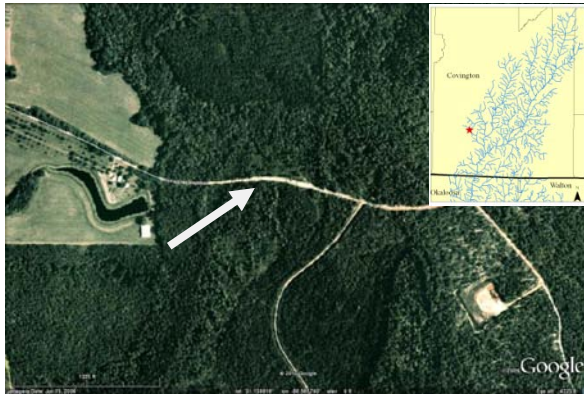
Crossing Structure: DS		DS																																																																			
<table border="1"> <thead> <tr> <th>Risk Factor</th> <th>Ranking</th> <th>Score</th> </tr> </thead> <tbody> <tr><td>US Channel Morph</td><td>WETLAND</td><td>5</td></tr> <tr><td>DS Channel Morph</td><td>C</td><td>5</td></tr> <tr><td>DS Bank Alteration</td><td>HIGH</td><td>1</td></tr> <tr><td>Upstream Skew Angle</td><td><5°</td><td>5</td></tr> <tr><td>Crossing fill condition</td><td>Poor/Bare soil</td><td>1</td></tr> <tr><td>Inlet/Outlet Condition</td><td>Sed Islands/Scouring</td><td>3</td></tr> <tr><td>Road Approach Material</td><td>All Sand/Clay</td><td>3</td></tr> <tr><td>Potential Eroded Volume Mean</td><td><21 y³</td><td>5</td></tr> <tr><td>Approach Slope Mean</td><td>2.1-4%</td><td>3</td></tr> <tr><td>Soil K Factor</td><td><0.20</td><td>5</td></tr> <tr><td>Upstream Rt Outlet</td><td>Bare soil</td><td>0</td></tr> <tr><td>Upstream Lt Outlet</td><td>Vegetated</td><td>1</td></tr> <tr><td>Upstream Rt Ditch</td><td>Bare soil</td><td>0</td></tr> <tr><td>Upstream Lt Ditch</td><td>Bare soil</td><td>0</td></tr> <tr><td>Downstream Rt Outlet</td><td>Vegetated</td><td>1</td></tr> <tr><td>Downstream Lt Outlet</td><td>Bare soil</td><td>0</td></tr> <tr><td>Downstream Rt Ditch</td><td>Bare soil</td><td>0</td></tr> <tr><td>Downstream Lt Ditch</td><td>Bare soil</td><td>0</td></tr> <tr><td>Outlet Total</td><td>Partially Improved Outlet System</td><td>3</td></tr> <tr><td>Ditches Total</td><td>Unimproved Drainage System</td><td>1</td></tr> <tr><td>SRI Total</td><td>Medium Risk</td><td>40</td></tr> </tbody> </table>		Risk Factor	Ranking	Score	US Channel Morph	WETLAND	5	DS Channel Morph	C	5	DS Bank Alteration	HIGH	1	Upstream Skew Angle	<5°	5	Crossing fill condition	Poor/Bare soil	1	Inlet/Outlet Condition	Sed Islands/Scouring	3	Road Approach Material	All Sand/Clay	3	Potential Eroded Volume Mean	<21 y ³	5	Approach Slope Mean	2.1-4%	3	Soil K Factor	<0.20	5	Upstream Rt Outlet	Bare soil	0	Upstream Lt Outlet	Vegetated	1	Upstream Rt Ditch	Bare soil	0	Upstream Lt Ditch	Bare soil	0	Downstream Rt Outlet	Vegetated	1	Downstream Lt Outlet	Bare soil	0	Downstream Rt Ditch	Bare soil	0	Downstream Lt Ditch	Bare soil	0	Outlet Total	Partially Improved Outlet System	3	Ditches Total	Unimproved Drainage System	1	SRI Total	Medium Risk	40
