| Unnamed tributary | | ok-0617-r-002 | Sedimentation Risk Index 42 | | | | | | | | | | | | | | | | | | | | | | | | | | | | | | | | | | | | | | | | | | | | | | | | | | | | | | | | | | | | | | | | | | |
| <u>Common:</u> 8.78mi NW of Crestview <u>Drainage:</u> Deadfall Creek <u>GPS:</u> 30.869556, -86.644992 <u>Land owner:</u> Lenwood Jackson-DS, Warren Griffith-US | | <u>County:</u> Okaloosa <u>State:</u> Florida <u>PLSS(T-R-S):</u> 4N-24-04 <u>Parcel No.:</u> 4, 5 <u>Road Name:</u> Lenwood Jackson Rd | | | | | | | | | | | | | | | | | | | | | | | | | | | | | | | | | | | | | | | | | | | | | | | | | | | | | | | | | | | | | | | | | | | |

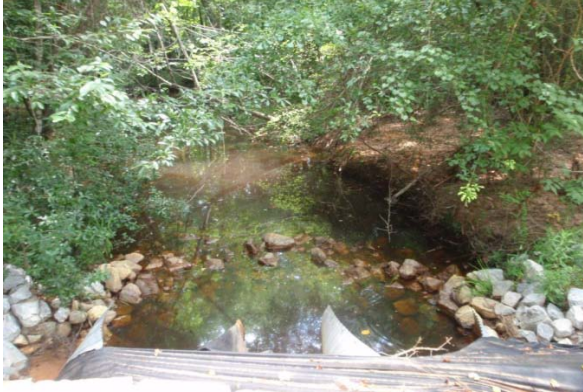
Notes: Oily sheen, LT buffer logged bare, severe erosion over culvert. Rip rap encircling DS. Impounded farther US.
